## Caveats for Cisco IOS Release 12.2(33)SRE through 12.2(33)SRE9

## Resolved Caveats—Cisco IOS Release 12.2(33)SRE9a

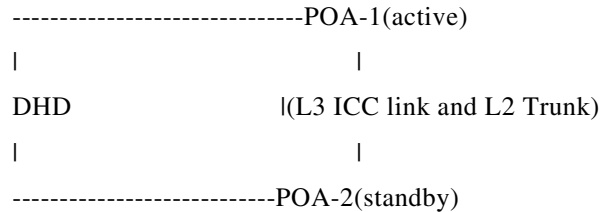
Topology:

Symptoms: In the following topology, the port-channel link on the standby PoA may forward packets unexpected to DHD. The issue is observed in both Cu's environment and the test lab:

In Cu's environment: When DHD sends an ARP request to ask for MAC of an HSRP virtual IP, it will receive the ARP reply from the standby PoA, causing MAC flapping on DHD. In the lab test environment: When you configure static ARP on PoAs to bind an IP address with a nonexistent MAC address, ping this IP, so it will do unicast flooding within VLAN. When you ping, POA-2(standby) also sends out the unicast packet to DHD via its port-channel link.

Conditions: This symptom occurs both on SRE2 and SRE3 with MLACP deployment.
