# GS7000, GainMaker, and 694X Node Transmitter RF Shutdown Technical Bulletin

The optical transmitters of the GS7000, GainMaker, and 694X Nodes with specific date codes may have a defective capacitor which results in RF shutdown.

© 2010 Cisco Systems, Inc. All rights reserved.  
January 2010

Printed in United States of America  
Part Number 4036533 Rev A

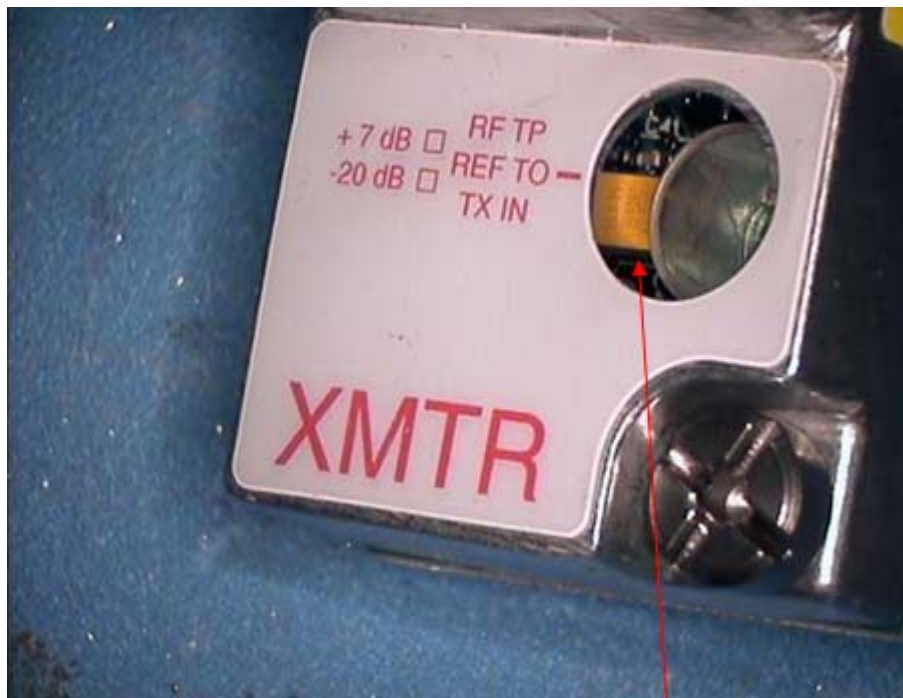
Illustration #3-Test Point opening and view of capacitor

The following illustration shows the test point opening for the GS700 transmitter and GainMaker 694X transmitter from illustration #1 and #2. Capacitor C42 (large yellow capacitor) and date code can be inspected via the test point opening using an ostoscope at an angle.

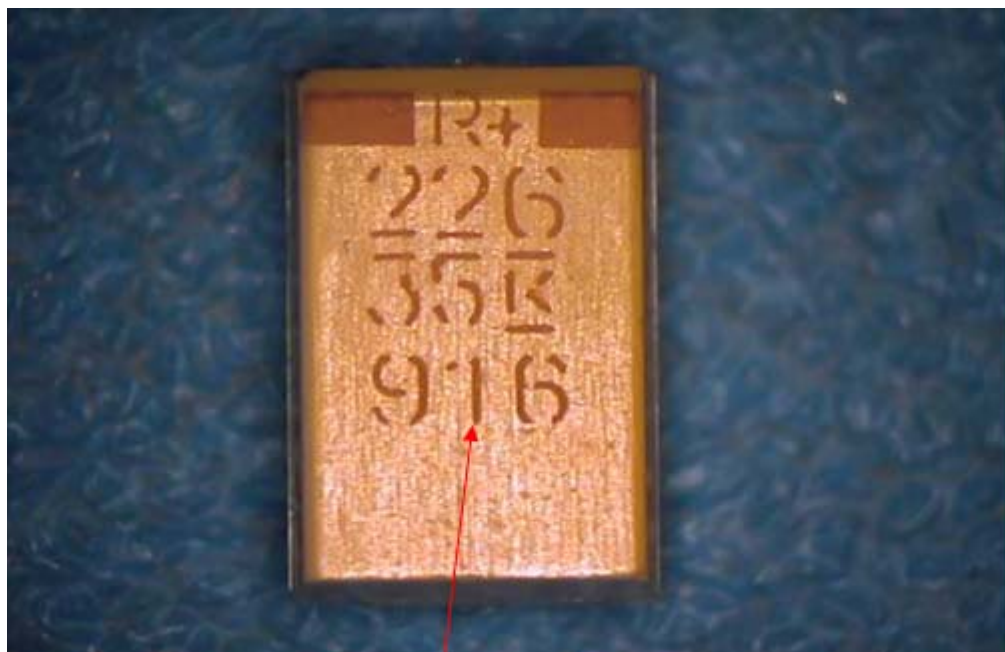
If you have a transmitter that displays this symptom and contains a capacitor with a date code of 916, 917, or 919 (As shown in illustration #4), the transmitter(s) should be returned to our repair facility for replacement.

**Illustration # 4-**The component date code is the bottom number (916)

**Note:** If you are not able to determine the date code, return the module for service. Refer to *Support Telephone Numbers* (on page 10).

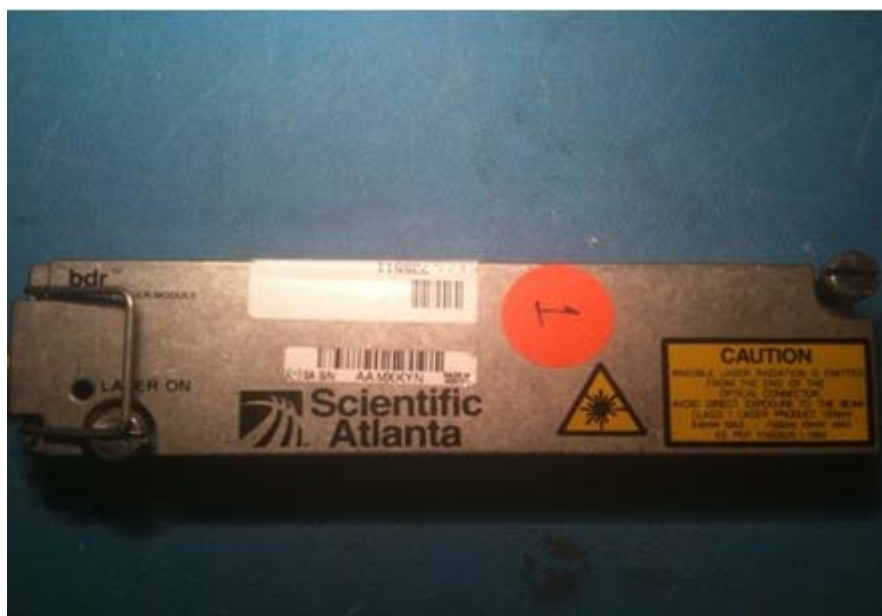
**Illustration #5-2:1 BDR Transmitter**

The following illustration shows BDR 2:1 transmitters ONLY. There is no access to view the capacitor with the cover installed. If the transmitters have date code D2009 - K2009 and they are listed under the affected part number series, return the module for service. Refer to *Support Telephone Numbers* (on page 10).

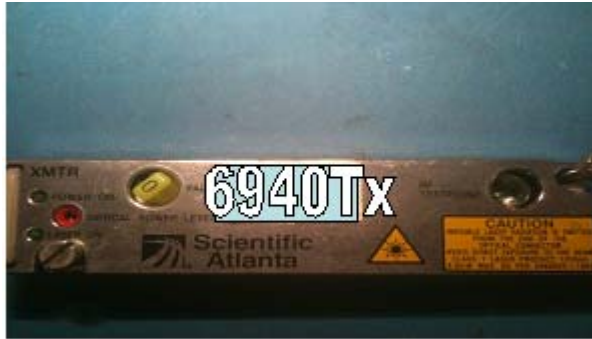
**Illustration #6-6940 Tx**

The following illustration shows a 6940 transmitter. The capacitor can be inspected via the RF test point opening using an ostoscope at an angle.

**Note:** If you are unable to determine the date code, return the module for service. Refer to *Support Telephone Numbers* (on page 10).

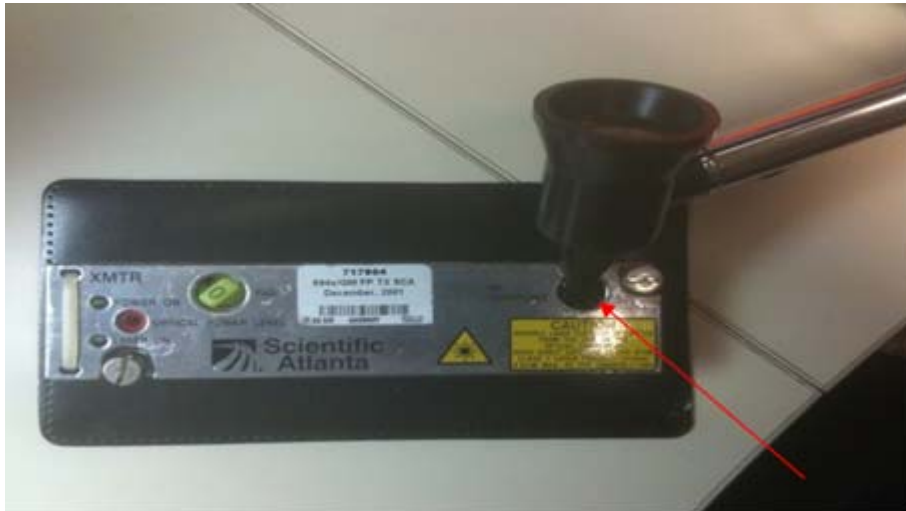
**Illustration #7-6940 Tx**

The following illustration shows the 6940 transmitter and the ostoscope used to inspect the capacitor. Capacitor location reference designator is C32.
