# Model GS7000 GainMaker Node Optical Interface Board DC Voltage Short Technical Bulletin

78-4020208-01 Rev D

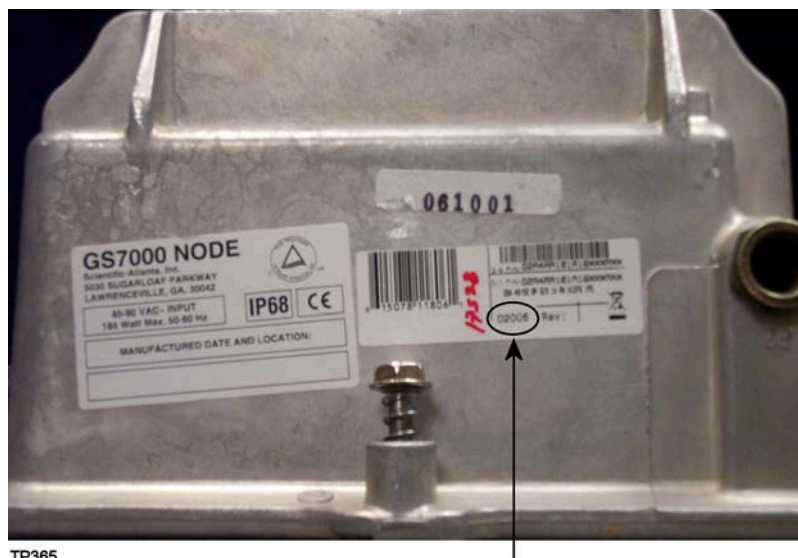
Manufactured Date Code

The manufactured date code appears on one of the product labels affixed to the side of the node housing. The following illustration shows the location of the date code. The date code in this example is D2006.

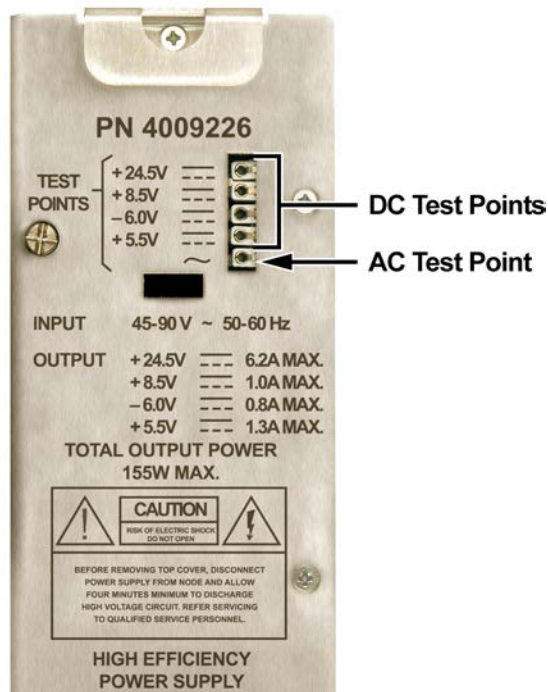
- 1 Measure voltages at the power supply test points and verify proper DC output.

**Note:** Improper voltage readings from the power supply do not necessarily indicate a failed power supply. It could indicate an issue in another node component.

- a If the power supply voltages are correct, continue with step 2.
- b If the power supply voltages are NOT correct, troubleshoot and/or replace the power supply before continuing with the rest of this test procedure.

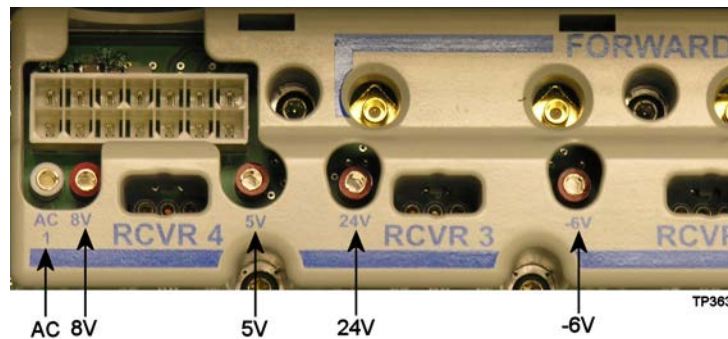
- 2 Measure voltages at the OIB test points.

**Note:** OIBs with the shorting condition will indicate improper voltages at the test points. Typically, only the 5 V DC is affected by the shorting condition.

- 3 If the OIB is bad, it should be replaced. Refer to *OIB Replacement Procedure* (on page 6).
