# Model GS7000 GainMaker Node RF Cable Technical Bulletin

A small percentage of Model GS7000 GainMaker® Nodes that were manufactured and shipped prior to May 2008 may exhibit an intermittent "no RF" or "low RF" condition in the forward or reverse path. This condition can be caused by forward or reverse RF cables that have intermittent continuity.

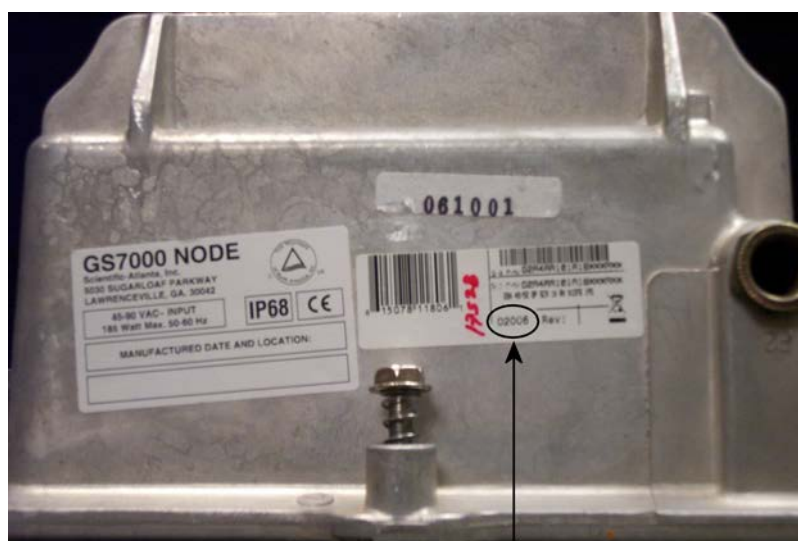
TP365

Model GS7000 Nodes with manufactured date codes before May 2008 (E2008) could be affected by this issue.

The manufactured date code appears on one of the product labels affixed to the side of the node housing. The following illustration shows the location of the date code. The date code in this example is D2006.

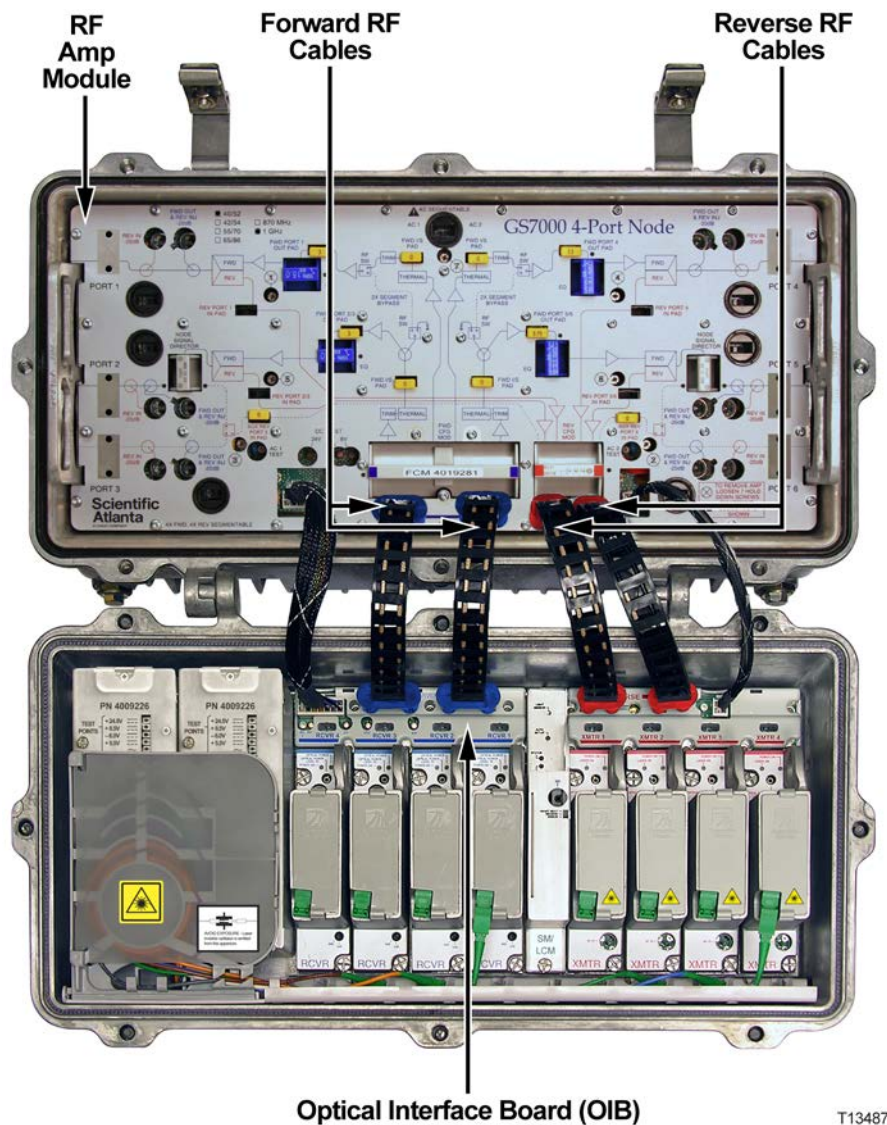
T13487

The plug-in RF cables are located between the RF Amplifier Module and the Optical Interface Board (OIB). The RF cable connectors have color-coded plastic molded ends. The forward RF cable connectors are **Blue** and the reverse RF cable connectors are **Red**.

The following illustration shows the location of the cables in an analog reverse node.

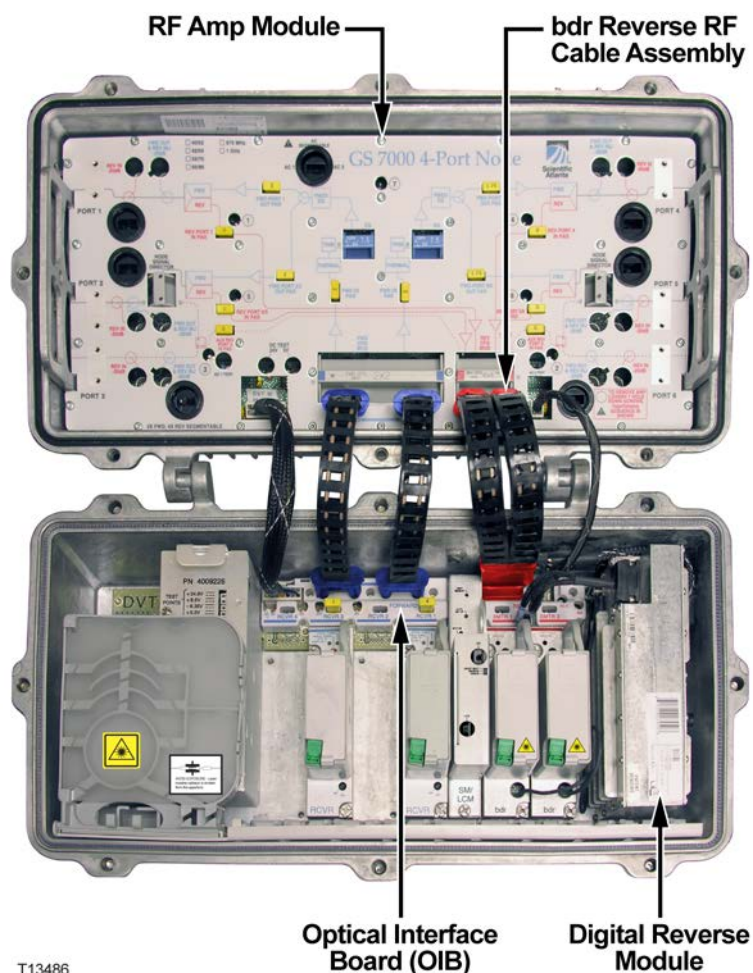
T13486

The bdr™ reverse RF cable connectors are also **Red**. The following illustration shows the location of the cables in a bdr digital reverse node.

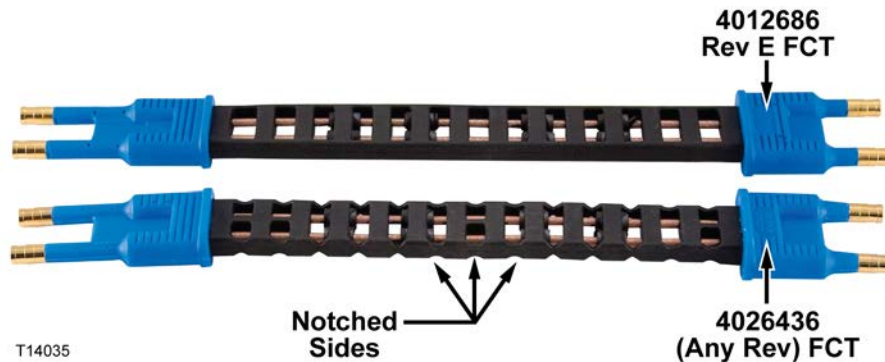
The following illustration shows the forward RF cables and their part numbers/revision levels. Their plastic molded connector ends are **Blue**.

**Note:** Either cable can be used. Both the part number 4012686 Rev E cable or any revision of the part number 4026436 cable correct the intermittent continuity issue described in this technical bulletin.

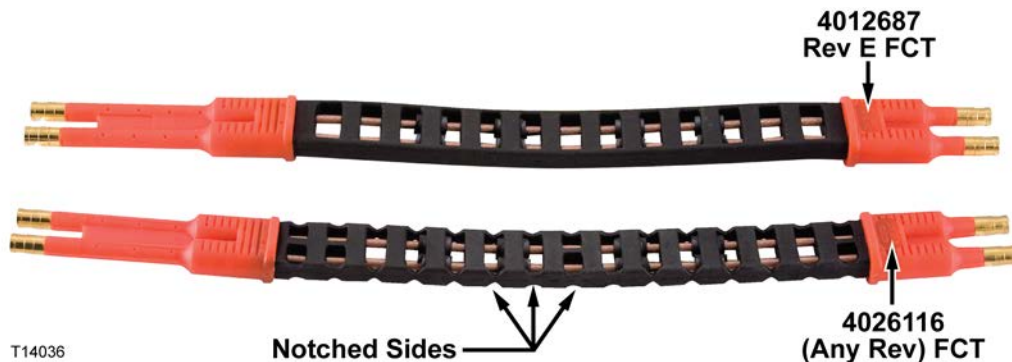
The following illustration shows the reverse RF cables and their part numbers/revision levels. Their plastic molded connector ends are **Red**.

**Note:** Either cable can be used. Both the part number 4012687 Rev E cable or any revision of the part number 4026116 cable correct the intermittent continuity issue described in this technical bulletin.

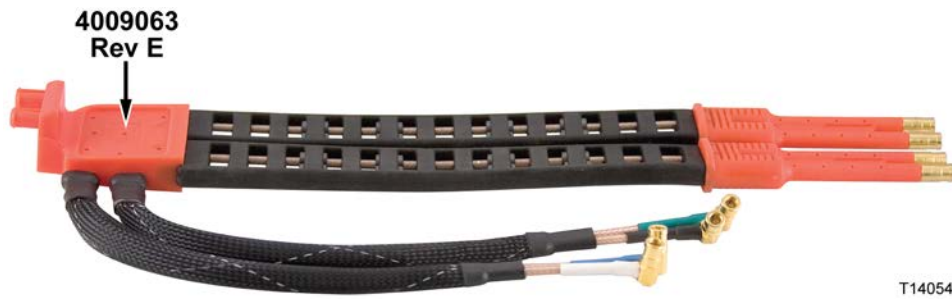
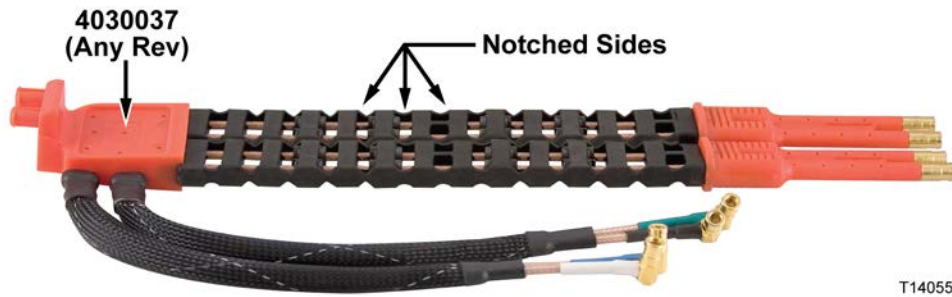
The following illustrations show the bdr reverse RF cables and their part numbers/revision levels. Their plastic molded connector ends are also **Red**.

**Note:** Either cable can be used. Both the part number 4009063 Rev E cable or any revision of the part number 4030037 cable correct the intermittent continuity issue described in this technical bulletin.
