# Model GS7000 GainMaker Node Optical Interface Board DC Voltage Short Technical Bulletin

Part Number 4020208 Rev D

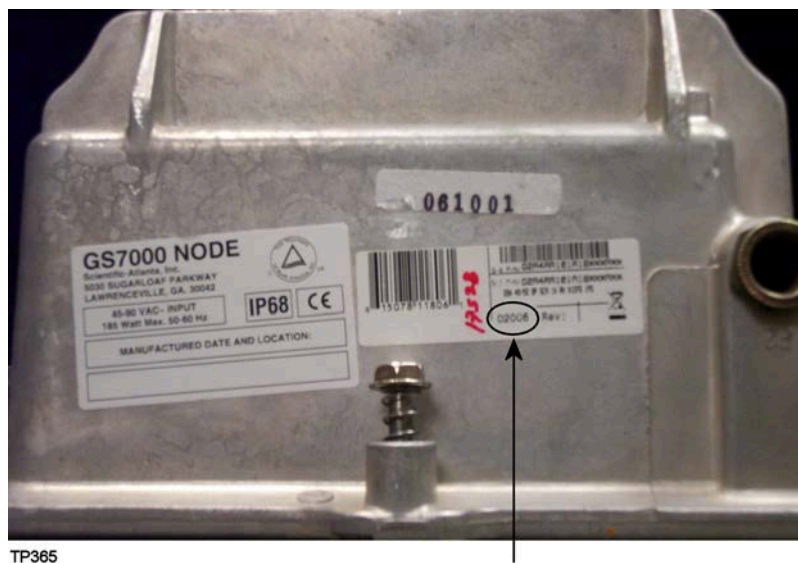
Manufactured Date Code

The manufactured date code appears on one of the product labels affixed to the side of the node housing. The following illustration shows the location of the date code. The date code in this example is D2006.

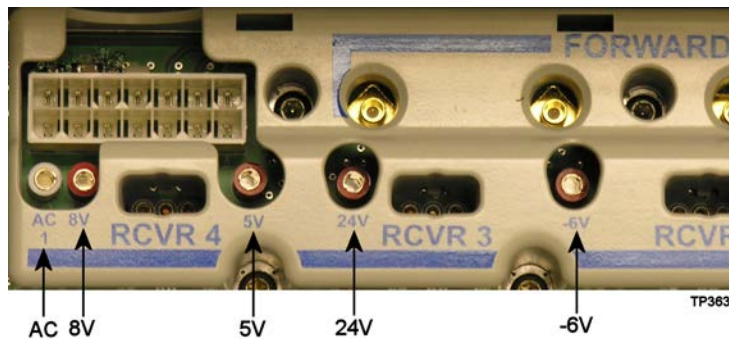
- 2 Measure voltages at the OIB test points.

**Note:** OIBs with the shorting condition will indicate improper voltages at the test points. Typically, only the 5 V DC is affected by the shorting condition.

- 3 If the OIB is bad, it should be replaced. Refer to *OIB Replacement Procedure* (on page 6).
