1 GHz GainMaker System Amplifier Low Forward Band Roll-off Technical Bulletin

78-4021314-01 Rev D

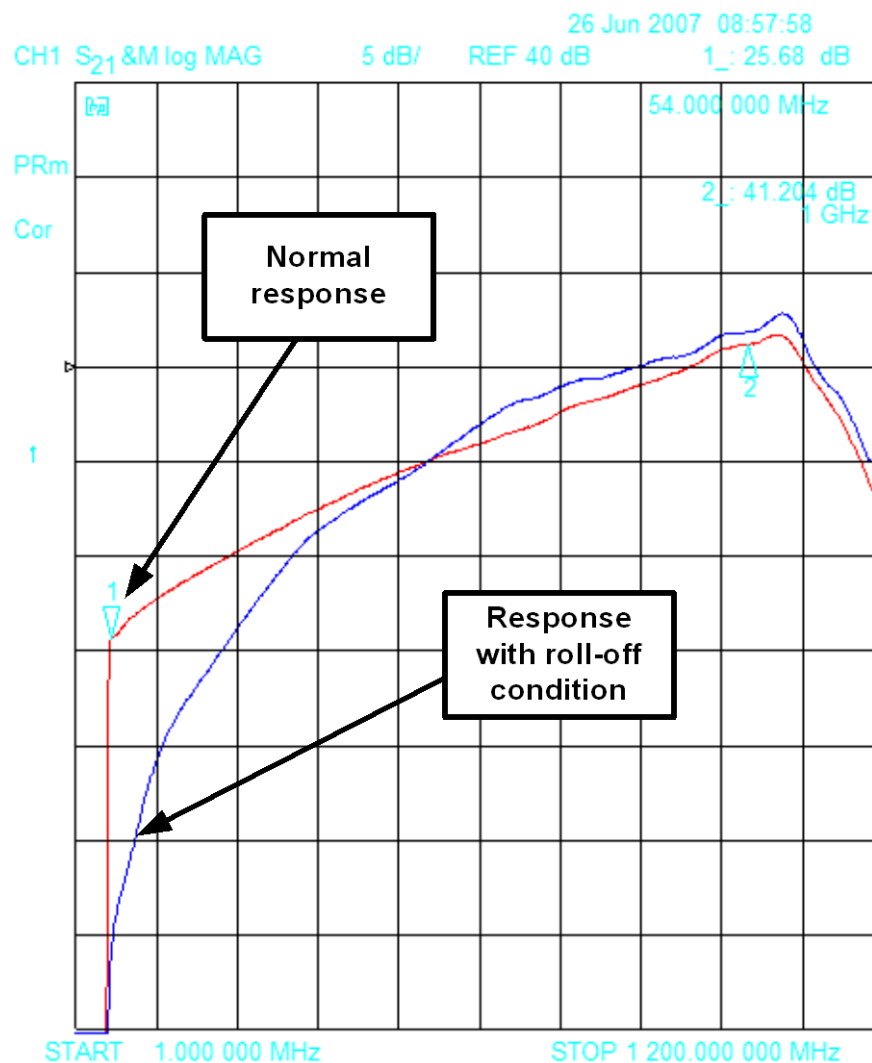
An issue was discovered recently with 1 GHz GainMaker® System Amplifiers exhibiting signal roll-off in the lower portion of the forward frequency band. The roll-off occurs when one or more capacitors in the pre-amplifier section become fractured. The effect of the damaged capacitor(s) on performance is most significant and noticeable in the lower portion (channels 2-6) of the forward band.

Reduced gain in the forward band, particularly at low frequencies, is a symptom of a possible fractured-capacitor condition. In the figure below, the plot labeled **Normal response** shows typical amplifier or node gain at 54 MHz. The plot labeled **Response with roll-off condition** shows the greatly reduced gain at the lower end of the band.

Note: This plot shows a gain reduction of nearly 15 dB at 54 MHz, but as little as 5 dB gain reduction at 54 MHz may indicate a fractured-capacitor condition.

If an amplifier exhibits the trouble symptom described in this document, we recommend returning the unit to Cisco for repair or replacement. Refer to *For Information* (on page 5).
