Reverse Segmentable GainMaker Node OIB Shorting Condition Technical Bulletin

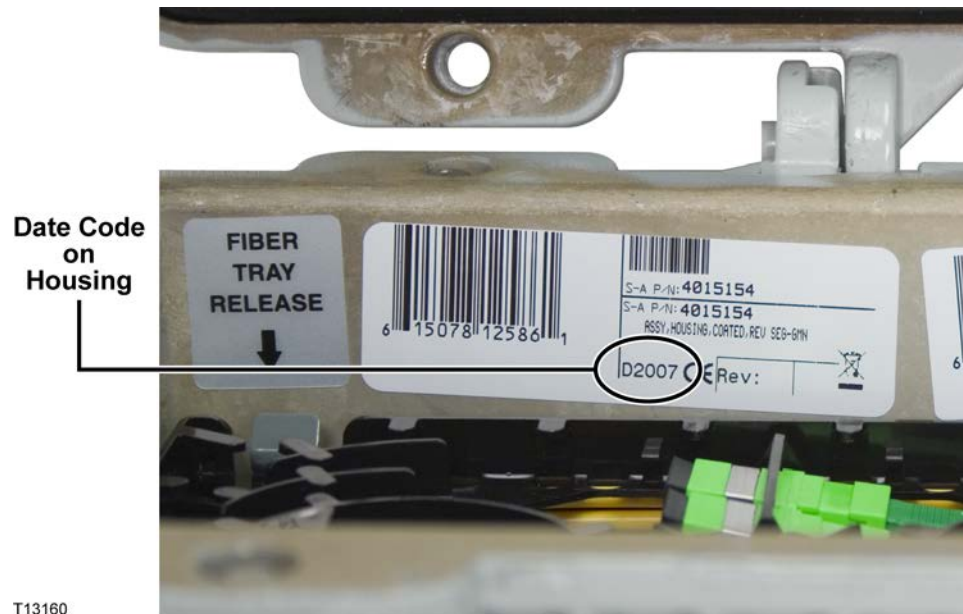
A sample date code label as it appears on the interior of a Reverse Segmentable GainMaker Node housing is shown below.

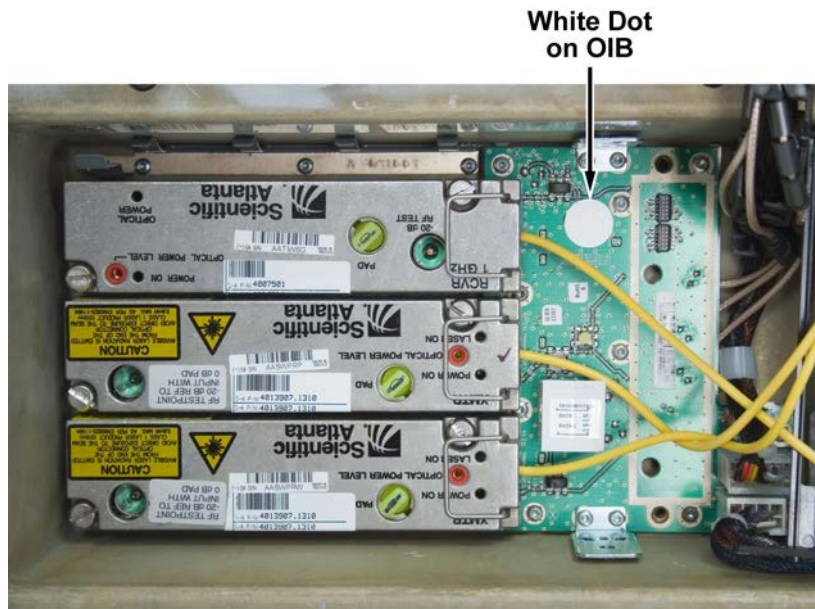
T13161

An identical white dot also appears inside a reworked node, affixed to the OIB just above the part number, as shown below.
