Prisma II 1310 nm AGC Transmitters Display White Lines Technical Bulletin

This technical bulletin applies to all cable system operators and technicians who use Prisma II™ 1310 nm Transmitters with manufacturing date codes between February 2003 (B03) and September 2003 (J03).

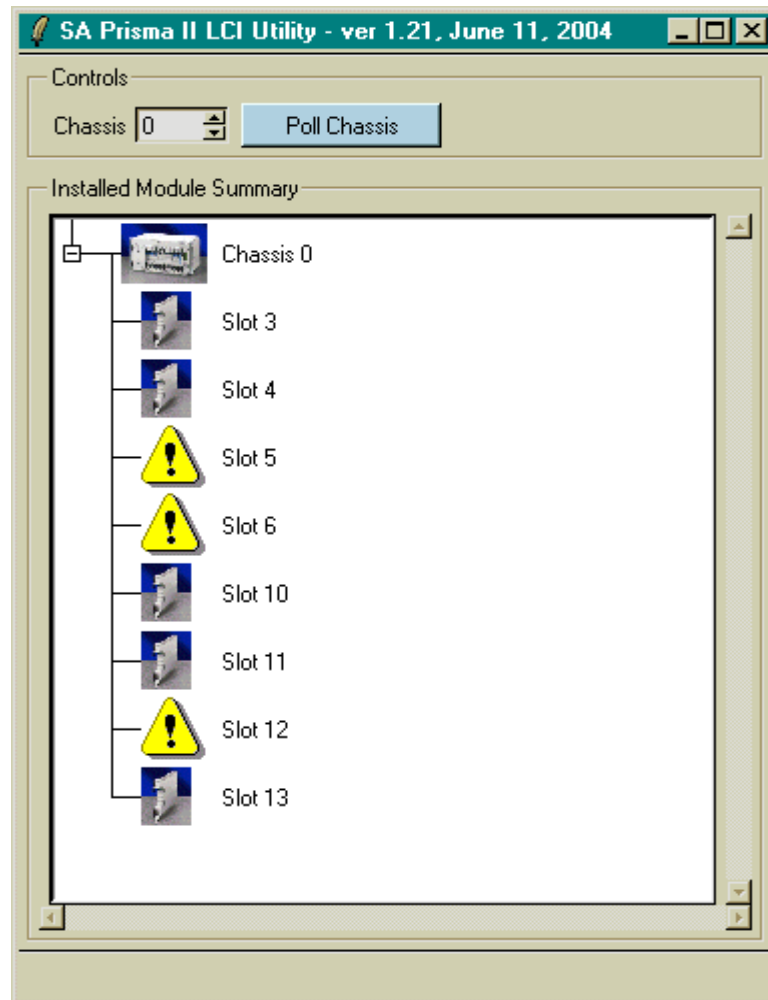
In the example above, slots 5, 6, and 12 contain transmitters that require an update. Slots 4, 10, 11, and 13 contain units that do not need an update.

Note: Slot 3 is the fan tray of the chassis, not a transmitter.

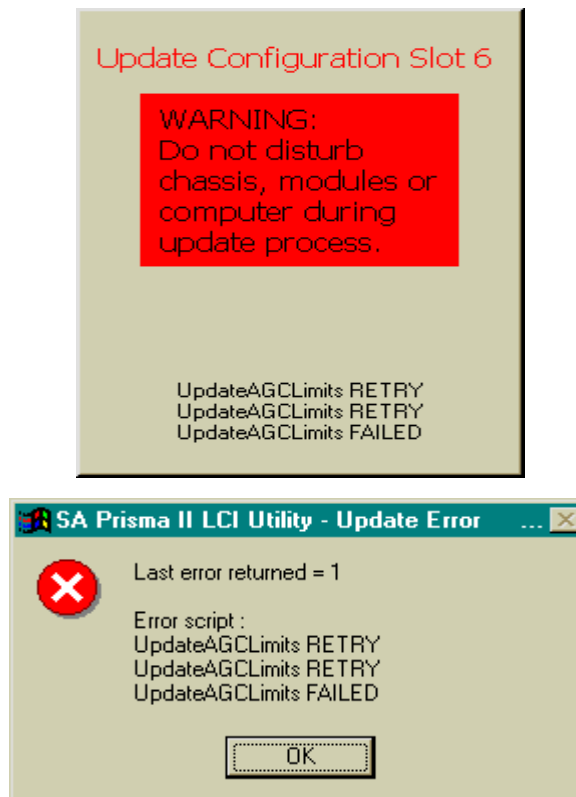
11. If you try to start the update and there is a communications failure, a message similar to the following displays.

If you receive a similar message, check the following:

- Is the transmitter you are trying to update still secure in the chassis?
- Is the RS-232 serial cable still connected properly?

After checking these items, click **OK** in the update error message box and then retry the update starting at step 9.
