Prisma II 1310 nm Reverse Transmitter Low RF Reading with RF Tap Terminated Technical Bulletin

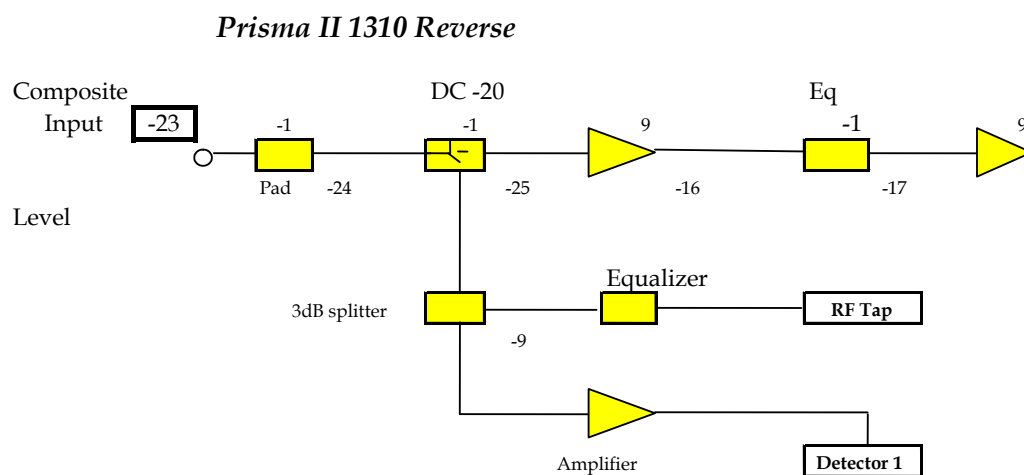
The following block diagram serves to illustrate the reason for this occurrence.

Per the design of the Prisma II 1310 nm Reverse Transmitters circuitry, the RF Tap and Video Detector circuit share a common output point at the 3 dB splitter. Under normal operating conditions, (i.e., RF tap is open-circuited) the RF tap leg of the 3 dB splitter will present a higher impedance path than when the tap is terminated with 75 ohms. This in turn has the effect of transferring more RF power to the detector leg of the splitter.

Tests were conducted and these tests showed that when the RF tap is not terminated, the voltage at the splitter node is higher by 52 mV than when terminated. This voltage translates into a -1.17 dB difference reported to the ICIM, LCI, TNCS and ROSA software. An impedance different from 75 ohms, for example, poor return loss of instrument, will give another tolerance. It has been confirmed by Cisco that this only has an impact on the ICIM, LCI, and TNCS and ROSA software reading, and has no affect upon the RF power used to modulate the laser. This has been verified by confirming the RX output power does not vary, when the RF tap on the reverse TX is terminated.

The RF power reported by ICIM, LCI, TNCS, or ROSA software will be approximately 1.0 dB to 1.5 dB lower than actual performance when a load is present at the RF test point on the module front panel. This condition is caused by a variance in the test point load presented by the operator and will not effect the performance of the actual RF power. When the RF power is being monitored by ICIM, LCI, TNCS, or ROSA software, take care to ensure the RF test point on the front panel is not loaded.
