# Prisma II Reverse Receiver Incorrect or Incomplete Data Display Technical Bulletin

The purpose of this document is to inform users of full-height Prisma II™ Reverse Receiver application modules of an issue regarding the display of incorrect or incomplete module status information.

- Model P2-RXRD Prisma II Dual Reverse Receiver (data), part numbers 716488, 734945, 734946, 734947, date code range B08 through E08
- Model P2-RXRV Prisma II Dual Reverse Receiver (video), part numbers 716480, 734948, 734949, 734950, date code range B08 through E08

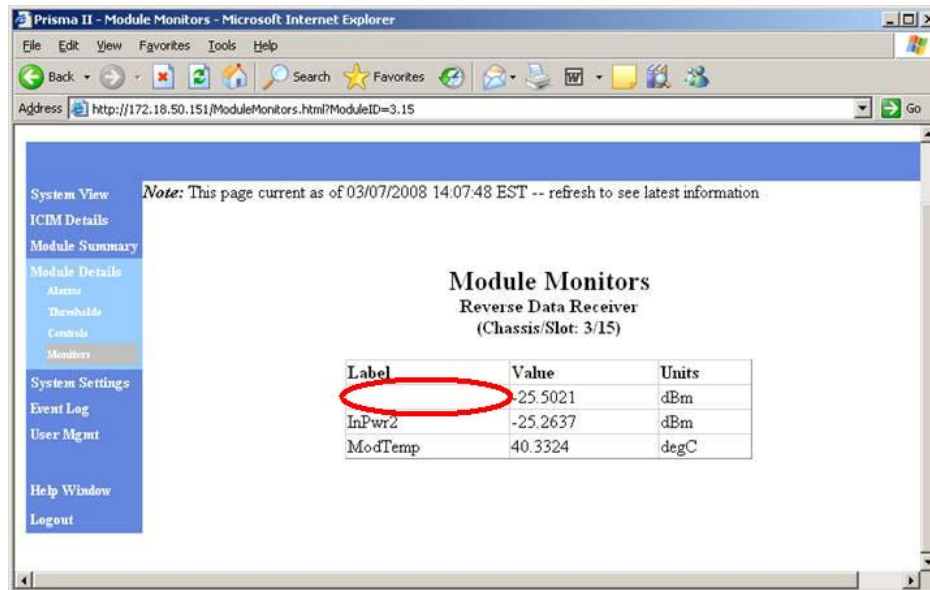
## ICIM Web Interface Screen

The following illustration shows an ICIM Web Interface screen in which the label for InPwr1 is missing (see circled area).

Customers can correct affected units by running a custom Windows software program, as described in this section, during their normal service window. This program updates the module firmware, and is available from Cisco Services.

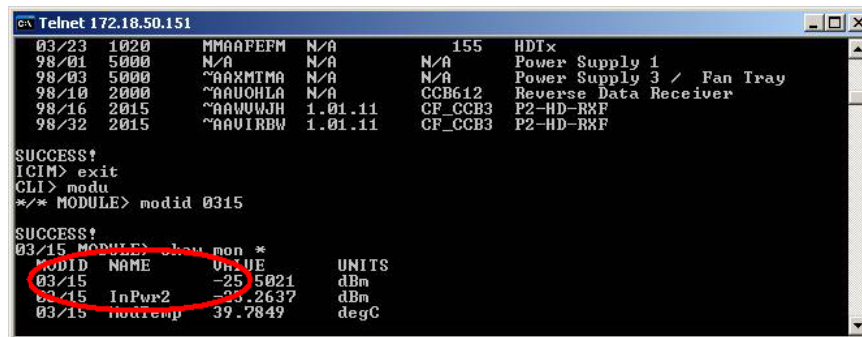
## ICIM2 CLI Session

The following illustration shows a CLI session window in which the label for InPwr1 is missing (see circled area).

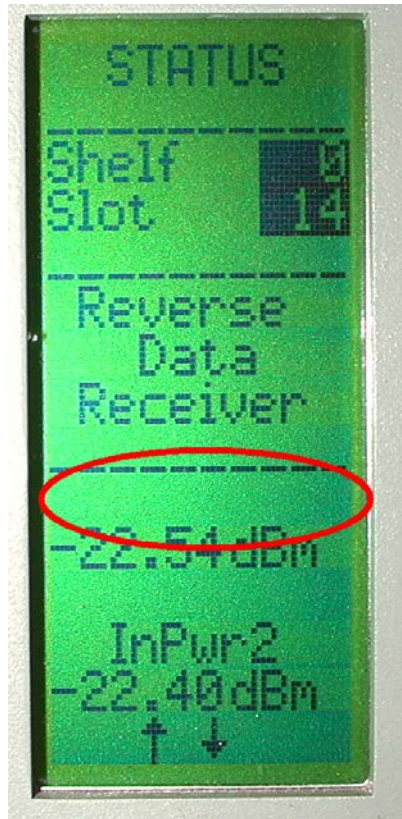
## ICIM Front-Panel LCD Display

The following illustration shows an ICIM2 LCD Status display in which the label for InPwr1 is missing (see circled area).
