9-Inch Stretch Tap Housing Seizure Screw Torque Specification

This technical bulletin defines the proper torque specification for the seizure screws when installing the 9-inch Addressable and Multimedia Stretch™ Tap housing.

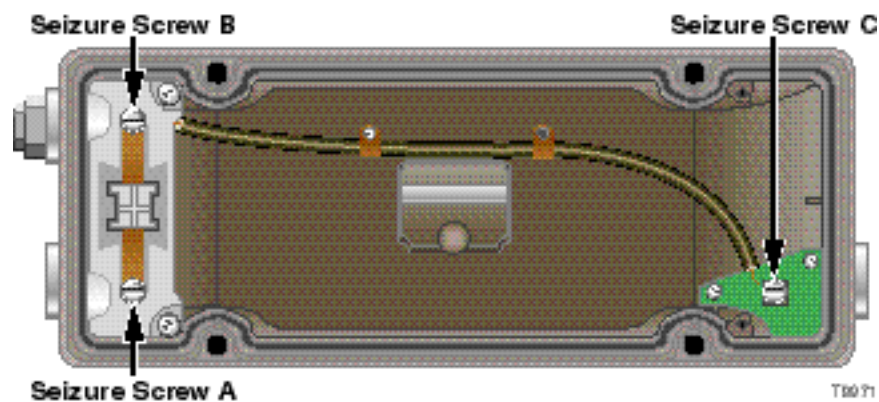
There is a potential failure condition in the Stretch Tap housing that can result in a junction overheating in the field. The failure is caused by insufficient torque on seizure screw B. Insufficient torque can cause a build up of resistive oxidation between the coax cable center conductor and the seizure screw. This can eventually cause the junction to overheat and burn.

When installing the Stretch Tap housing, follow the instructions in the appropriate Installation and Operations Guide for all seizure screw torque specifications. Seizure screw A and seizure screw C require a torque of 15 in-lb to 20 in-lb (1.7 Nm to 2.3 Nm). Additionally, seizure screw B requires a torque of 12 in-lb to 15 in-lb (1.4 Nm to 1.7 Nm).
