Release Notes for Cisco RV Series Multi-WAN VPN Routers Firmware Version 4.0.4.02

July 29, 2011

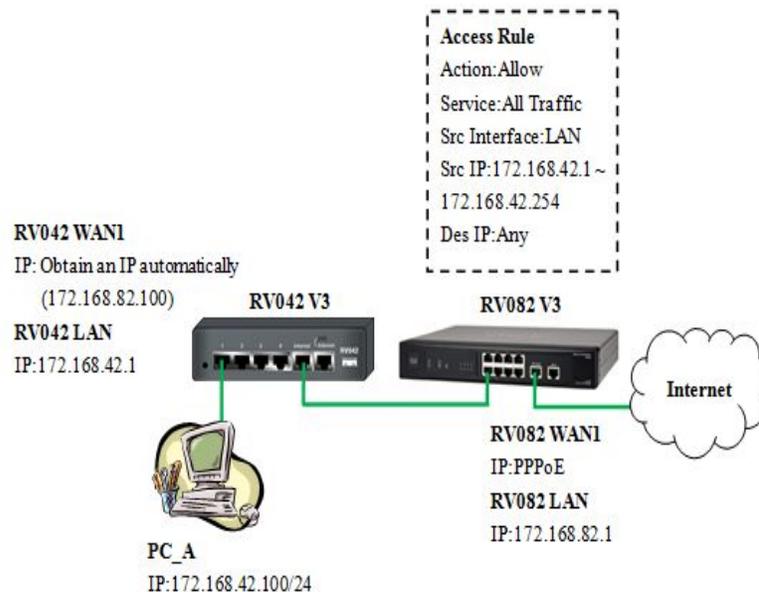
Multiple subnets on LAN issue.

- Description**—The RV0xx version 3 routers handle multiple subnets on the LAN side differently than the RV0xx version 2 routers. For example, the illustration below shows a sample network where the RV082 v3 (running in Gateway Mode, with NAT enabled) is the internet gateway and the RV042 v3 running in Router Mode is connected to the RV082 v3. To allow the computers in the LAN of the RV042 v3 to access the Internet, you need to add an Access Rule.

- **Workaround**—Add an access rule; for example, in the previous network example, the access rule would be configured as shown below:
