# Cisco RF Gateway 1 Software Release Notes, Release 2.05.06

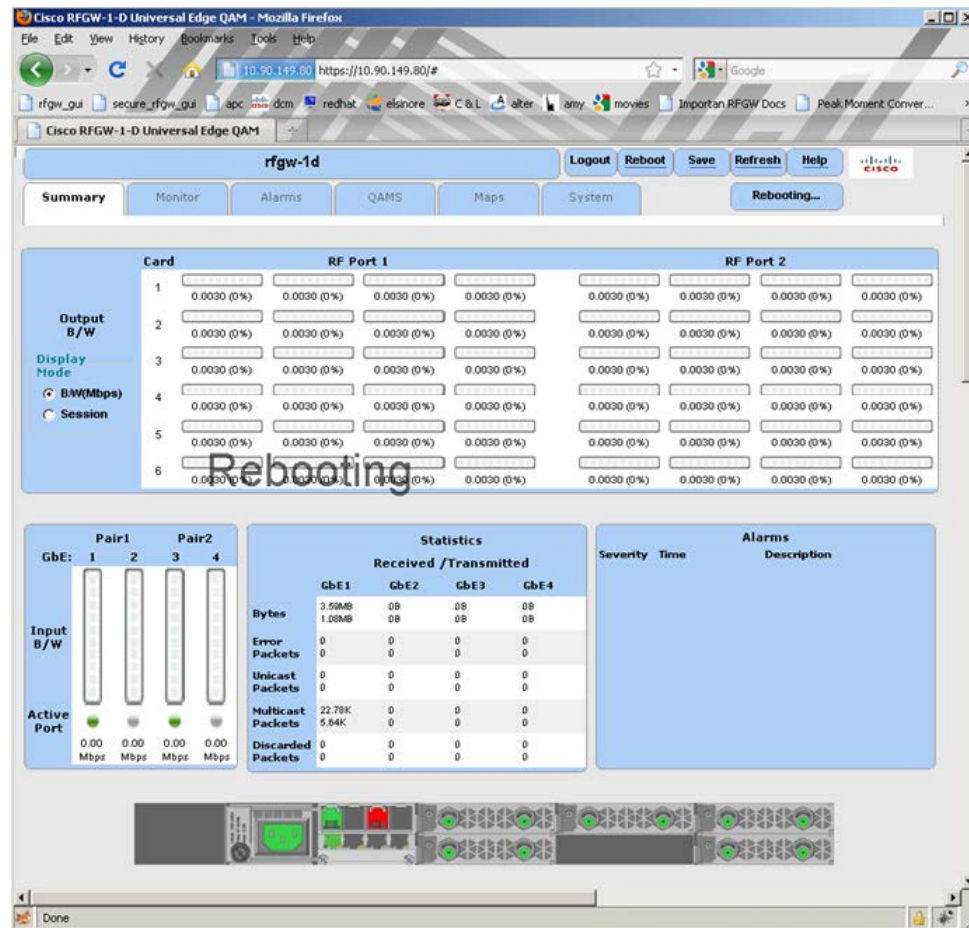
- The GUI times out after about 17 seconds of inactivity and no longer automatically reconnects to the RF Gateway 1. For example, if the RF Gateway 1 is rebooted from the GUI, the following page is displayed.

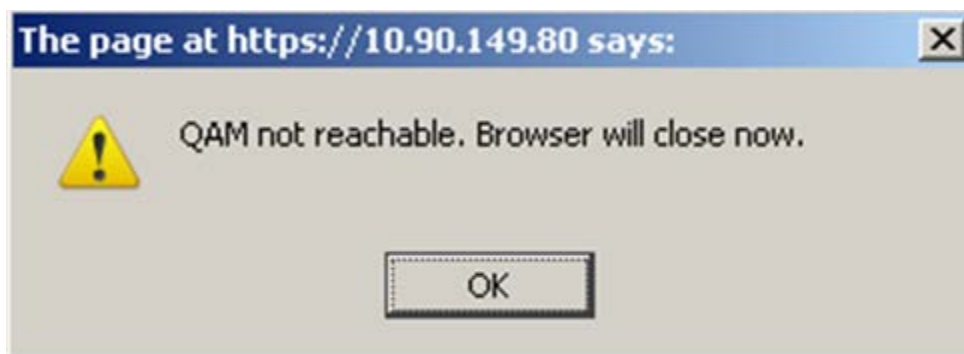
After 17 seconds, the screen below is displayed. Click **OK**. The browser closes. You will need to reopen the browser upon an RFGW reboot.
