Cisco RF Gateway 1 Software Release 3.01.08 Release Note

Overview

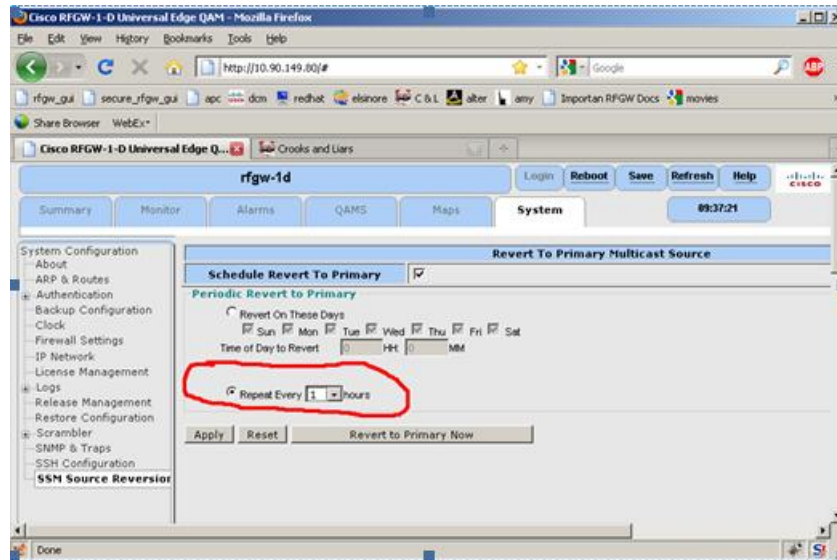
- When using the *Revert to Primary* option, select all the days of the week using the *Revert On These Days* option. See screen below. Depending on the operating conditions, the actual repeat cycle can increase from the initial set value by as much as one hour per week.

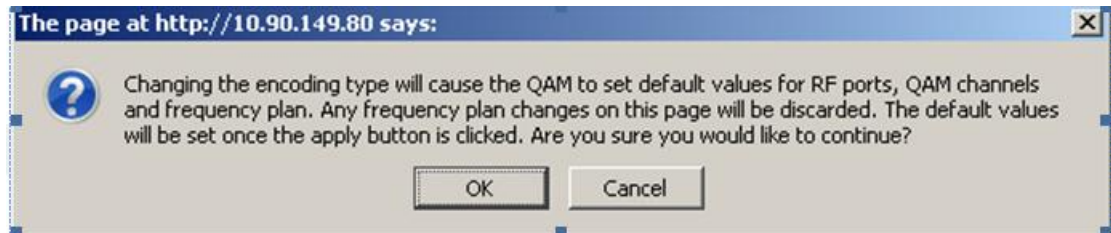
- The RF Gateway 1 reboots if the IP MIB is walked.
- The interleaver values for RF channels 5-8 are incorrect after upgrading. See *Upgrade Information* (on page 6) for a simple workaround.

The following special upgrade steps must be followed if the QAM encoding type is set to ITU-A and an 8 channel per-port license is to be installed after the upgrade.

- 1 Record the settings for RF ports, QAM channels, and frequency plan as they will be set to default values in a later step.
- 2 Upgrade to 3.01.08.
- 3 Install the 8 channel per-port license.
- 4 Set the QAM encoding type to ITU-B.

Result: The following message is displayed.

- 5 Press **OK**.
- 6 Set the QAM encoding back to ITU-A and restore the QAM settings.
