Release Notes for Cisco Business Edition 3000 Release 8.6(3)

December 5, 2011

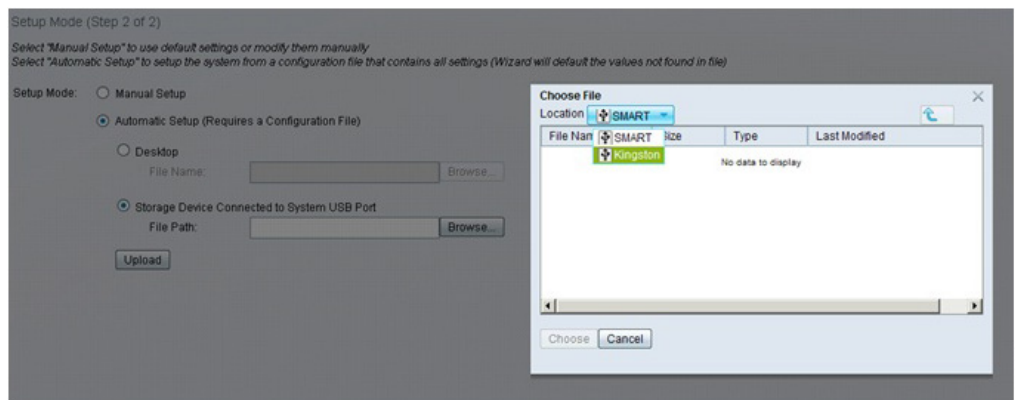
Figure 2 *Internal USB Key Displayed While Spreadsheet Is Copied*

Figure 2 shows that by default the internal USB key is displayed while the configuration spreadsheet is copied. Select the external USB key to copy the configuration spreadsheet.

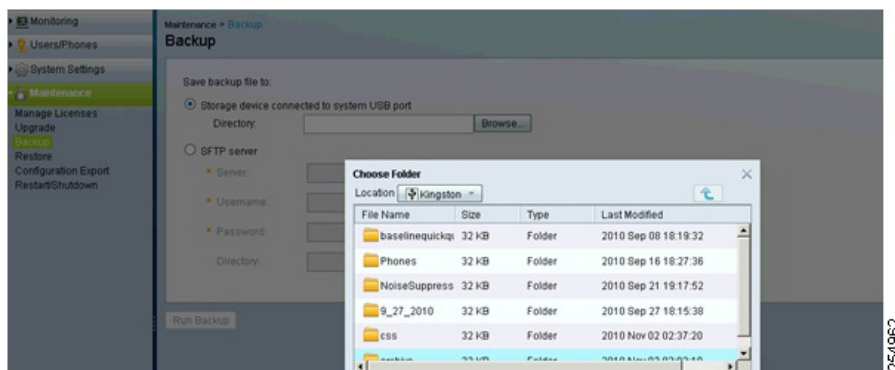
Figure 4 *Internal USB Key Displayed During Backup Operation*

Figure 4 shows that by default the internal USB key is displayed during a backup operation. Select the external USB key for a backup operation.
