# Release Notes for Cisco Business Edition 3000, Release 8.6(4)

June 25, 2012

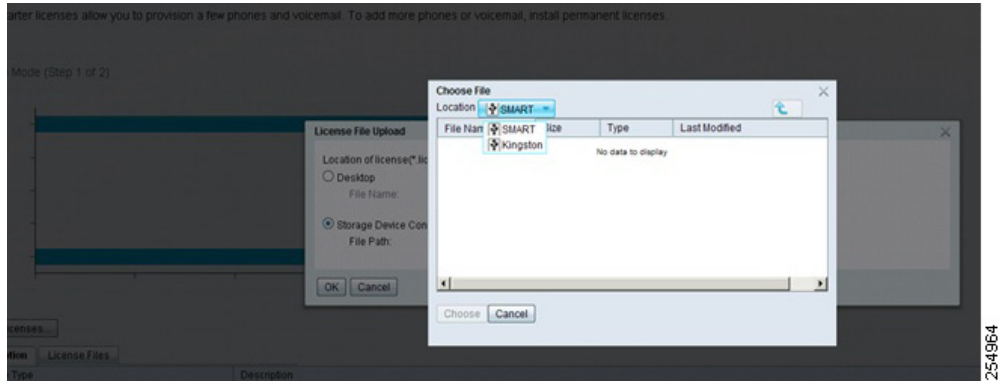
**Figure 1** *Internal USB Key Displayed While License Is Copied*

Figure 1 shows that by default the internal USB key is displayed while the license file is copied. Select the external USB key to copy the license file.

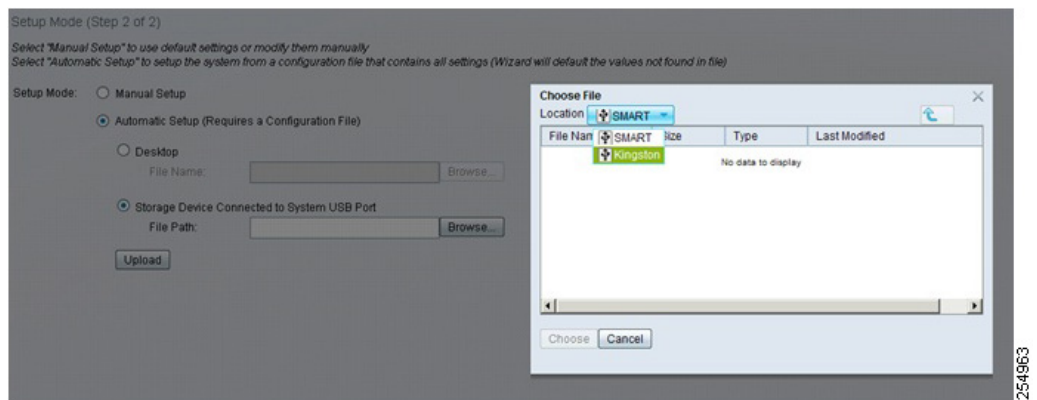
**Figure 2** *Internal USB Key Displayed While Spreadsheet Is Copied*

Figure 2 shows that by default the internal USB key is displayed while the configuration spreadsheet is copied. Select the external USB key to copy the configuration spreadsheet.

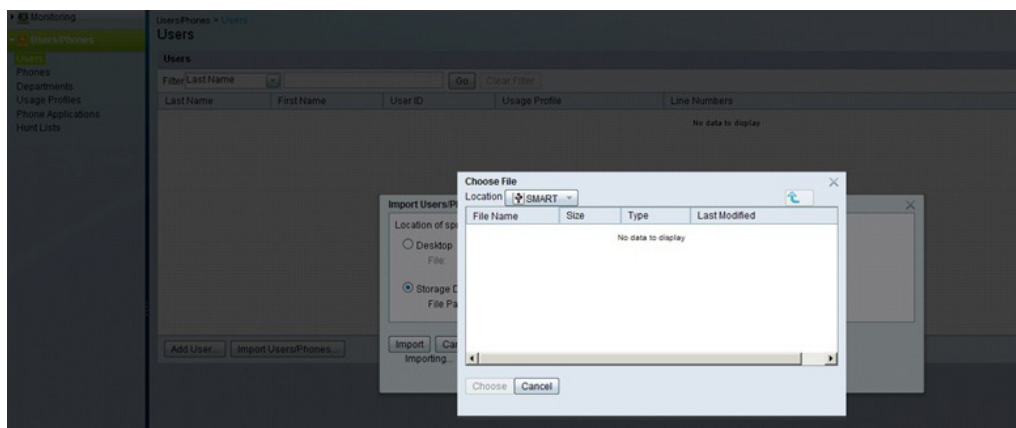
**Figure 3** *Internal USB Key Displayed for Users/Phones Operation*

Figure 3 shows that by default the internal USB key is displayed for the Users/Phones operation. Select the external USB key to copy the Users/Phones information.

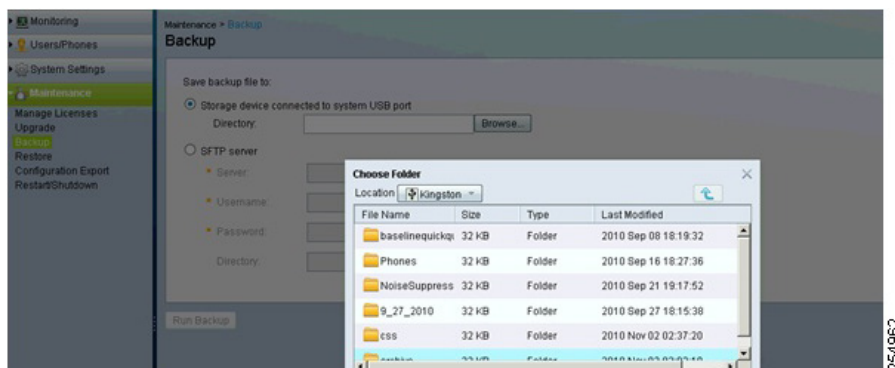
**Figure 4** *Internal USB Key Displayed During Backup Operation*

Figure 4 shows that by default the internal USB key is displayed during a backup operation. Select the external USB key for a backup operation.
