Release Notes for Cisco Aironet Access Points and Bridges for Cisco IOS Release 12.4(21a)JY

April 2010

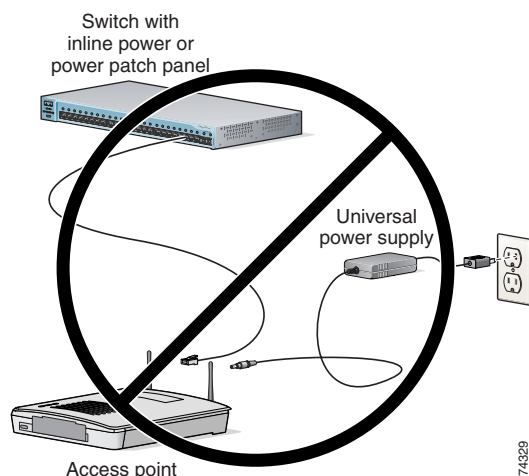
Figure 1 *Improper Power Configuration Using Two Power Sources*

You cannot provide redundant power to 1130 series access points with both DC power to its power port and inline power from a patch panel or powered switch to the access point Ethernet port. If you apply power to the access point from both sources, the switch or power patch panel might shut down the port to which the access point is connected. [Figure 1](#) shows the power configuration that can shut down the port on the patch panel or powered switch.
