Release Notes for Cisco Aironet Access Points for Cisco IOS Release 12.3(7)JA1

October 18, 2005

These release notes describe features, enhancements, and caveats for Cisco IOS Release 12.3(7)JA1. They also provide important information about Cisco Aironet 350, 1100, 1130AG, 1200, 1230AG, and 1240AG Series Access Points.

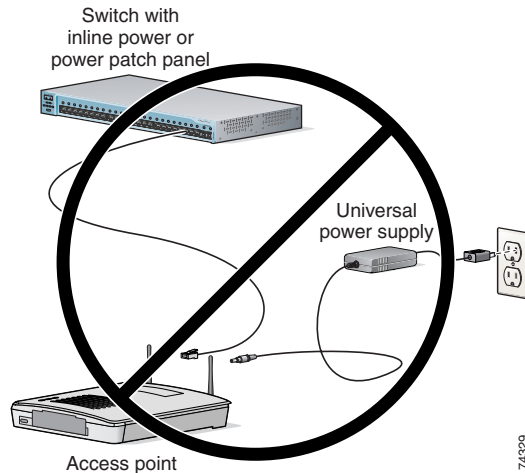
Figure 2 *Improper Power Configuration Using Two Power Sources*

You cannot provide redundant power to 1100, 1130AG, and 1200 series access points with both DC power to its power port and inline power from a patch panel or powered switch to the access point's Ethernet port. If you apply power to the access point from both sources, the switch or power patch panel might shut down the port to which the access point is connected. [Figure 2](#) shows the power configuration that can shut down the port on the patch panel or powered switch.
