Release Notes for Cisco Aironet Access Points for Cisco IOS Release 12.3(7)JA2

November 21, 2005

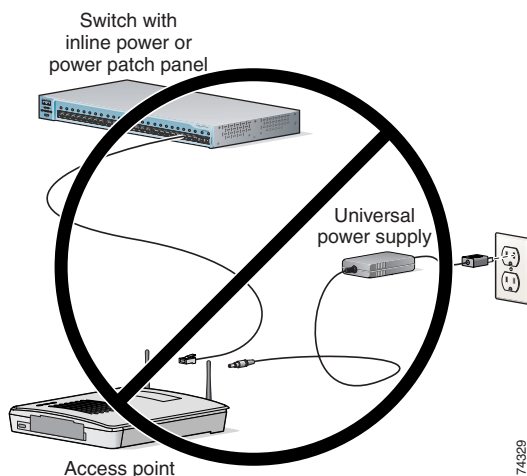
Figure 2 *Improper Power Configuration Using Two Power Sources*

You cannot provide redundant power to 1100, 1130AG, and 1200 series access points with both DC power to its power port and inline power from a patch panel or powered switch to the access point's Ethernet port. If you apply power to the access point from both sources, the switch or power patch panel might shut down the port to which the access point is connected. [Figure 2](#) shows the power configuration that can shut down the port on the patch panel or powered switch.
