Release Notes for Cisco MWR 2941 Mobile Wireless Edge Router Release 3.5.4, Cisco IOS Release 15.1(3)MRA3

January 10, 2014

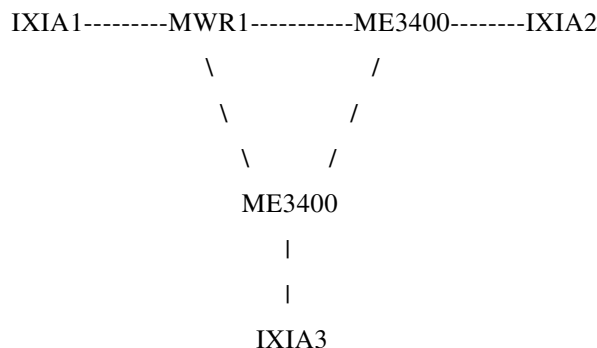
Topology:

- CSCui50681
Symptom: Traffic Leak with flex-link on MWR2941, where the two members of a flexi-link are connected to two different ME3400 belonging to a REP-ring.
Conditions: Traffic leaking over backup interface would cause L2-loop, if they did not have configured port-security on the ME3400.

Configure Flexi link in MWR towards peer nodes and flapping any of the flexi-link members.

Workaround: Currently there is no known workaround.

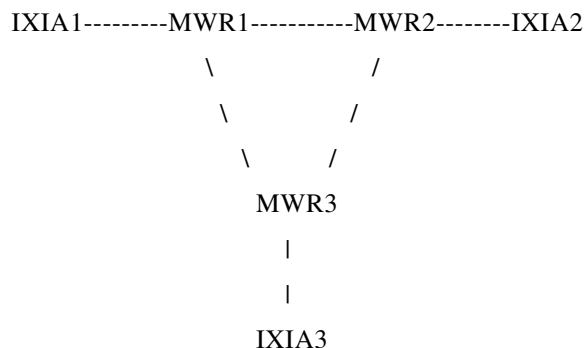
Topology:

Symptom: Command "**xconnect backup force-switchover peer**" does not work.

Configure Primary PW between MWR1 and MWR2, Back-up PW between MWR1 and MWR3. Make primary PW down, then backup PW comes up but the traffic will not forward through it.

Workaround: Flap the PW associated SVI in MWR1.
