## **Cisco ONS 15454 DWDM Troubleshooting Guide, Releases 9.8 and 10.x.x**

Text Part Number: 78-21405-01

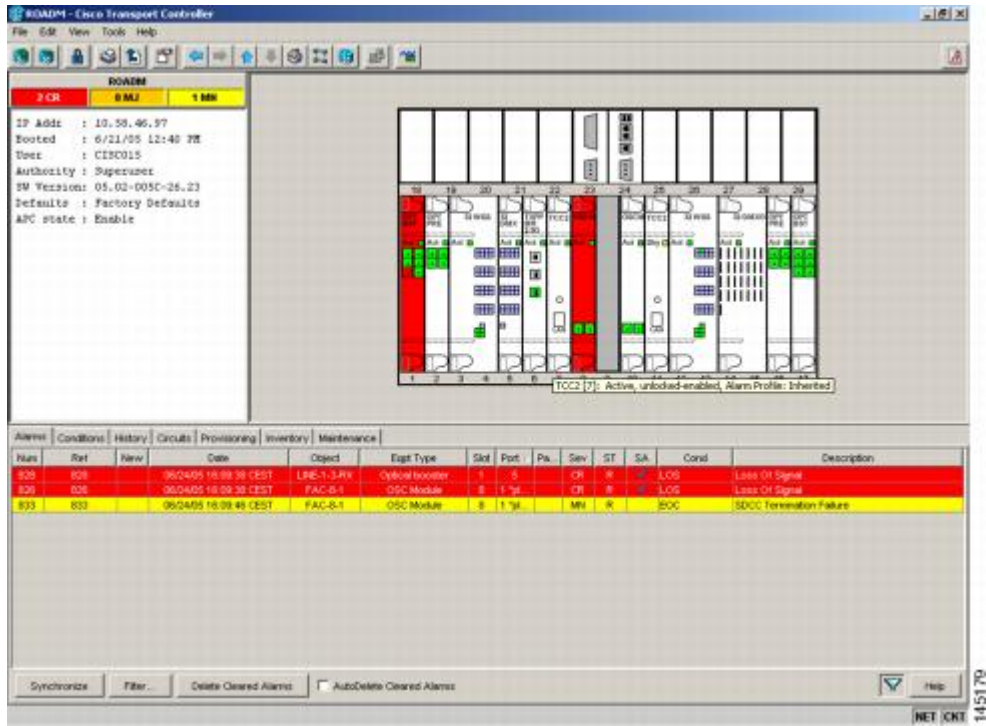
**Figure 17: LOS Indication on the OLA Node OPT-BST**

Node OSC-CSM, on page 67) and the LOS (OTS) on Port 5 of the OPT-BST (see Figure 17: LOS Indication on the OLA Node OPT-BST, on page 67).
