Alarm Troubleshooting

This chapter gives a description, severity, and troubleshooting procedure for each commonly encountered dense wavelength division multiplexing (DWDM) alarm and condition—whether for trunk or client—used in the Cisco ONS platforms. Tables 2-1 through 2-5 provide lists of DWDM alarms organized by severity. Table 2-6 on page 2-5 provides a list of alarms organized alphabetically. Table 2-7 gives definitions of all DWDM alarm logical objects, which are the basis of the alarm profile list in Table 2-8 on page 2-9.

2.1 Alarm Indexes by Default Severity

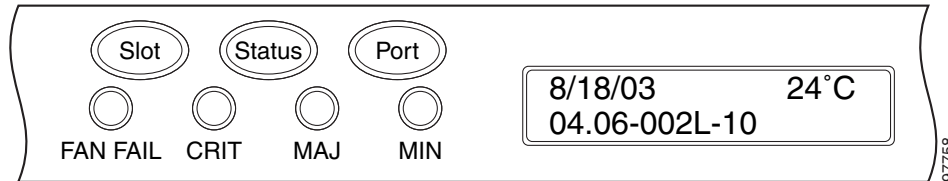
Figure 2-1 Shelf LCD Panel

- Step 1** View the temperature displayed on the ONS system LCD front panel. For example, the ONS 15454 front panel is illustrated in [Figure 2-1](#).

- Step 1** Check for any outstanding alarms that were raised against the active and standby TCC2/TCC2P and resolve them.
- Step 2** If the alarm does not clear, determine whether the LCD display on the fan tray ([Figure 2-1 on page 2-53](#)) is blank or if the text is garbled. If so, proceed to [Step 8](#). If not, continue with [Step 3](#).
- Step 3** At the earliest maintenance window, reset the standby TCC2/TCC2P:
