General Troubleshooting

This chapter provides procedures for troubleshooting the most common problems encountered when operating a Cisco ONS 15454 DWDM shelf in ANSI or ETSI platforms. To troubleshoot specific alarms, see [Chapter 2, “Alarm Troubleshooting.”](#) If you cannot find what you are looking for, contact Cisco Technical Support (1 800 553-2447).

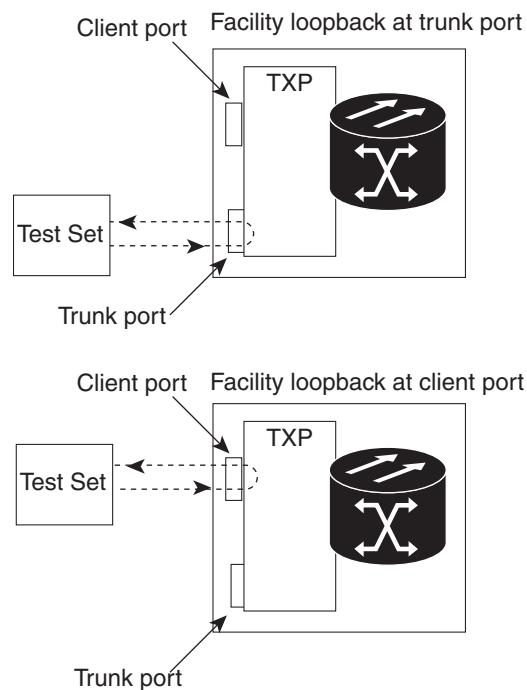
Figure 1-1 Facility Loopback Path on a Near-End Transponder Card

A facility loopback tests the line interface unit (LIU) of a card, the electrical interface assembly (EIA), and related cabling. After applying a facility loopback on a port, use a test set to run traffic over the loopback. A successful facility loopback isolates the LIU, the EIA, or the cabling plant as the potential cause of a network problem.

To test a card LIU, connect an optical test set to a trunk or client port and perform a facility loopback. Alternately, use a loopback or hairpin circuit on a card that is farther along the circuit path. For example, [Figure 1-1](#) shows a facility loopback at a trunk port and at a client port on a TXP card.

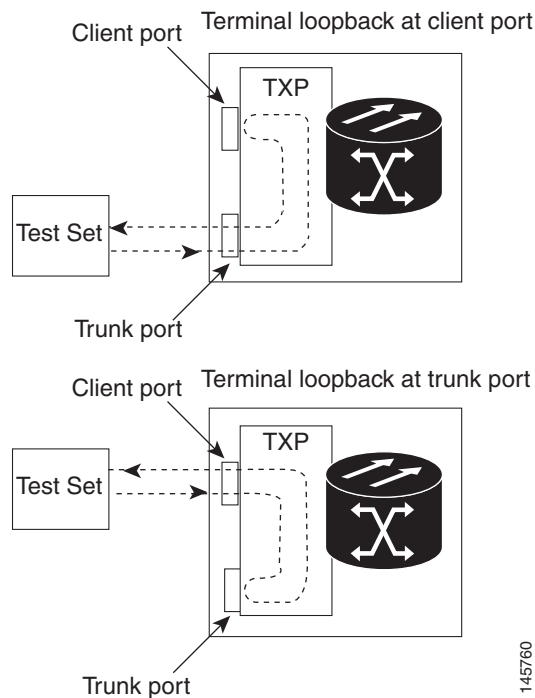
Figure 1-2 Terminal Loopback on a TXP Card

A terminal loopback tests a circuit path as it passes through a TXP or MXP card and loops back. For example, as shown in [Figure 1-2](#), there are two types of terminal loopbacks shown for a TXP card.

This test verifies that the terminal circuit paths are valid, but does not test the LIU on the TXP card.

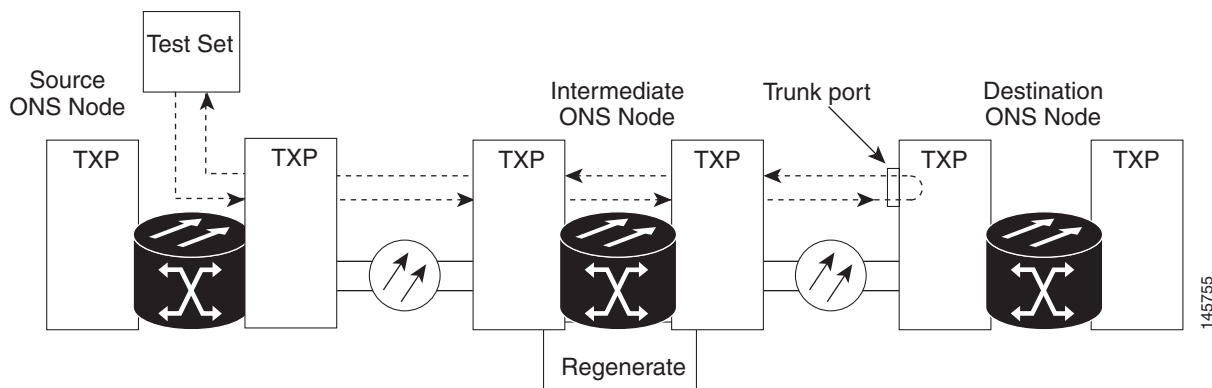
Figure 1-7 Facility Loopback on a Destination-Node MXP or TXP Port

You perform a facility loopback test at the destination port to determine whether this local port is the source of circuit trouble. The example in [Figure 1-7](#) shows a facility loopback being performed on a TXP client or trunk port at a destination node.

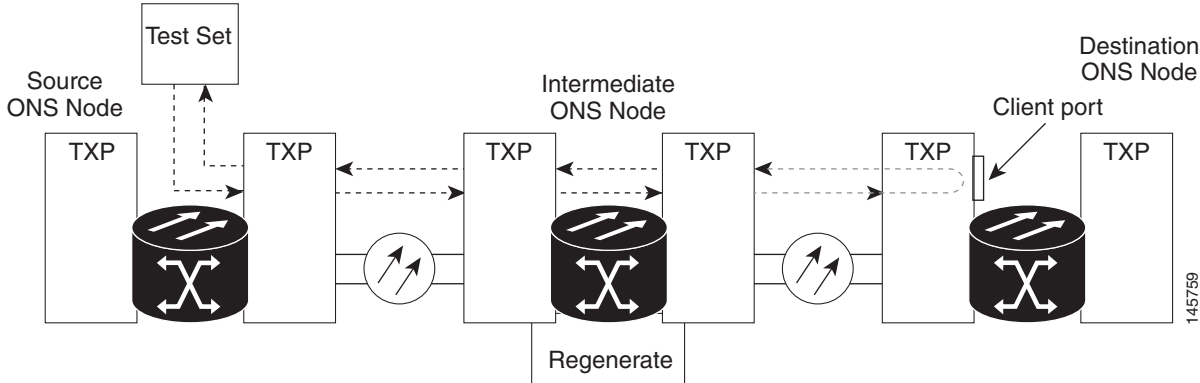
Figure 1-8 Terminal Loopback on a Destination-Node MXP or TXP Port

The terminal loopback at the destination-node port is the final local hardware error elimination in the circuit troubleshooting process. If this test is completed successfully, you have verified that the circuit is good up to the destination port. The example in [Figure 1-8](#) shows a terminal loopback on an destination node TXP port.

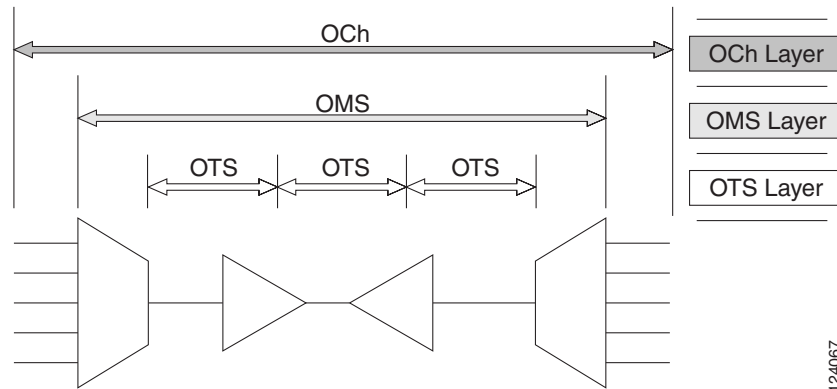
Figure 1-9 Optical Transport Network Layers

Like traditional SONET networks, ITU-T G.709 optical networks have a layered design ([Figure 1-9](#)). This structure enables localized monitoring that helps you isolate and troubleshoot network problems.

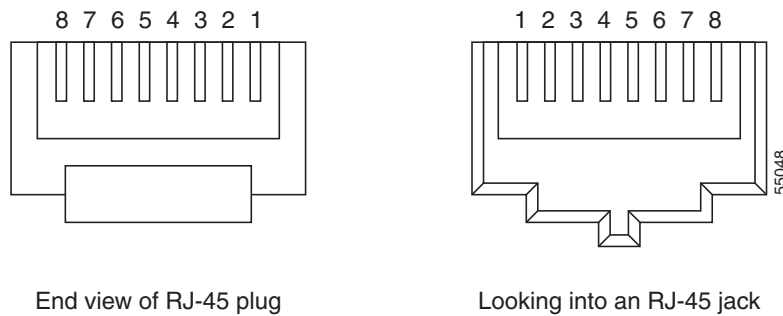
**Figure 1-17** RJ-45 Pin Numbers

You can crimp your own LAN cables for use with the ONS 15454. Use a cross-over cable when connecting an ONS 15454 to a hub, LAN modem, or switch, and use a LAN cable when connecting an ONS 15454 to a router or workstation. Use CAT-5 cable RJ-45 T-568B, Color Code (100 Mbps), and a crimping tool. [Figure 1-17](#) shows the wiring of an RJ-45 connector. [Figure 1-18](#) shows a LAN cable layout, and [Table 1-5](#) shows the cable pinouts. [Figure 1-19](#) shows a cross-over cable layout, and [Table 1-6](#) shows the cross-over pinouts.

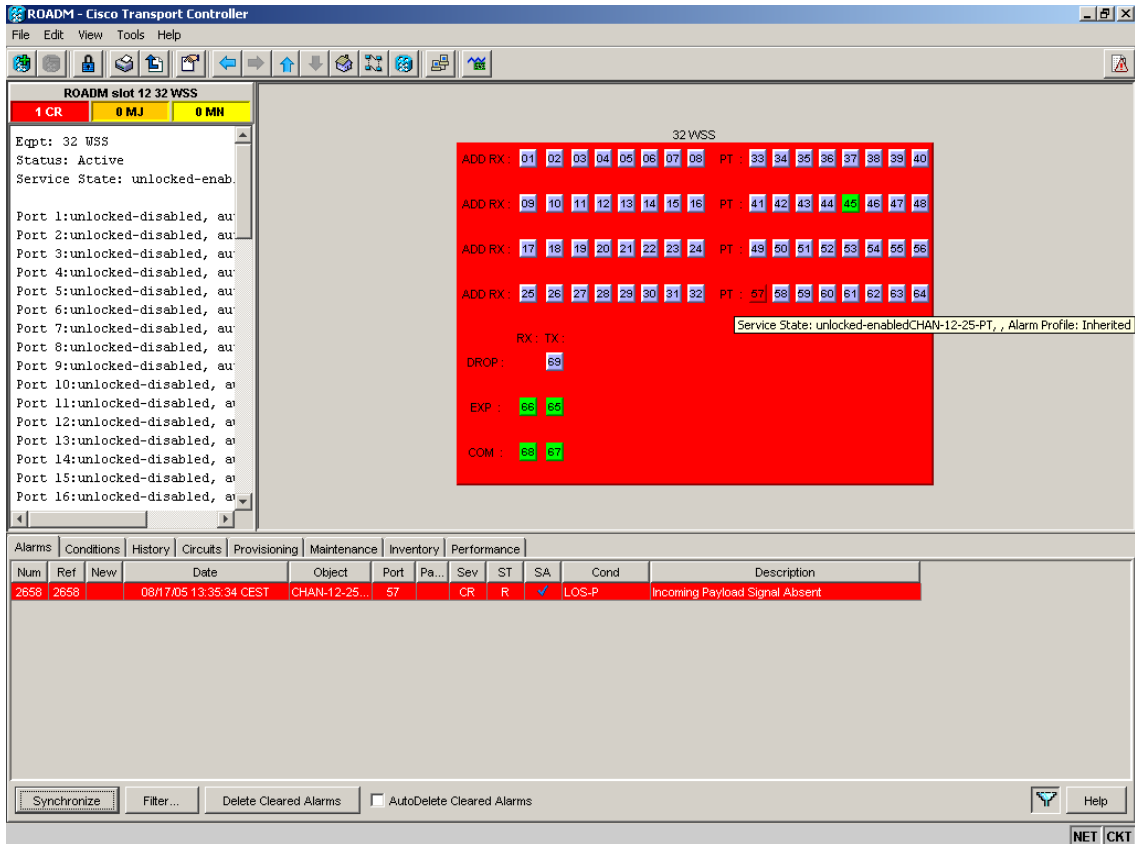
Figure 1-32 LOS-P Indication on the VOA Port

If the incoming power level is lower than the minimum allowed, the startup procedure always stops at Phase 1 (see [Figure 1-32](#)). This is the case even if the final VOA Power Reference reported in CTC is reachable.

- A LOS-P (OCH layer) alarm on the port associated with the VOA (see [Figure 1-32](#))
- A valid (different from the end of scale value of  $-50$  dBm) optical power value in the Power field, but the value for Power is less than  $-33$  dBm. (To view the Power field, in card view, click the **Provisioning > Parameters** tabs.)

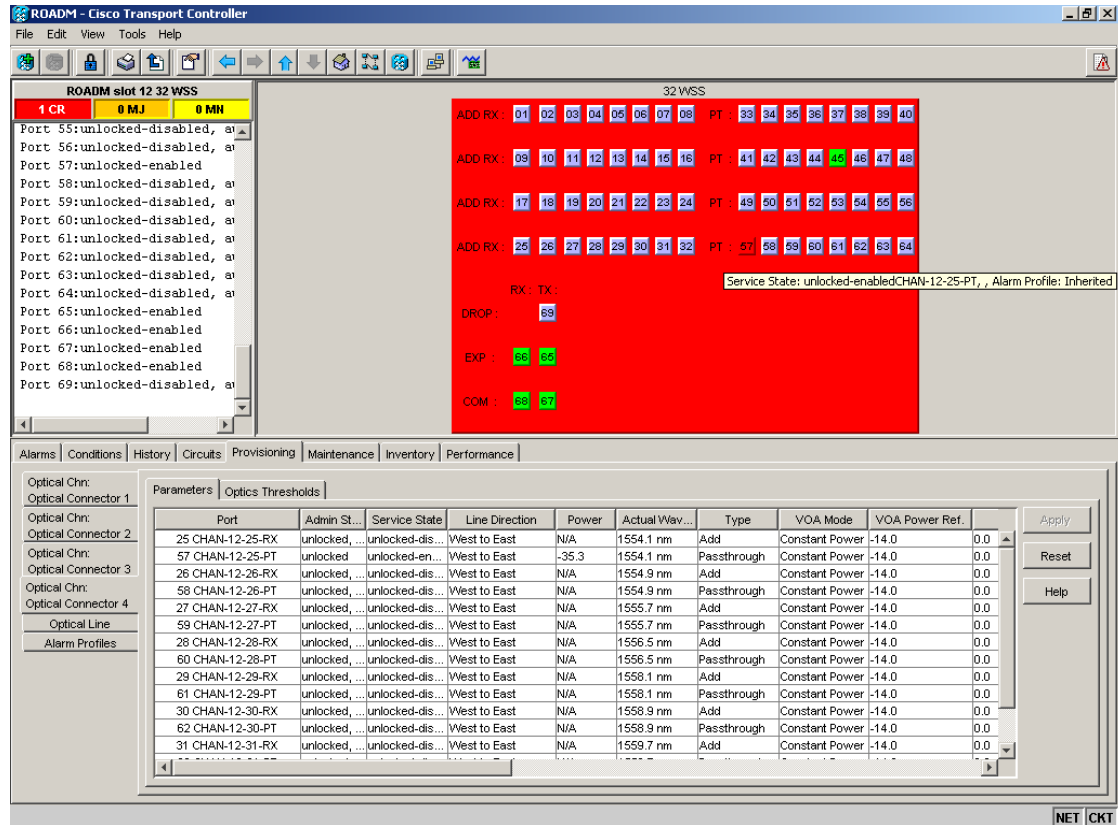
**Figure 1-33** Power Level of Incoming Signal Less than -33 dBm

- A LOS-P (OCH layer) alarm is present on the port associated with the VOA.
- A valid (different from the end of scale value of – 50 dBm) optical power value can be read in the Power field, but the value for Power is less than – 33 dBm (see [Figure 1-33](#)). (To access this value, in card view, click the **Provisioning > Parameters** tabs.)

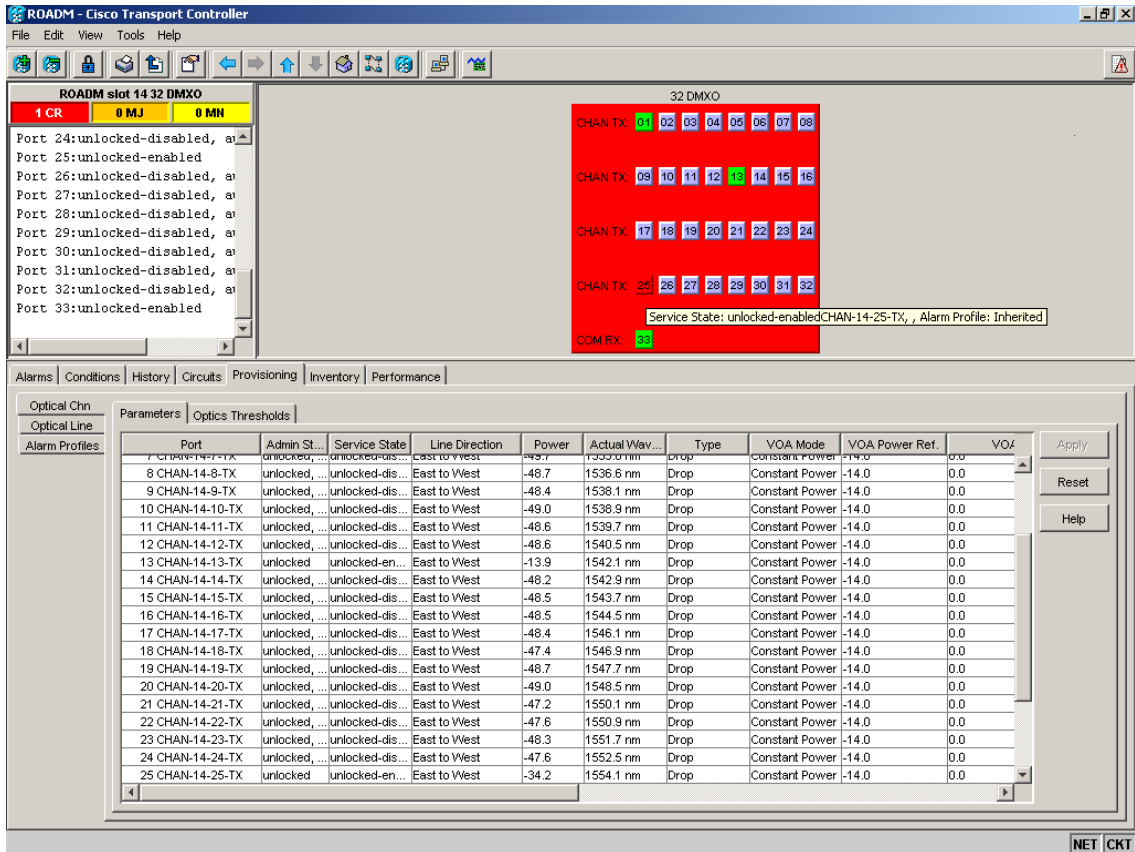
Figure 1-36 Optical Drop Power Less than 6 dB Lower than Expected

A dirty connection or excessive loss of the incoming span are among the possible reasons that can lead to a fault condition. They are the most common and affect all wavelengths, whereas an excessive amplifier gain tilt or a wavelength misconfiguration on the far-end TXP or MXP card can lead to condition where only a single wavelength fails, such as the one (Channel 25) shown in Figure 1-36.
