## **Cisco ONS 15454 DWDM Troubleshooting Guide**

Product and Software Release 6.0  
June 2012

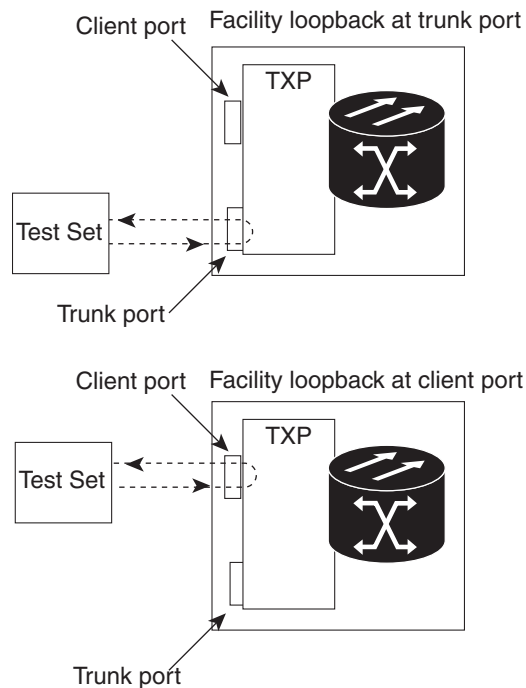
**Figure 1-1 Facility Loopback Path on a Near-End Transponder Card**

To test a card LIU, connect an optical test set to a trunk or client port and perform a facility loopback. Alternately, use a loopback or hairpin circuit on a card that is farther along the circuit path. For example, [Figure 1-1](#) shows a facility loopback at a trunk port and at a client port on a TXP card.

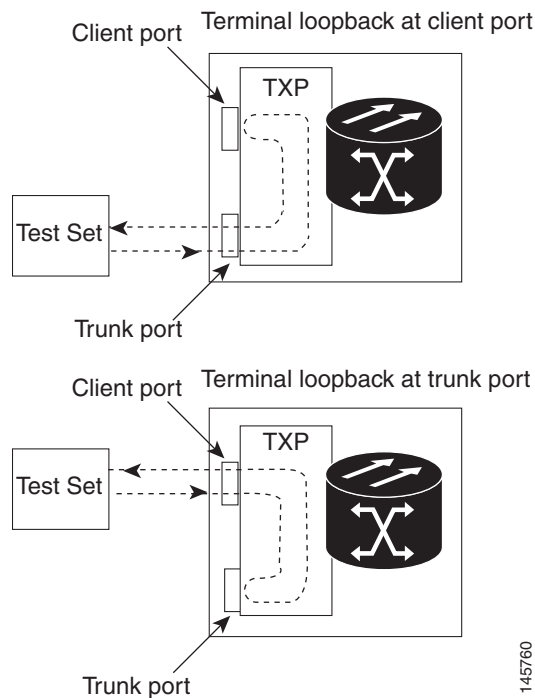
**Figure 1-2** *Terminal Loopback on a TXP Card*

A terminal loopback tests a circuit path as it passes through a TXP or MXP card and loops back. For example, as shown in [Figure 1-2](#), there are two types of terminal loopbacks shown for a TXP card.

This test verifies that the terminal circuit paths are valid, but does not test the LIU on the TXP card.

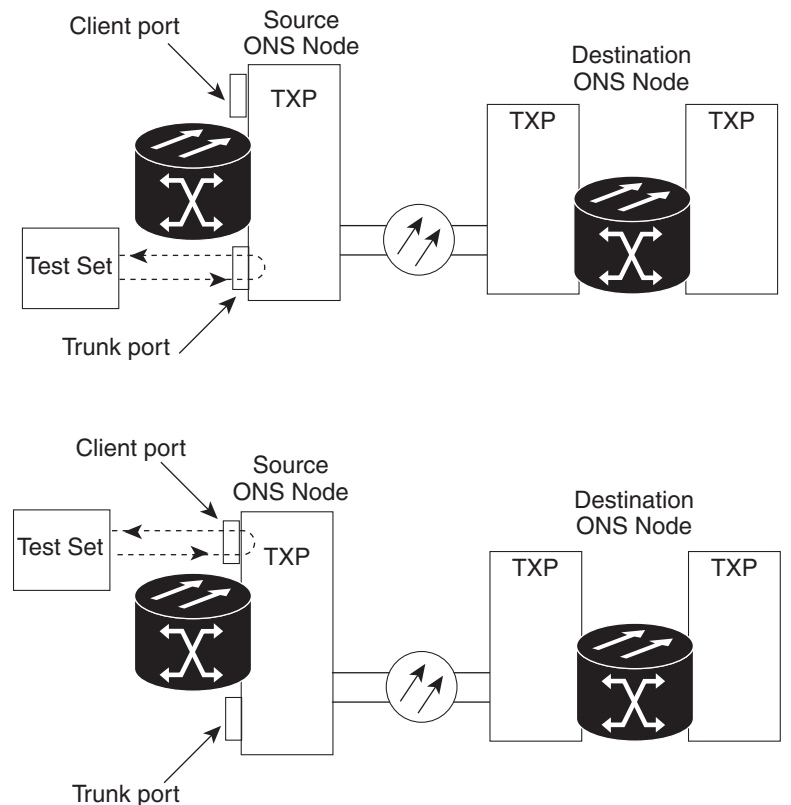
**Figure 1-3 Facility Loopback on a Circuit Source MXP or TXP Port**

This facility loopback test is performed on the node source port in the network circuit. In the testing situation used in this example, the source muxponder or transponder port under test is located in the source node. Facility loopback can be performed at the trunk port or at a client port. Completing a successful facility loopback on this port isolates the source MXP or TXP port as a possible failure point. [Figure 1-3](#) shows the facility loopback examples on source ONS node TXP ports (client and trunk).

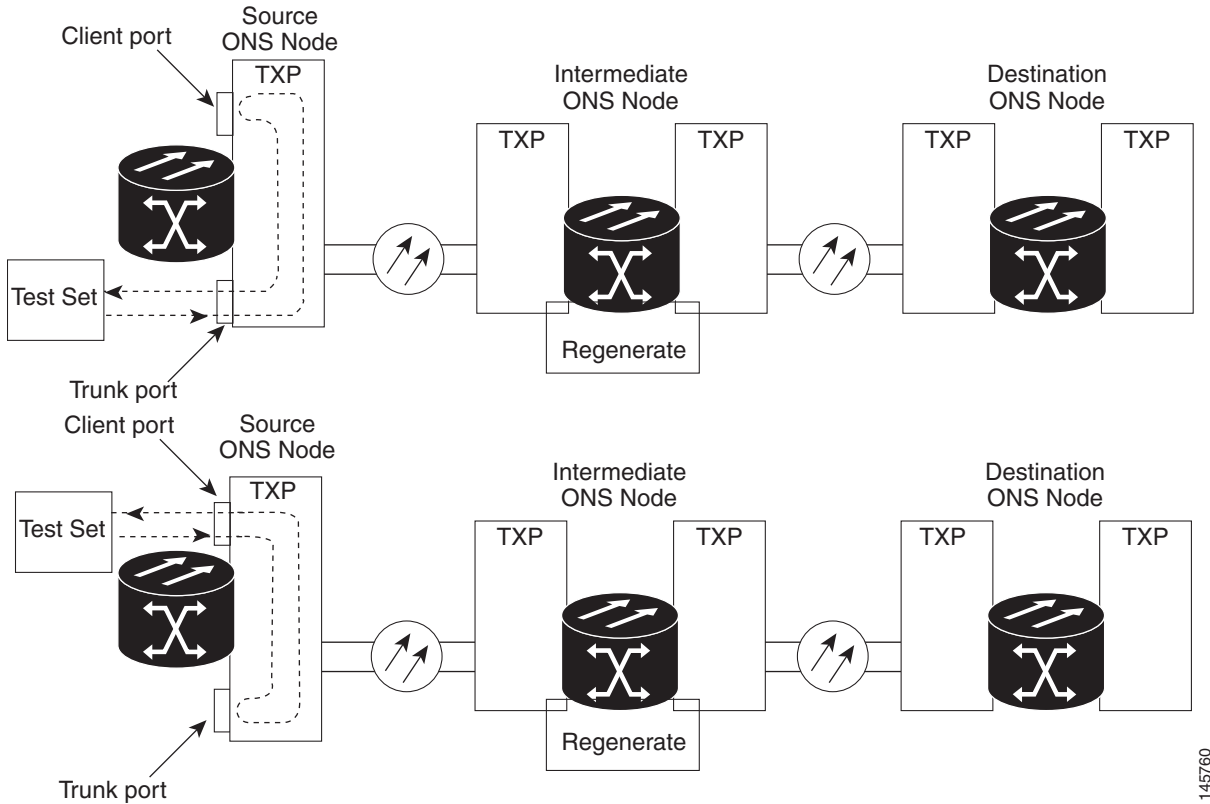
**Figure 1-4** Terminal Loopback on a Source-Node MXP or TXP Port

The terminal loopback test is performed on the node source MXP or TXP muxponder or transponder port. For the circuit in this example, it is the source TXP trunk port or a client port in the source node. Completing a successful terminal loopback to a node source port verifies that the circuit is through the source port. [Figure 1-4](#) shows an example of a terminal loopback on a source TXP port and a client TXP port.

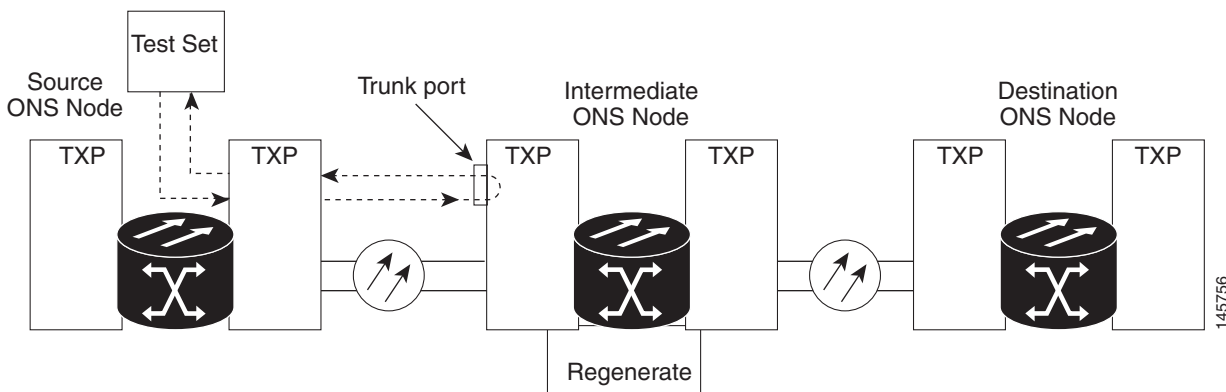
**Figure 1-5 Facility Loopback on an Intermediate-Node MXP or TXP Port**

Performing the facility loopback test on an intermediate port isolates whether this node is causing circuit failure. In the situation shown in [Figure 1-5](#), the test is being performed on an intermediate MXP or TXP port.

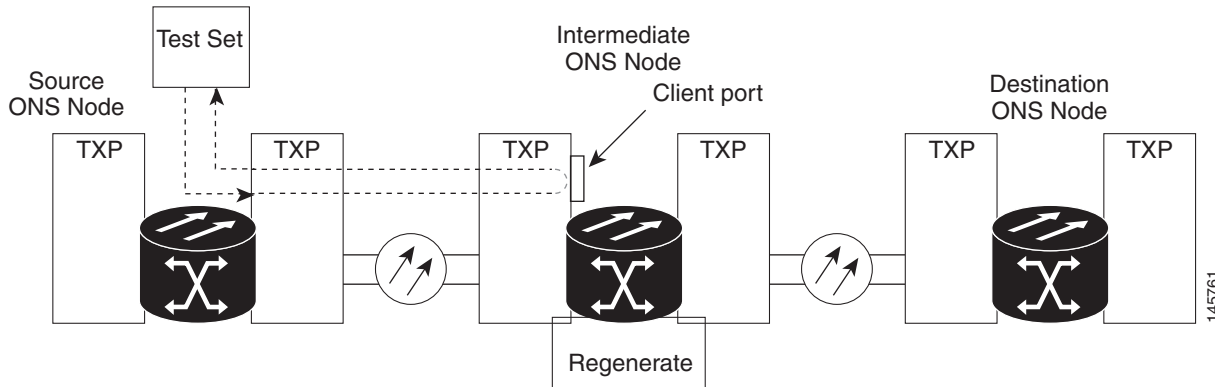
**Figure 1-6** Terminal Loopback on an Intermediate-Node MXP or TXP Port

In the next troubleshooting test, you perform a terminal loopback on the intermediate-node port to isolate whether the intermediate client or trunk port is causing circuit trouble. In the example situation in [Figure 1-6](#), the terminal loopback is performed on an intermediate MXP or TXP port in the circuit. If you successfully complete a terminal loopback on the node, this node is excluded from possible sources of circuit trouble.

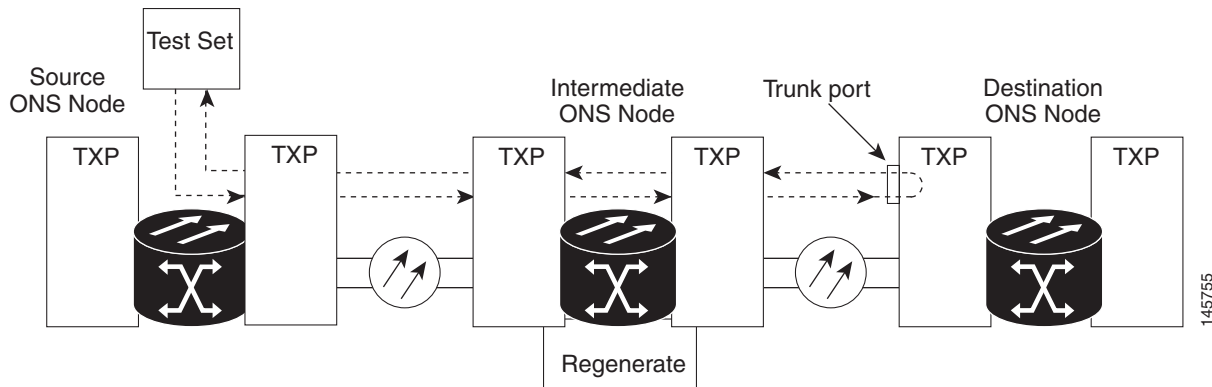
**Figure 1-7** Facility Loopback on a Destination-Node MXP or TXP Port

You perform a facility loopback test at the destination port to determine whether this local port is the source of circuit trouble. The example in [Figure 1-7](#) shows a facility loopback being performed on a TXP client or trunk port at a destination node.

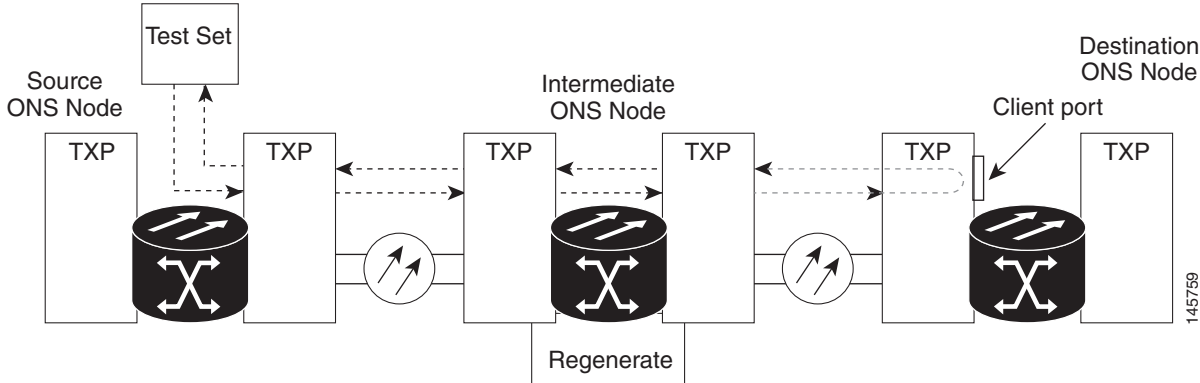
**Figure 1-8** Terminal Loopback on a Destination-Node MXP or TXP Port

The terminal loopback at the destination-node port is the final local hardware error elimination in the circuit troubleshooting process. If this test is completed successfully, you have verified that the circuit is good up to the destination port. The example in [Figure 1-8](#) shows a terminal loopback on an destination node TXP port.

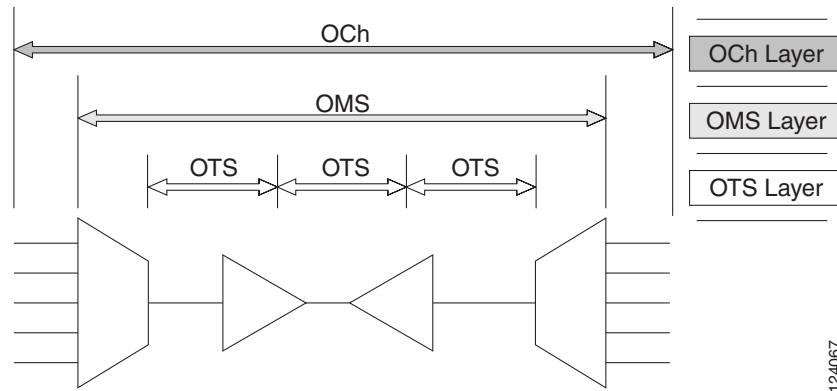
**Figure 1-9 Optical Transport Network Layers**

Like traditional SONET networks, ITU-T G.709 optical networks have a layered design ([Figure 1-9](#)). This structure enables localized monitoring that helps you isolate and troubleshoot network problems.

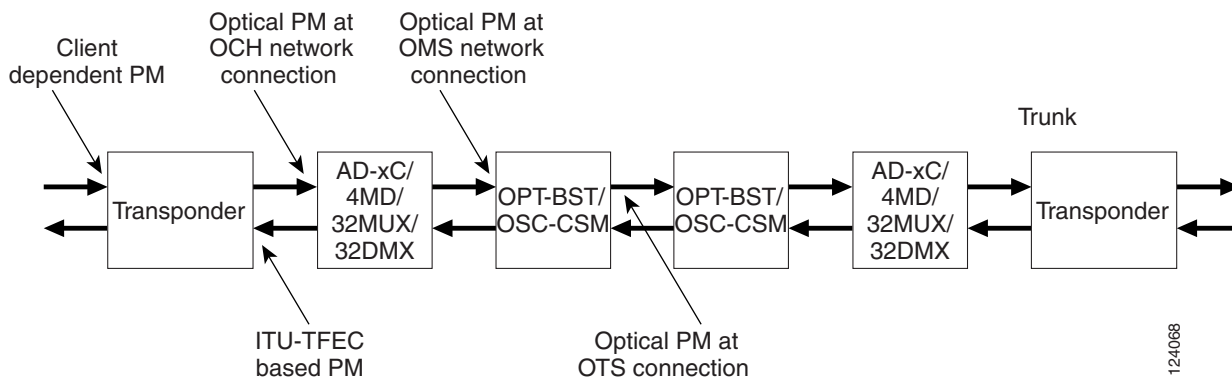
**Figure 1-10** Performance Monitoring Points on ONS DWDM

Different PM count parameters are associated with different read points in a network. [Figure 1-10](#) illustrates the PM read points that are useful in identifying DWDM circuit points of failure. [Chapter 5, “Performance Monitoring,”](#) lists all PM parameters and provides block diagrams of signal entry points, exit points, and interconnections between the individual circuit cards. Consult these specifications to determine which PM parameters are associated with the system points you want to monitor or provision with CTC or TL1. The monitoring points can vary according to your configuration.

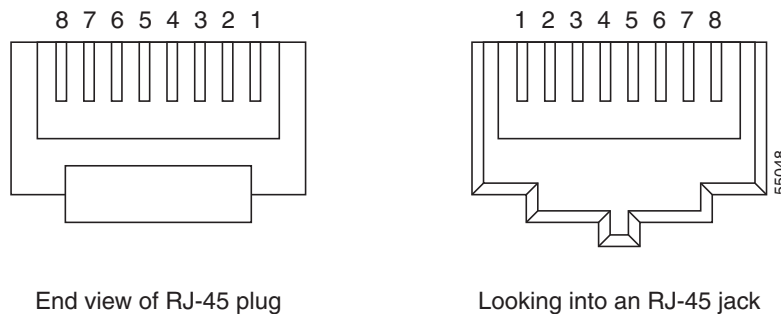
**Figure 1-17 RJ-45 Pin Numbers**

You can crimp your own LAN cables for use with the ONS 15454. Use a cross-over cable when connecting an ONS 15454 to a hub, LAN modem, or switch, and use a LAN cable when connecting an ONS 15454 to a router or workstation. Use CAT-5 cable RJ-45 T-568B, Color Code (100 Mbps), and a crimping tool. [Figure 1-17](#) shows the wiring of an RJ-45 connector. [Figure 1-18](#) shows a LAN cable layout, and [Table 1-5](#) shows the cable pinouts. [Figure 1-19](#) shows a cross-over cable layout, and [Table 1-6](#) shows the cross-over pinouts.

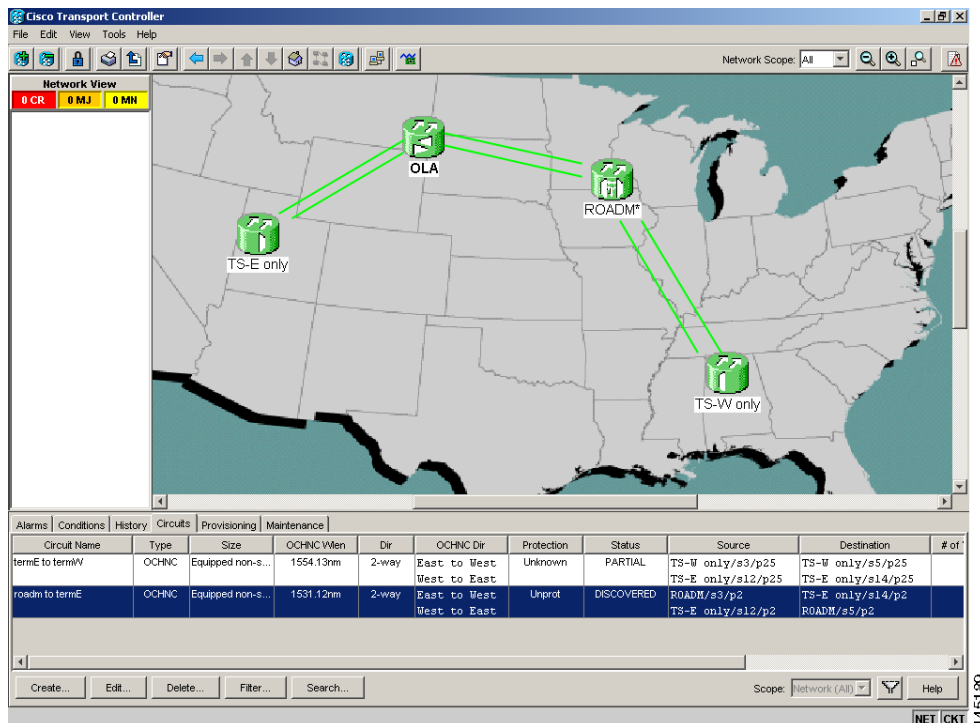
**Figure 1-20** Linear Network, With No Fiber Cut

Different symptoms and scenarios can occur, according to the network ALS settings. Consider the linear network (four nodes) in [Figure 1-20](#) as a reference. The scenarios are presented after the figure.

The symptoms of the possible span loss scenarios (except for span loss decrease) are described in the following paragraphs. Refer to the linear network in [Figure 1-20](#) during the discussion of the scenarios.

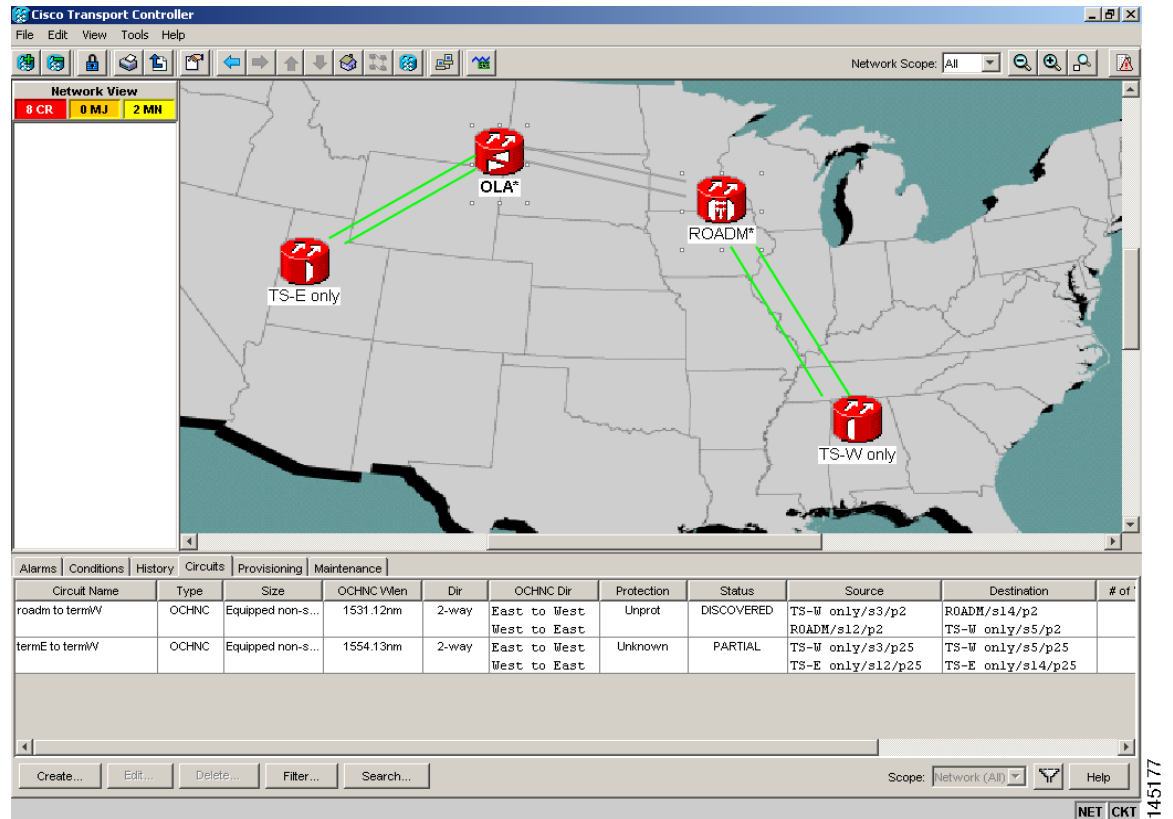
**Figure 1-21 Fiber Cut with ALS MODE = Auto Restart**

The final fault condition of the network is shown in [Figure 1-21](#).

In network view, both of the lines representing the span were formerly green and have now changed to gray. Notice also that the status of all the OCHNC circuits on the broken span have changed from Discovered to Partial.

The basic assumption is that the network ALS feature (for feature details, refer to the “Network Optical Safety—Automatic Laser Shutdown” section in the *Cisco ONS 15454 DWDM Installation and Operation Guide*) is active (ALS Mode = Auto Restart on the OPT-BST [+ OSCM] and OSC-CSM). Given this assumption, the starting condition is as shown in [Figure 1-21](#).

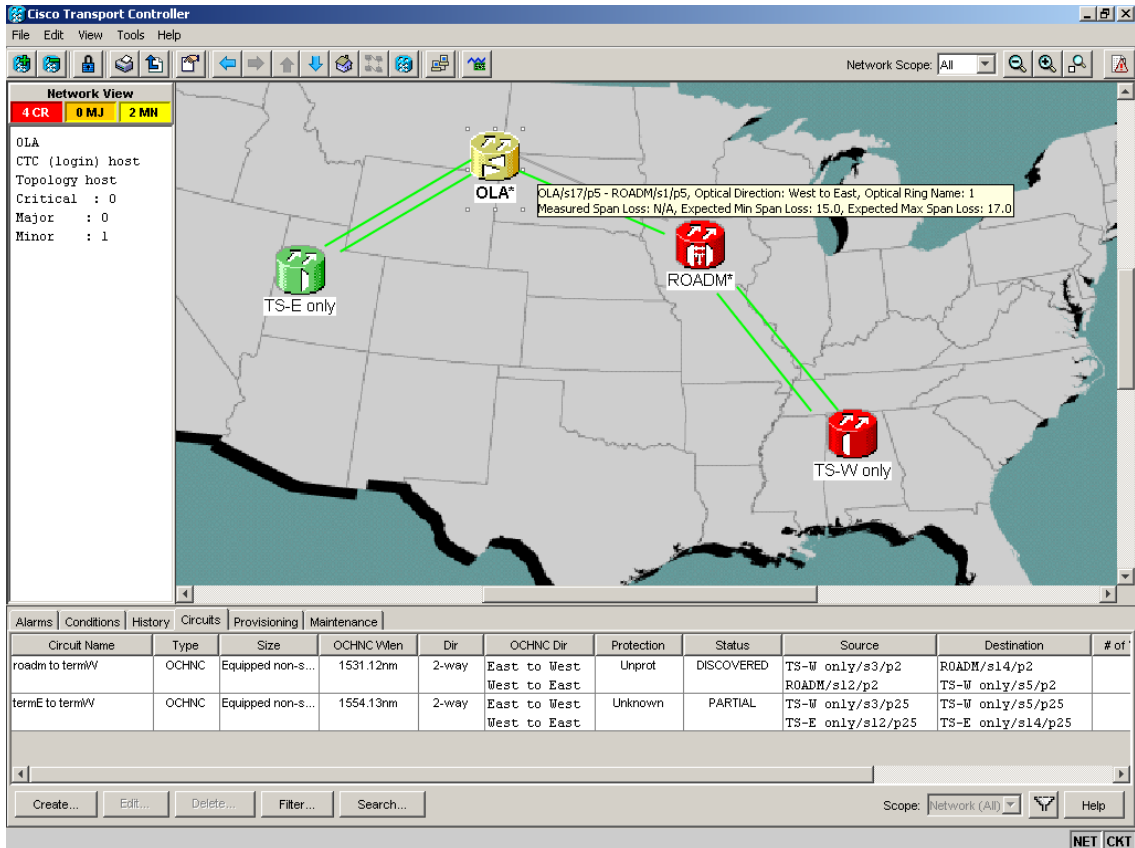
**Figure 1-24** Network View Fault Condition for Fiber Cut with ALS Mode Disabled

The LOS (OTS or AOTS) alarm is raised by the ROADM-RX node that was receiving the signal coming from the broken fiber. The final fault condition of the network is shown in [Figure 1-24](#).

In network view (Figure 1-24), only the actual affected fiber becomes gray, whereas the traffic (and OSC signal as well) on the good fiber is active and fault identification is immediate.

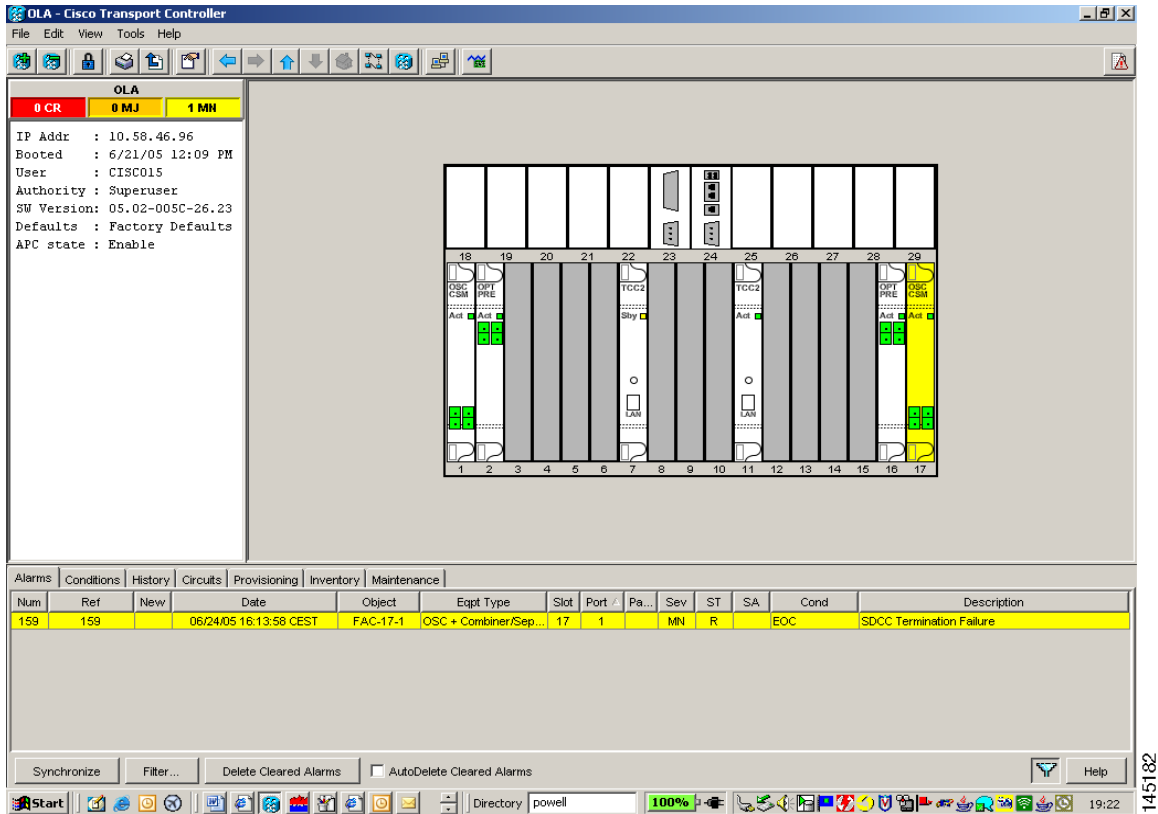
**Figure 1-26 OLA Node View with Fault Condition for ALS MODE Disabled**

In node views (Figure 1-25 and Figure 1-26), the alarm panel of the receiving node (ROADM in this example) reports the LOS (OTS), while the transmitting node (OLA) reports only an EOC alarm.

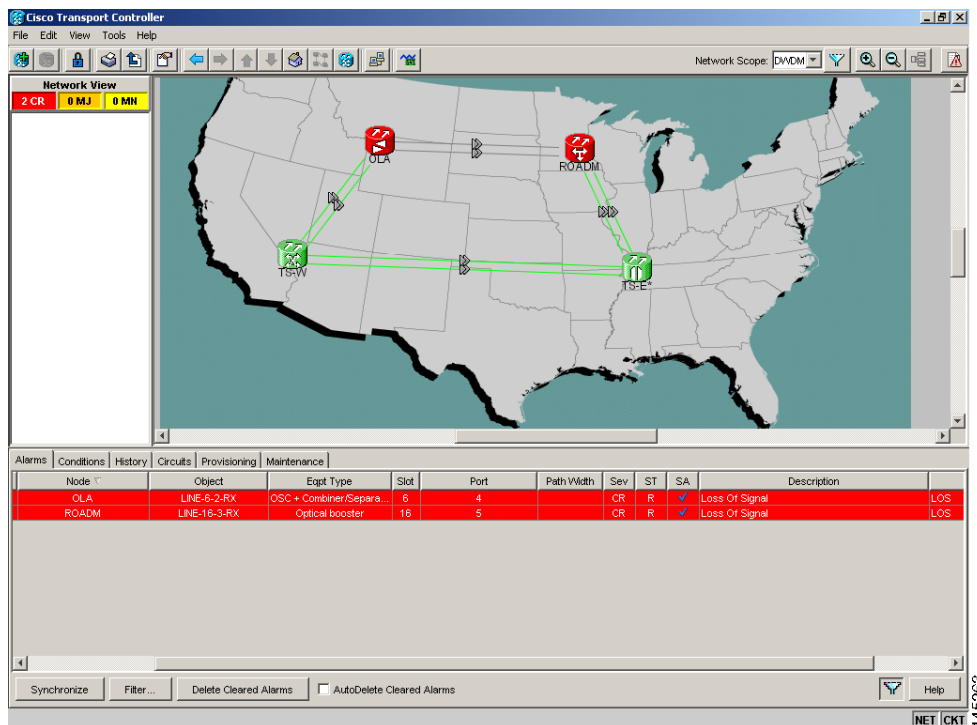
**Figure 1-27** Network View for Span Loss Change > 5 dBm and OSC Power Value at Receiver > -42 dBm

This change is due to the fact the physical optical power value received by the OSC transceiver is above the sensitivity limit (-42 dBm) and consequently, the OSC optical link can be rebuilt, allowing the restoration of the Section DCC (SDCC) or multiplex section DCC (MS-DCC). The network view for this condition is shown in Figure 1-27.

In node view, the EOC condition is cleared, but the alarm panels of the two nodes (ROADM and OLA in the example) continue to show LOS (OTS or AOTS) on the LINE-RX port of the OPT-BST or OSC-CSM.

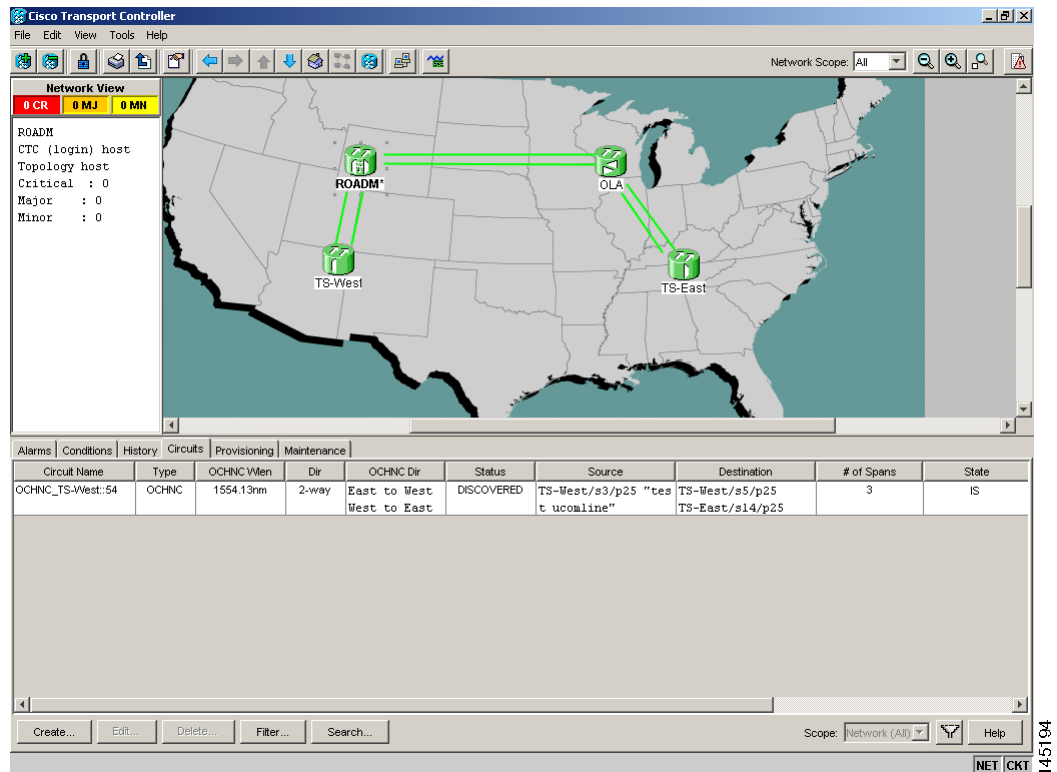
**Figure 1-28 OCHNC Circuit Successfully Completed**

OCHNC circuit creation is successfully completed when the CTC circuit table reports the situation shown in [Figure 1-28](#).

- Circuit Status has turned to DISCOVERED.
- The # of spans field shows the correct number of hops among different nodes that the OCHNC circuit passes through to reach the final destination.
- Circuit State reports IS (unlocked).

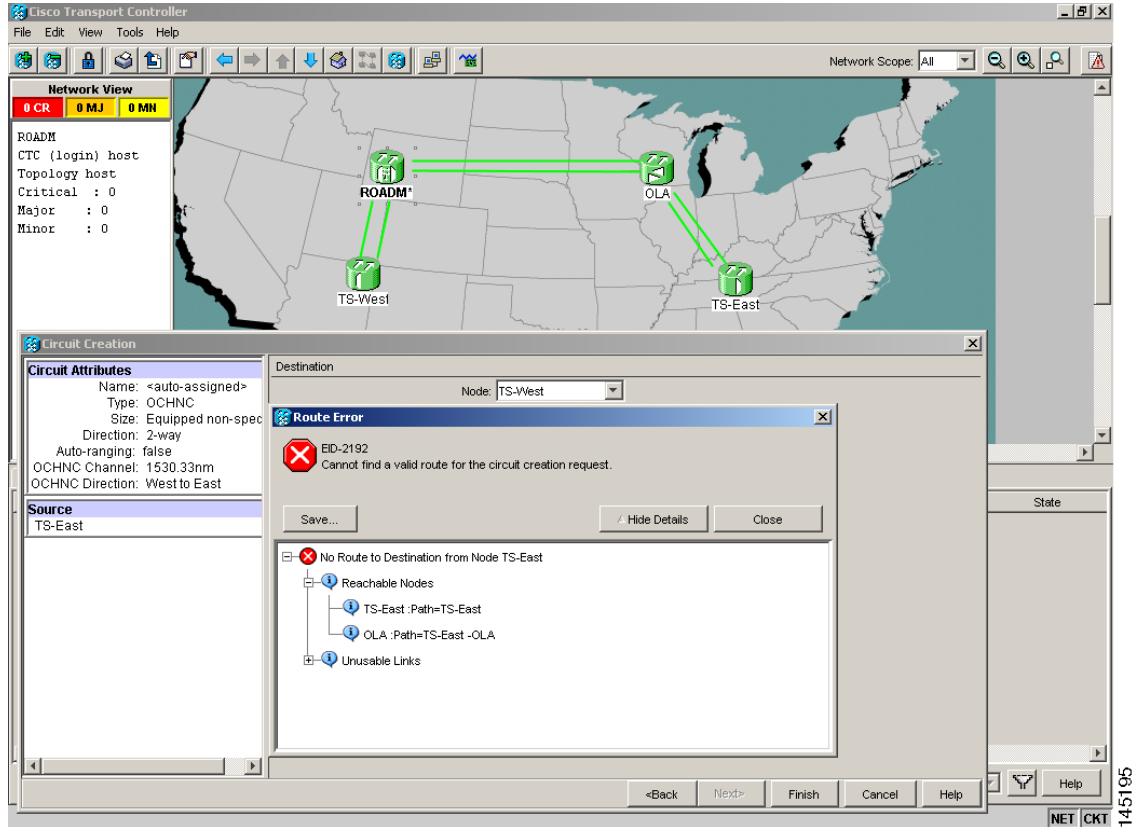
Figure 1-29 Partial Circuit

- If the WPP wizard cannot complete the circuit creation procedure, CTC displays the error message shown in [Figure 1-29](#). In the message, click **Details** to see the partial connections that WPP can set up. Start troubleshooting the problem in the first node unreachable along the path.

To troubleshoot and eventually fix issues related to the faulty OCHNC circuit creation shown in [Figure 1-29](#), the following procedure must be performed.

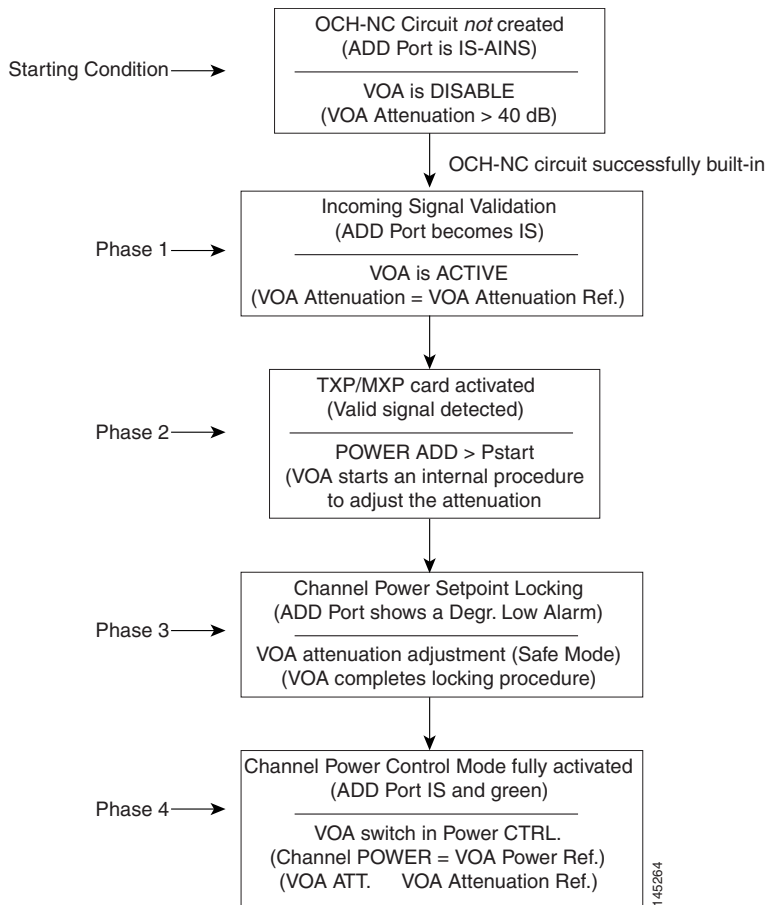
**Figure 1-31 VOA Startup Procedure**

The final VOA condition is achieved through a startup procedure divided into the four sequential phases shown in [Figure 1-31](#).

Until the VOA has completed all the phases shown in [Figure 1-31](#), the power control mode is not fully activated.

When the power is lower than expected, the start-up procedure can stop at Phase 1, Phase 2, or Phase 3 (see [Figure 1-31](#)). The point at which the start-up procedure stops depends on the amount of power missing.

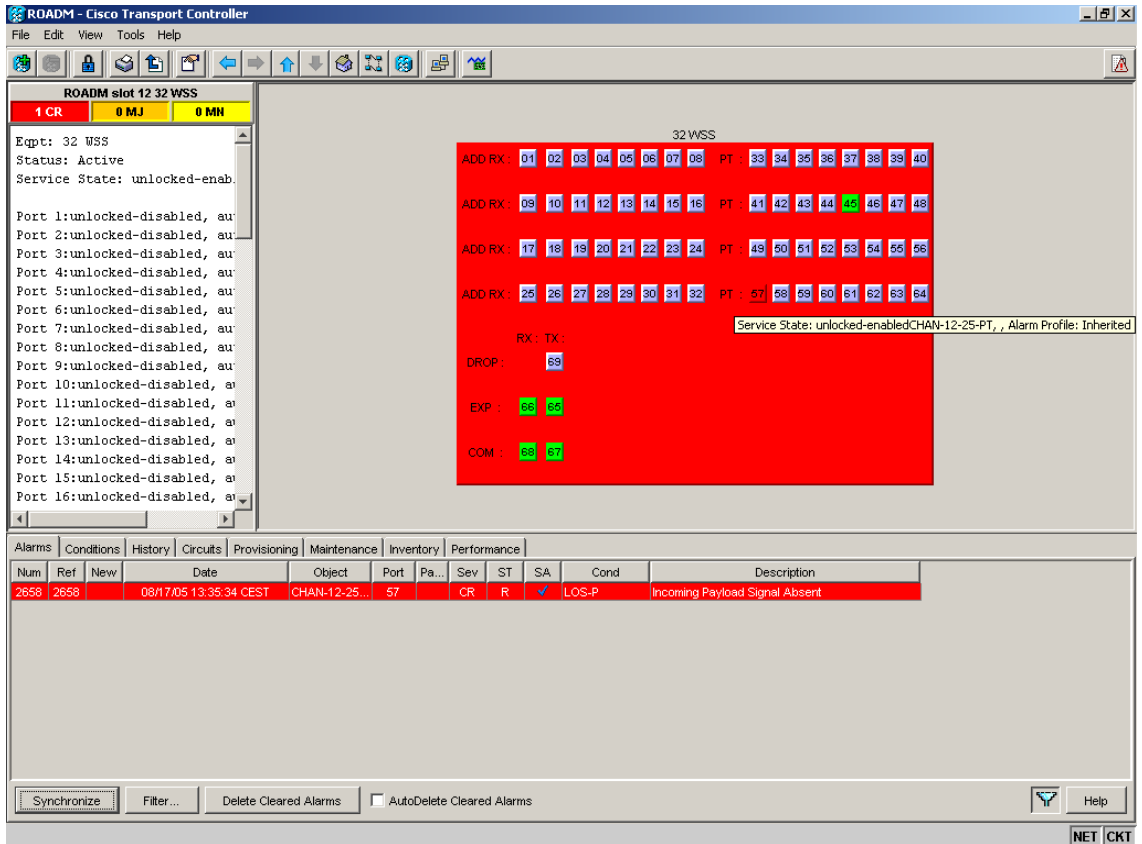
Figure 1-32 LOS-P Indication on the VOA Port

If the incoming power level is lower than the minimum allowed, the startup procedure always stops at Phase 1 (see [Figure 1-32](#)). This is the case even if the final VOA Power Reference reported in CTC is reachable.

- A LOS-P (OCH layer) alarm on the port associated with the VOA (see [Figure 1-32](#))
- A valid (different from the end of scale value of  $-50$  dBm) optical power value in the Power field, but the value for Power is less than  $-33$  dBm. (To view the Power field, in card view, click the **Provisioning > Parameters** tabs.)

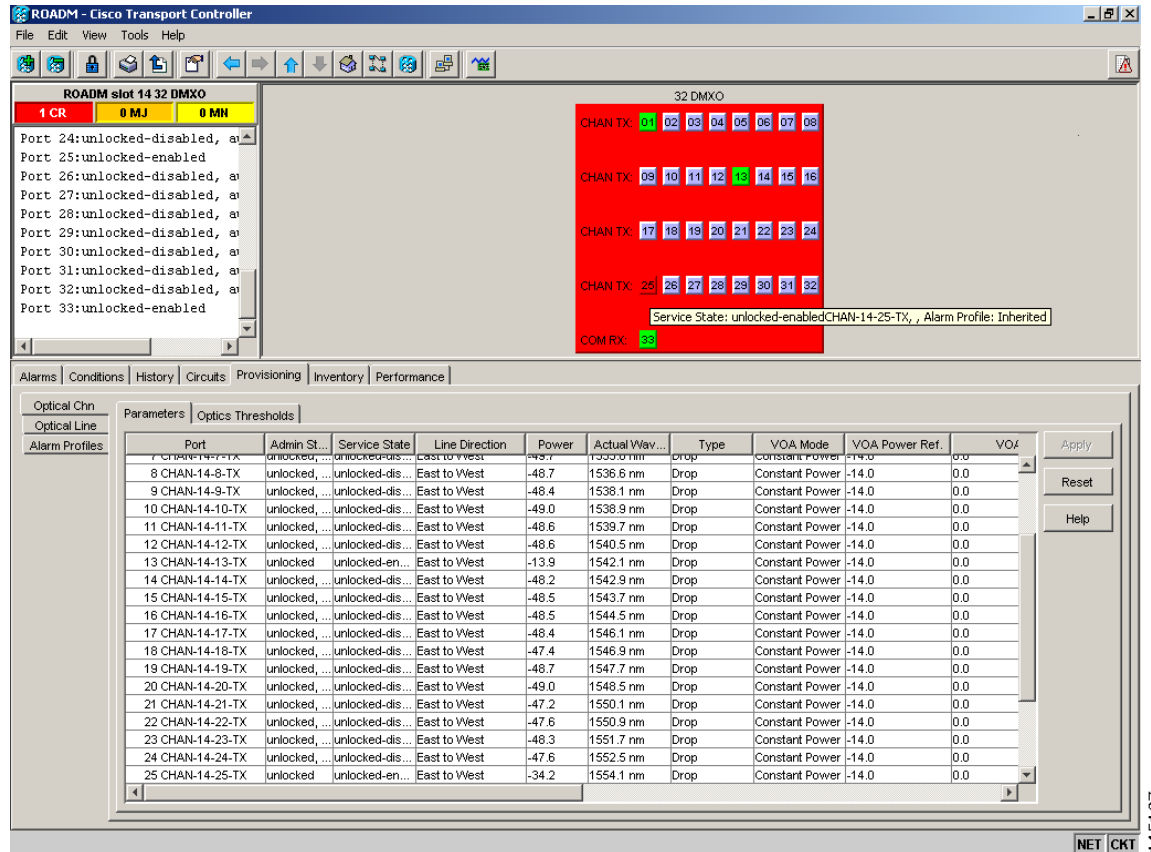
Figure 1-36 Optical Drop Power Less than 6 dB Lower than Expected

A dirty connection or excessive loss of the incoming span are among the possible reasons that can lead to a fault condition. They are the most common and affect all wavelengths, whereas an excessive amplifier gain tilt or a wavelength misconfiguration on the far-end TXP or MXP card can lead to condition where only a single wavelength fails, such as the one (Channel 25) shown in Figure 1-36.

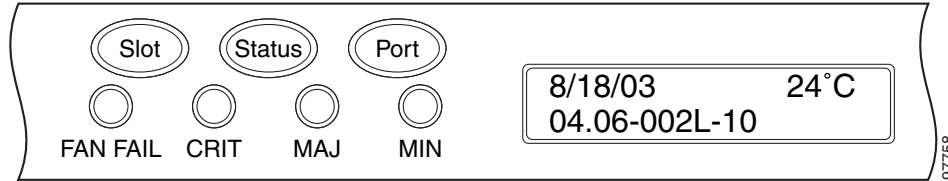
**Figure 2-1 Shelf LCD Panel**

- 
- Step 1** View the temperature displayed on the ONS system LCD front panel. For example, the ONS 15454 front panel is illustrated in [Figure 2-1](#).

- Step 1** Check for any outstanding alarms that were raised against the active and standby TCC2/TCC2P and resolve them.
- Step 2** If the alarm does not clear, determine whether the LCD display on the fan tray ([Figure 2-1 on page 2-53](#)) is blank or if the text is garbled. If so, proceed to [Step 8](#). If not, continue with [Step 3](#).
- Step 3** At the earliest maintenance window, reset the standby TCC2/TCC2P:

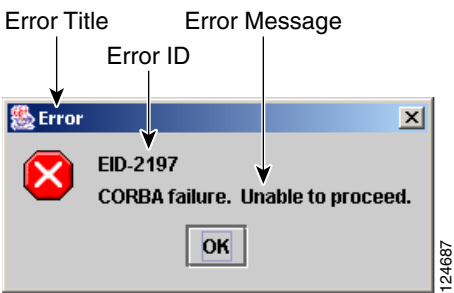
**Figure 4-1**      **Error Dialog Box**

This chapter lists the Cisco ONS 15454, 15454 SDH, 15600, 15327 and 15310-CL error messages. The error dialog box in [Figure 4-1](#) consists of three parts: the error title, error ID, and error message. The table lists two types of messages: error messages (EID-*nnnn*) and warning messages (WID-*nnnn*). Error messages are alerts that an unexpected or undesirable operation has occurred which either indicates the risk of loss of traffic or an inability to properly manage devices in the network. Warnings are alerts that the requested operation could lead to an error. Warnings are sometimes used to convey important information.

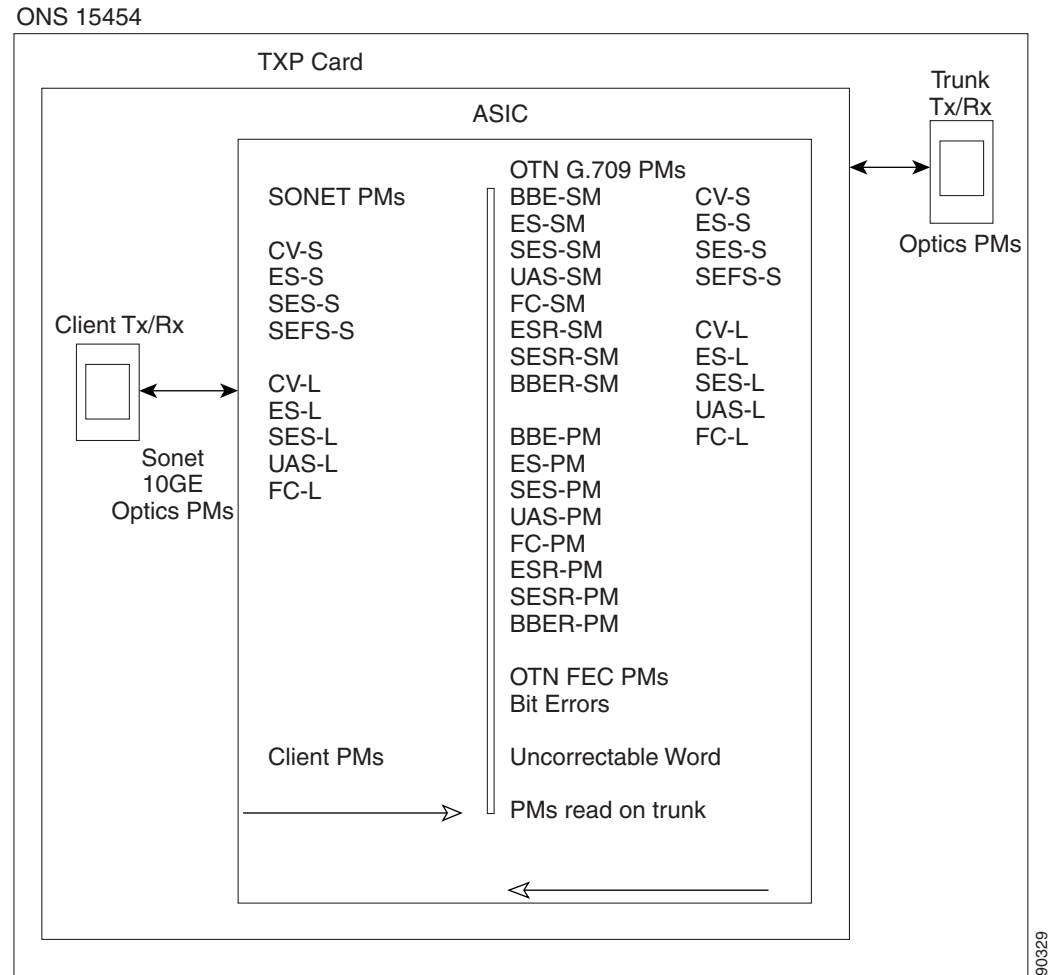
**Figure 5-1 ONS 15454 ANSI Node PM Read Points for TXP\_MR\_10G Card**

For ONS 15454 ANSI nodes, [Figure 5-1](#) shows where overhead bytes detected on the application-specific integrated circuits (ASICs) produce PM parameters for the TXP\_MR\_10G card. The remaining transponder and muxponder cards perform similarly to this illustration.

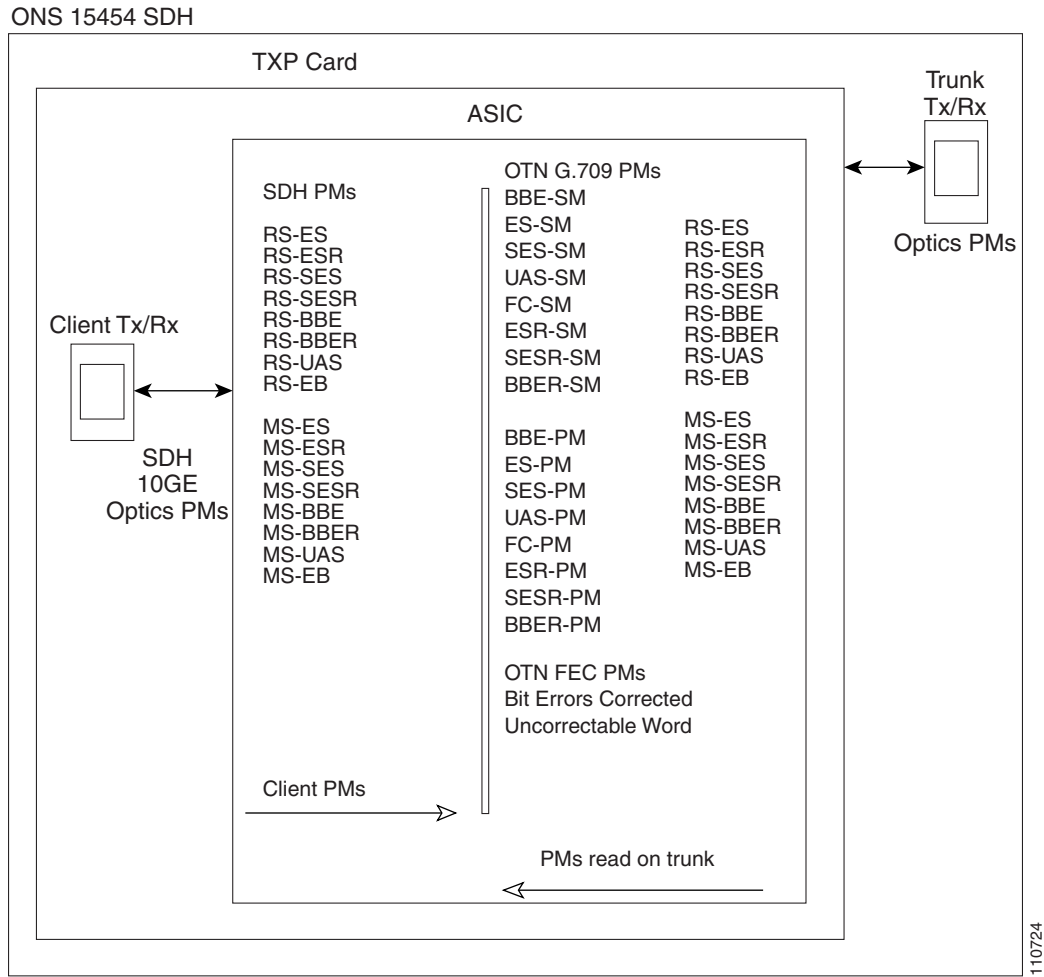
Figure 5-2 ONS 15454 ETSI Node PM Read Points on TXP\_MR\_10G Cards

For ONS 15454 ETSI nodes, [Figure 5-2](#) shows where overhead bytes detected on the ASICs produce PM parameters for the TXP\_MR\_10G card. The remaining transponder and muxponder cards perform similarly to this illustration.

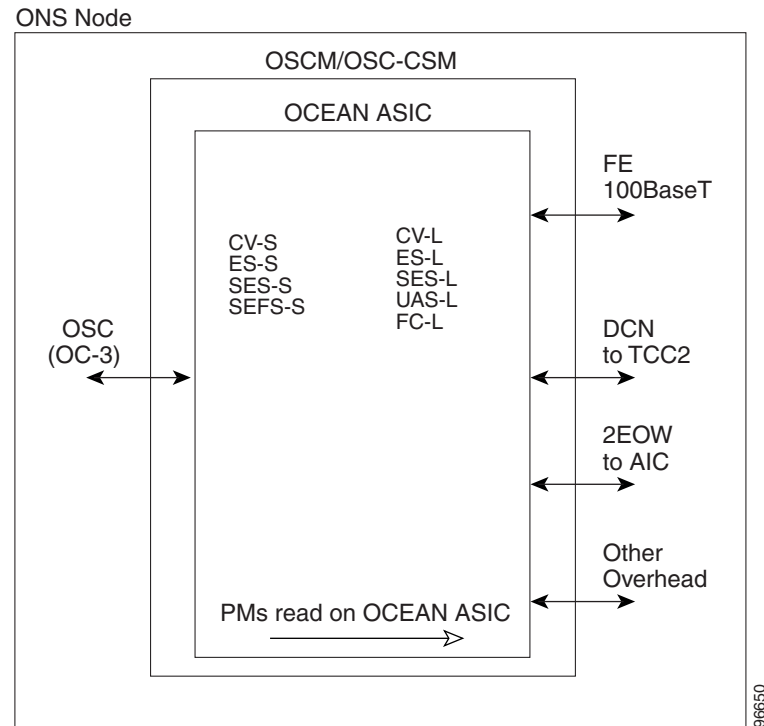
**Figure 5-3** *ONS 15454 ANSI Node PM Read Points on OSCM and OSC-CSM Cards*

For ONS 15454 ANSI nodes, [Figure 5-3](#) shows where overhead bytes detected on the ASICs produce PM parameters for the OSCM and OSC-CSM cards.

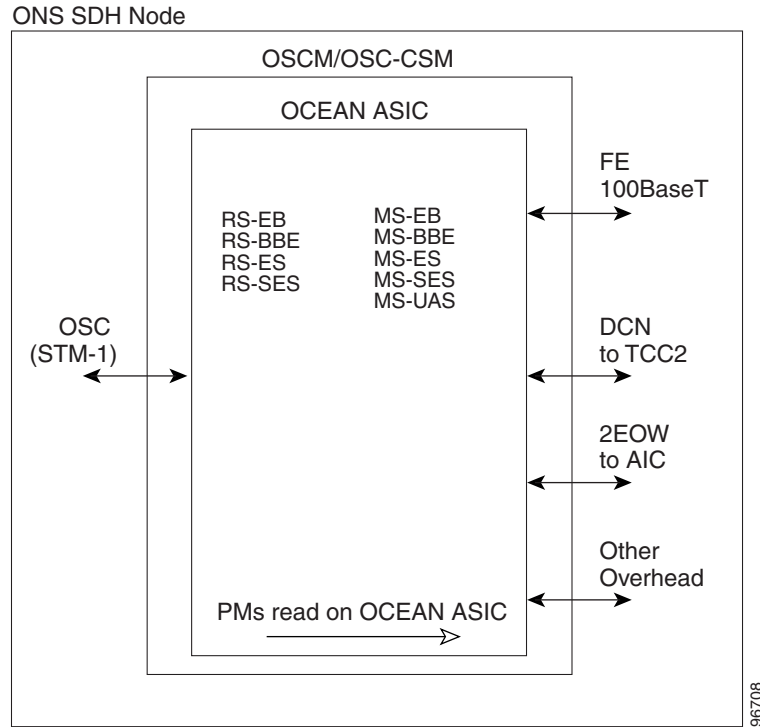
**Figure 5-4** ONS 15454 ETSI Node PM Read Points on OSCM and OSC-CSM Cards

For ONS 15454 ETSI nodes, [Figure 5-4](#) shows where overhead bytes detected on the ASICs produce PM parameters for the OSCM and OSC-CSM cards.

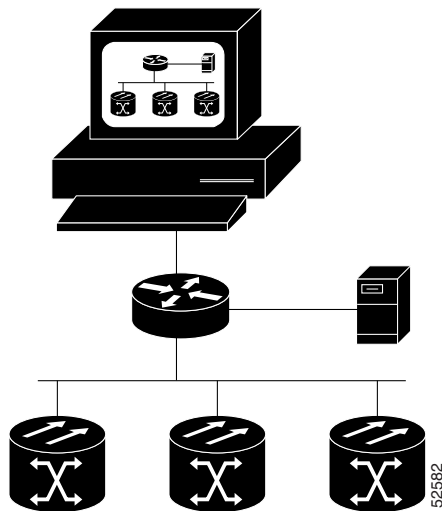
**Figure 6-1 Basic Network Managed by SNMP**

Figure 6-1 illustrates the basic layout idea of an SNMP-managed network.

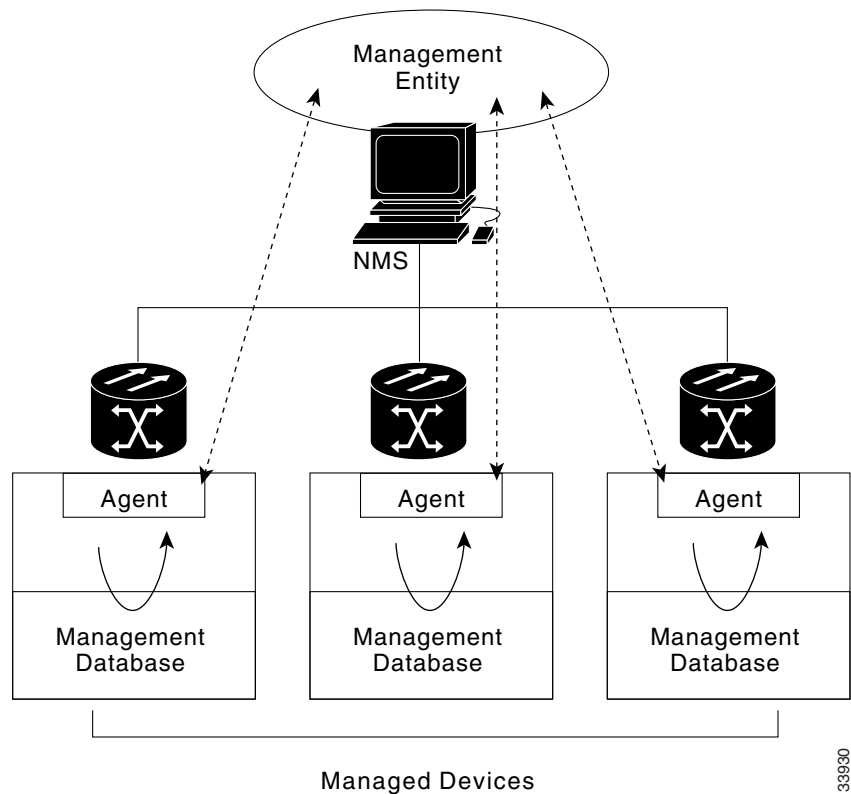
**Figure 6-2** Example of the Primary SNMP Components

A management system such as HP OpenView executes monitoring applications and controls managed devices. Management systems execute most of the management processes and provide the bulk of memory resources used for network management. A network might be managed by one or more management systems. Figure 6-2 illustrates the relationship between the network manager, the SNMP agent, and the managed devices.

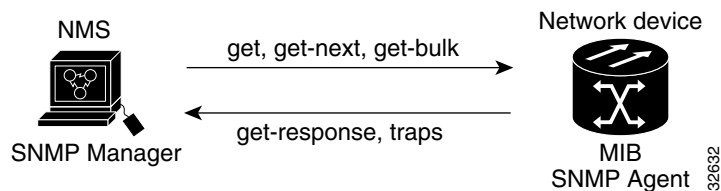
**Figure 6-3** Agent Gathering Data from a MIB and Sending Traps to the Manager

An agent (such as SNMP) residing on each managed device translates local management information data, such as performance information or event and error information caught in software traps, into a readable form for the management system. [Figure 6-3](#) illustrates SNMP agent get-requests that transport data to the network management software.

The SNMP agent captures data from MIBs, which are device parameter and network data repositories, or from error or change traps.

| <i>Figure 6-3</i> | Agent Gathering Data from a MIB and Sending Traps to the Manager | <b>6-3</b> |
