## Alarm Troubleshooting

This chapter gives a description, severity, and troubleshooting procedure for each commonly encountered Cisco DWDM alarm and condition. Tables 2-1 through 2-5 provide lists of DWDM alarms organized by severity. Table 2-6 on page 2-7 provides a list of alarms organized alphabetically. Table 2-7 gives definitions of all DWDM alarm logical objects, which are the basis of the alarm profile list in Table 2-8 on page 2-13. For a comprehensive list of all conditions and instructions for using TL1 commands, refer to the *Cisco SONET TL1 Command Guide*.

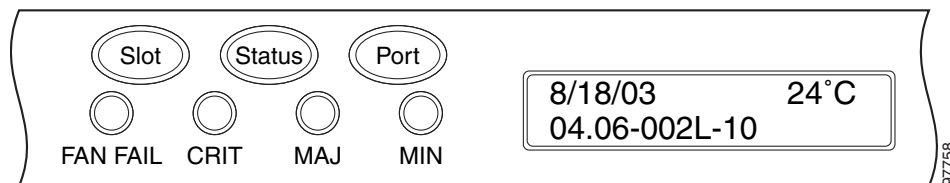
**Figure 2-1 Shelf LCD Panel**

- Step 1** View the temperature displayed on the ONS system LCD front panel. For example, the ONS 15454 front panel is illustrated in [Figure 2-1](#).

- Step 1** Check for any outstanding alarms that were raised against the active and standby TCC2/TCC2P and resolve them.
- Step 2** If the alarm does not clear, determine whether the LCD display on the fan tray ([Figure 2-1 on page 2-64](#)) is blank or if the text is garbled. If so, proceed to [Step 8](#). If not, continue with [Step 3](#).
- Step 3** At the earliest maintenance window, reset the standby TCC2/TCC2P:
