# General Troubleshooting

This chapter provides procedures for troubleshooting the most common problems encountered when operating a Cisco ONS 15454 DWDM shelf in ANSI or ETSI platforms. To troubleshoot specific alarms, see [Chapter 2, “Alarm Troubleshooting.”](#) If you cannot find what you are looking for, contact Cisco Technical Support (1-800-553-2447).

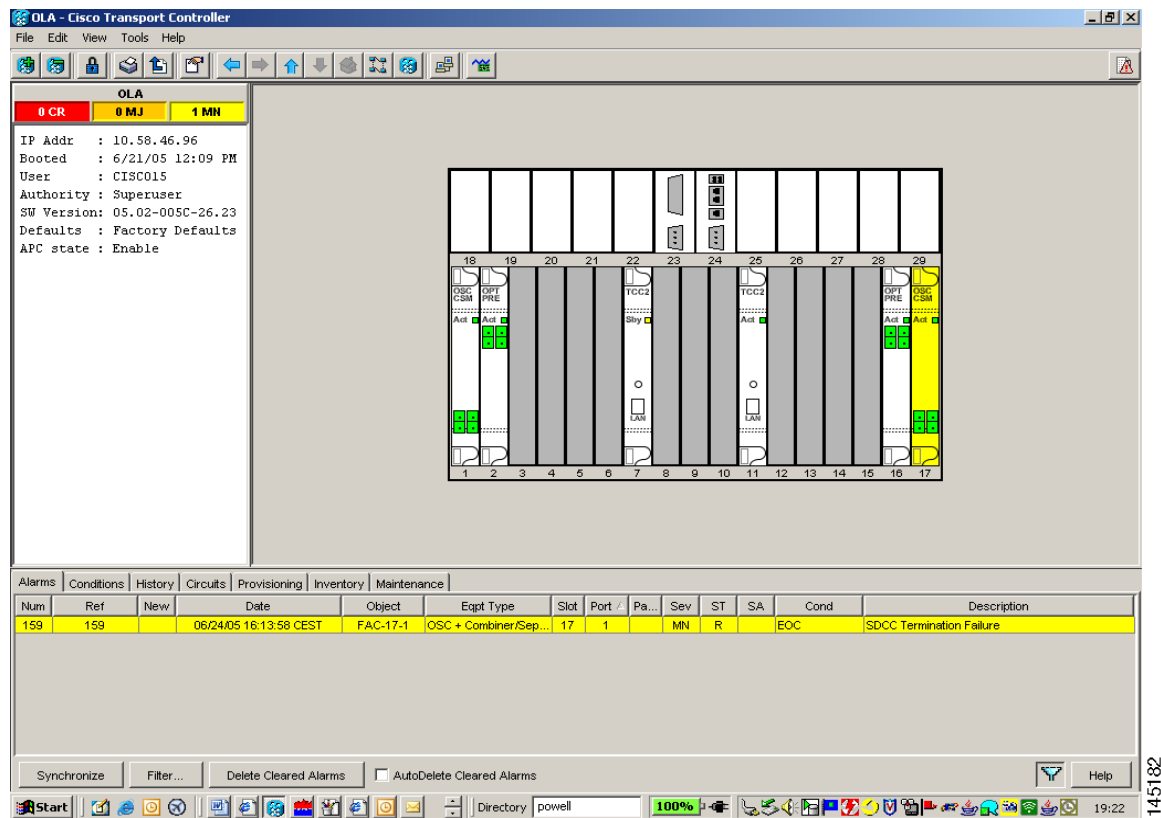
**Figure 1-27 ONS 15454 SDH OLA Node View with Fault Condition for ALS MODE Disabled**

In node view (single-shelf mode) or shelf view (multishelf mode) (Figure 1-26 and Figure 1-27), the alarm panel of the receiving node (ROADM in this example) reports the LOS (OTS), while the transmitting node (OLA) reports only an EOC alarm.

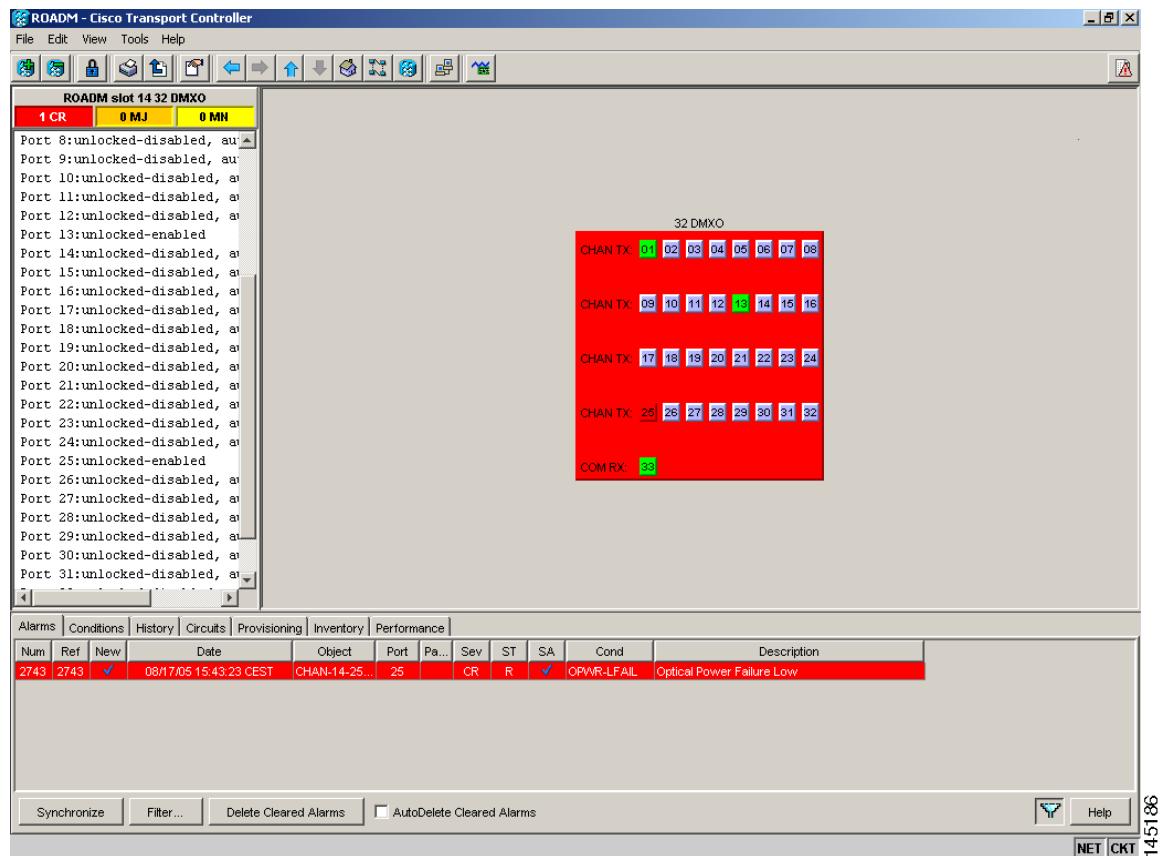
- An OPWR-LFAIL (OCH layer) alarm is present on the port associated with the VOA (see [Figure 1-36](#)).
- A valid optical power value (different from the end of scale value of –50 dBm) can be read in the CTC Power field, but the Power value is less than –33 dBm. (To view this value in card view, click the **Provisioning > Parameters** tabs.)

**Figure 1-36** Optical Drop Power More than 6 dB Lower than Expected
