Cisco ONS 15454 DWDM Troubleshooting Guide

Product and Software Release 7.0
June 2012

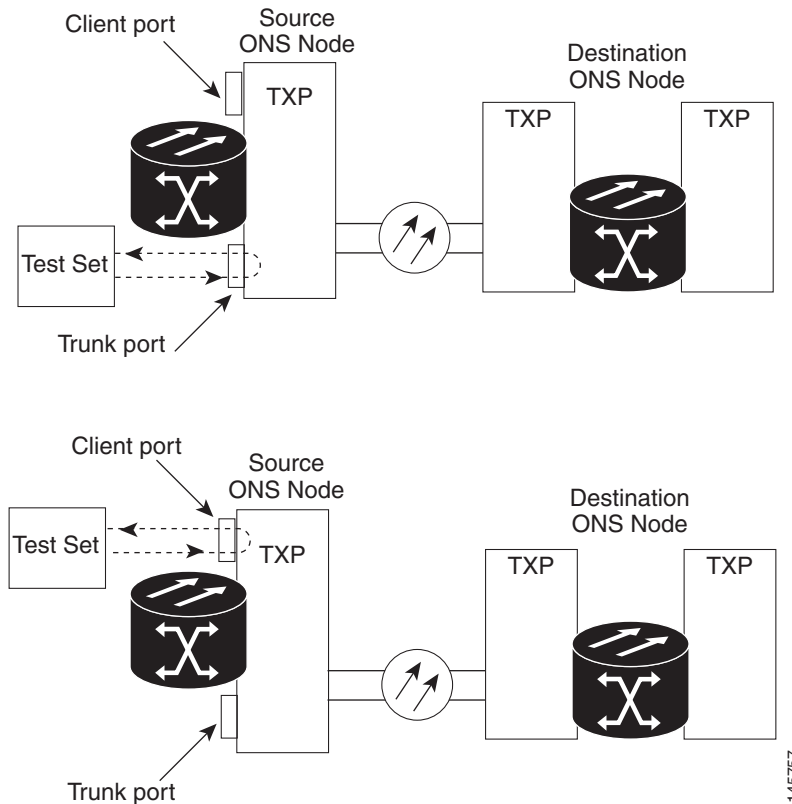
Figure 1-3 Facility Loopback on a Circuit Source MXP or TXP Port

This facility loopback test is performed on the node source port in the network circuit. In the testing situation used in this example, the source muxponder or transponder port under test is located in the source node. Facility loopback can be performed at the trunk port or at a client port. Completing a successful facility loopback on this port isolates the source MXP or TXP port as a possible failure point. [Figure 1-3](#) shows the facility loopback examples on source ONS node TXP ports (client and trunk).

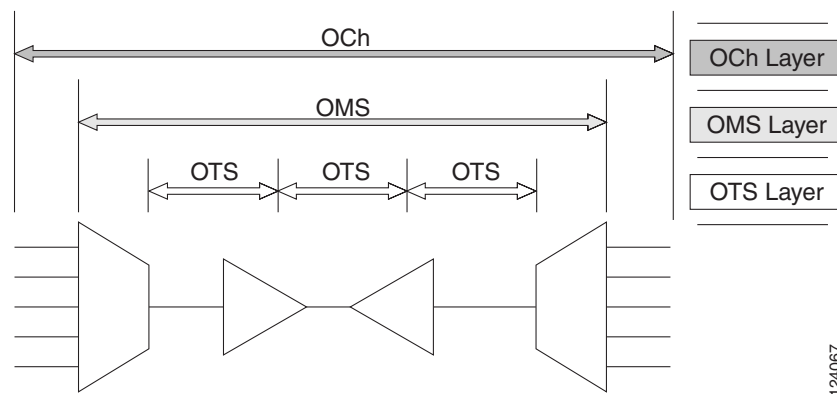
Figure 1-9 Optical Transport Network Layers

Like traditional SONET networks, ITU-T G.709 optical networks have a layered design (Figure 1-9). This structure enables localized monitoring that helps you isolate and troubleshoot network problems.

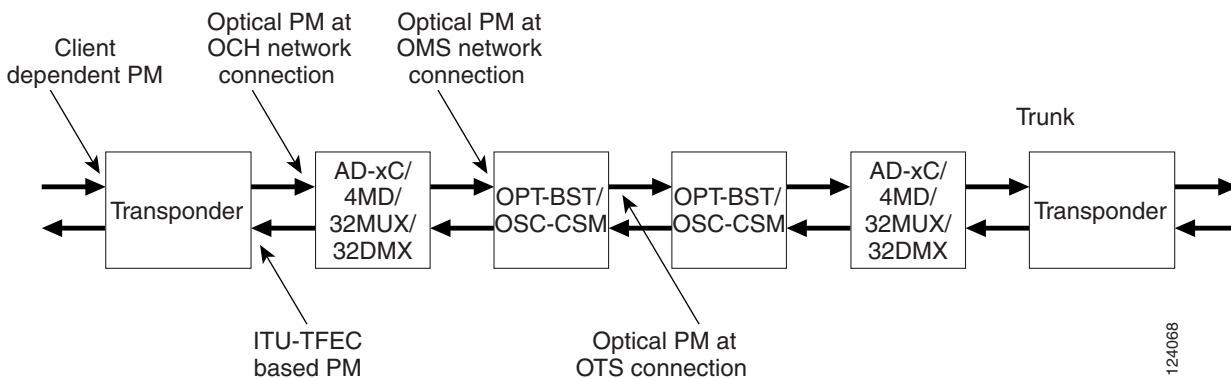
Figure 1-10 Performance Monitoring Points on ONS DWDM

Different PM count parameters are associated with different read points in a network. [Figure 1-10](#) illustrates the PM read points that are useful in identifying DWDM circuit points of failure. The “Performance Monitoring” chapter in the *Cisco ONS 15454 DWDM Reference Manual* lists all PM parameters and provides block diagrams of signal entry points, exit points, and interconnections between the individual circuit cards. Consult these specifications to determine which PM parameters are associated with the system points you want to monitor or provision with CTC or TL1. The monitoring points might vary according to your configuration.

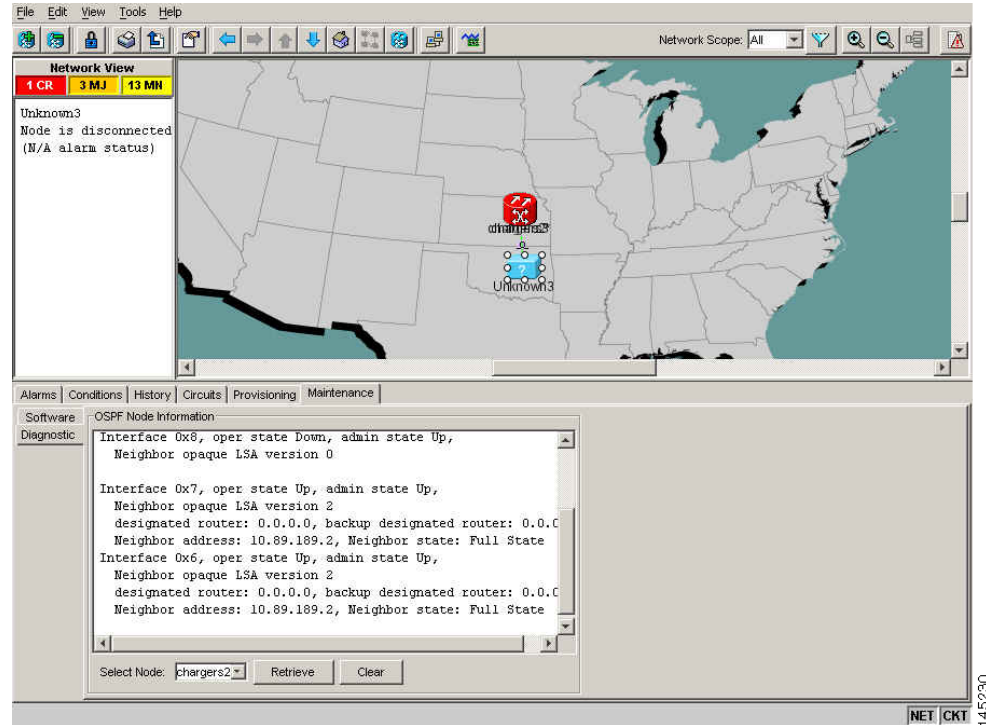
**Figure 1-16** DCN Tools OSPF Dump

CTC contains a data communications network (DCN) tool that assists with network troubleshooting for Open Shortest Path First (OSPF) networks. This tool, located in network view, is shown in [Figure 1-16](#). It executes an internal dump command to retrieve information about all nodes accessible from the entry point.

The dump, which provides the same information as a dump executed by special networking commands, is available at the network view in the Maintenance > Diagnostic tab. You can select the access point node in the Select Node drop-down list. To create the dump, click Retrieve. (To clear the dump, click Clear.)

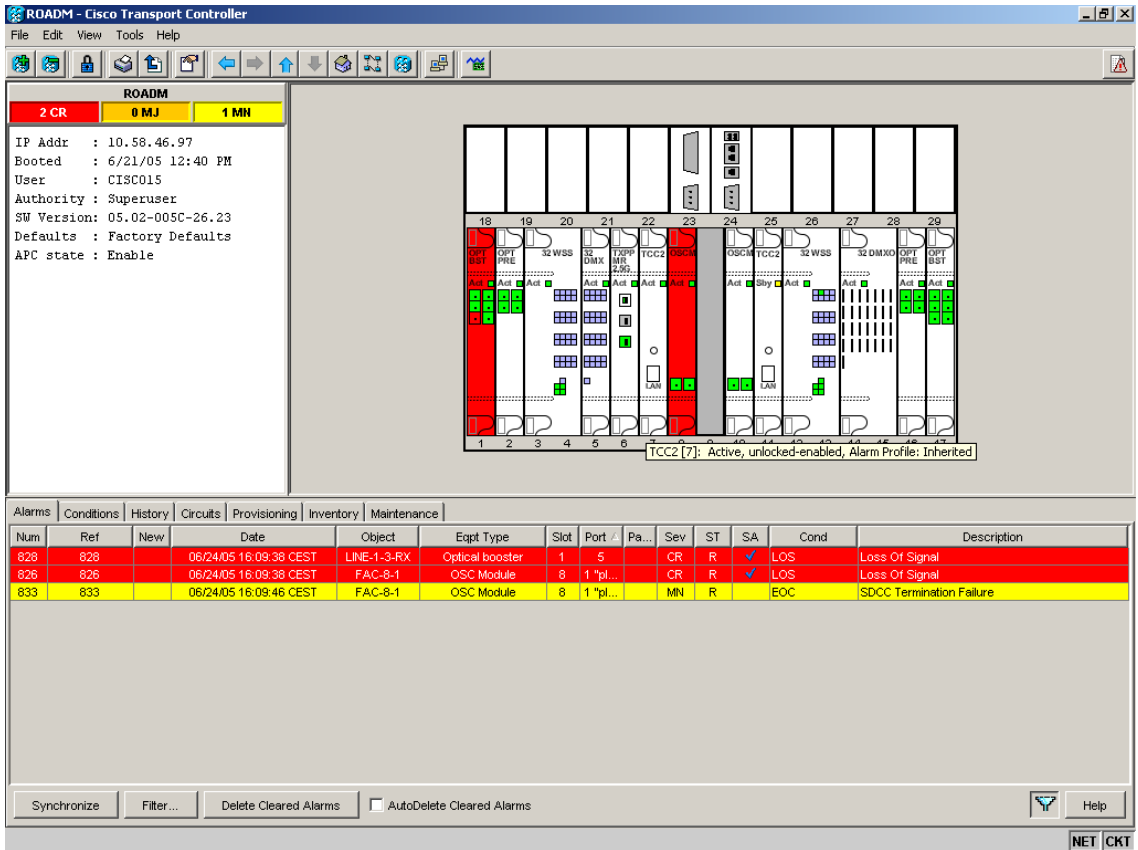
Figure 1-24 LOS Indication on the OLA Node OPT-BST

In node view (single-shelf mode) or shelf view (multishelf mode), the alarm panel of the two nodes (reconfigurable optical add/drop multiplexing [ROADM] and optical line amplification [OLA] in the example) show the LOS (AOTS) alarm on Port 4 of the OSC-CSM (see [Figure 1-23](#)) and the LOS (OTS) on Port 5 of the OPT-BST (see [Figure 1-24](#)).

An EOC condition is always present on both nodes, because the optical service channel (OSC) link (to which the communication channel applies) is down.

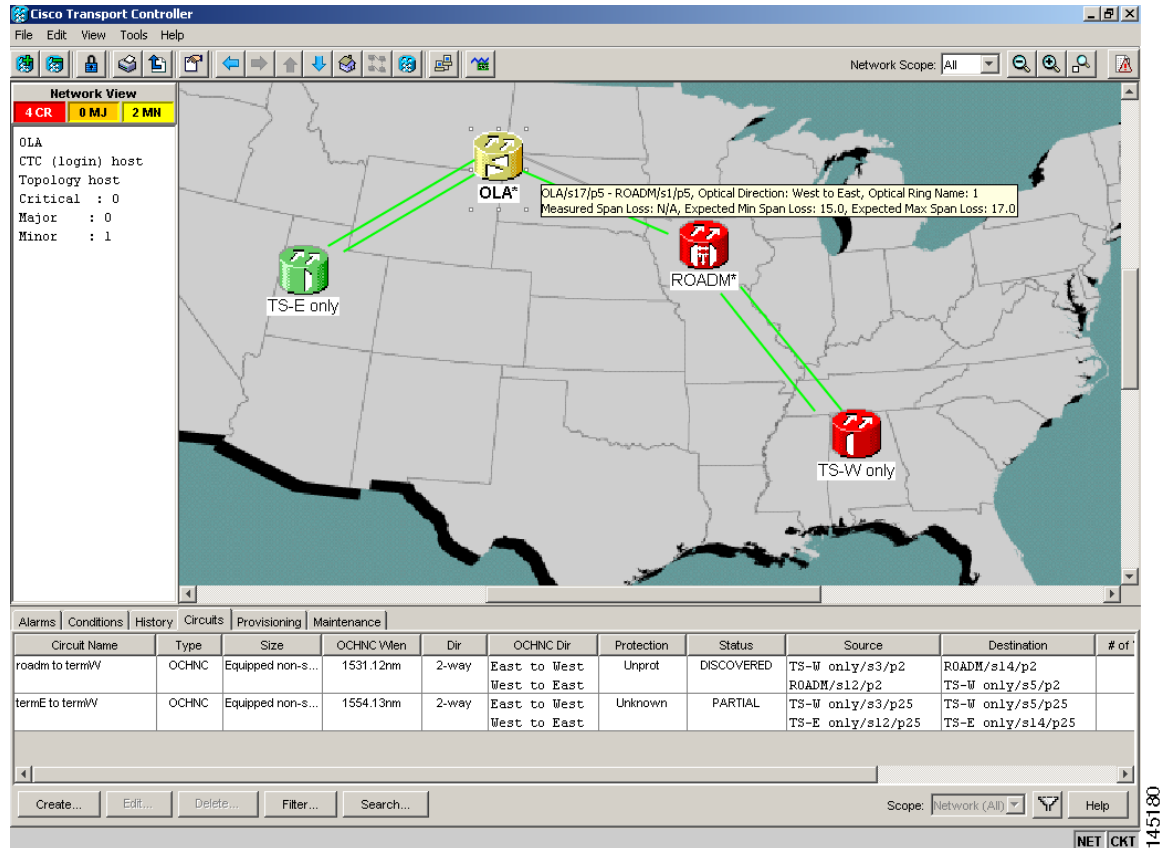
**Figure 1-25** Network View Fault Condition for Fiber Cut with ALS Mode Disabled

The LOS (OTS or AOTS) alarm is raised by the ROADM-RX node that was receiving the signal coming from the broken fiber. The final fault condition of the network is shown in Figure 1-25.

In network view (Figure 1-25), only the actual affected fiber becomes gray, whereas the traffic (and OSC signal as well) on the good fiber is active and fault identification is immediate.

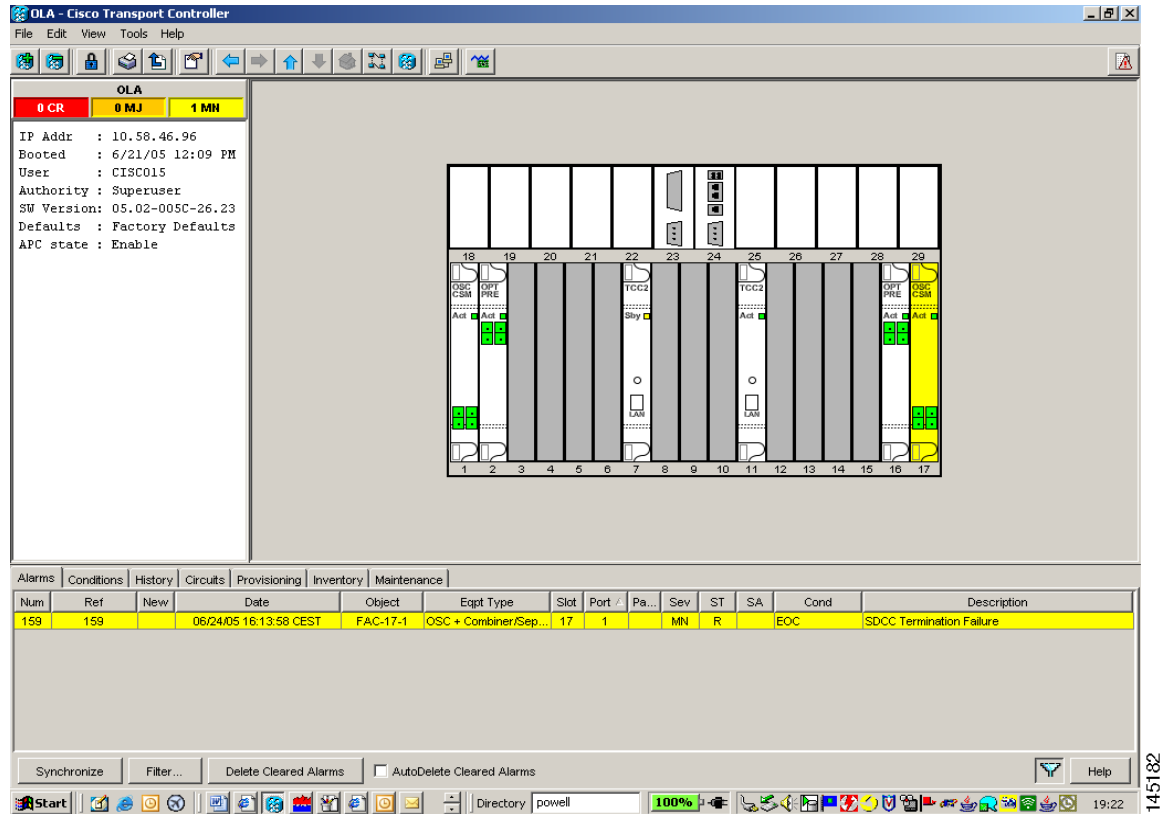
**Figure 1-27 ONS 15454 SDH OLA Node View with Fault Condition for ALS MODE Disabled**

In node view (single-shelf mode) or shelf view (multishelf mode) (Figure 1-26 and Figure 1-27), the alarm panel of the receiving node (ROADM in this example) reports the LOS (OTS), while the transmitting node (OLA) reports only an EOC alarm.

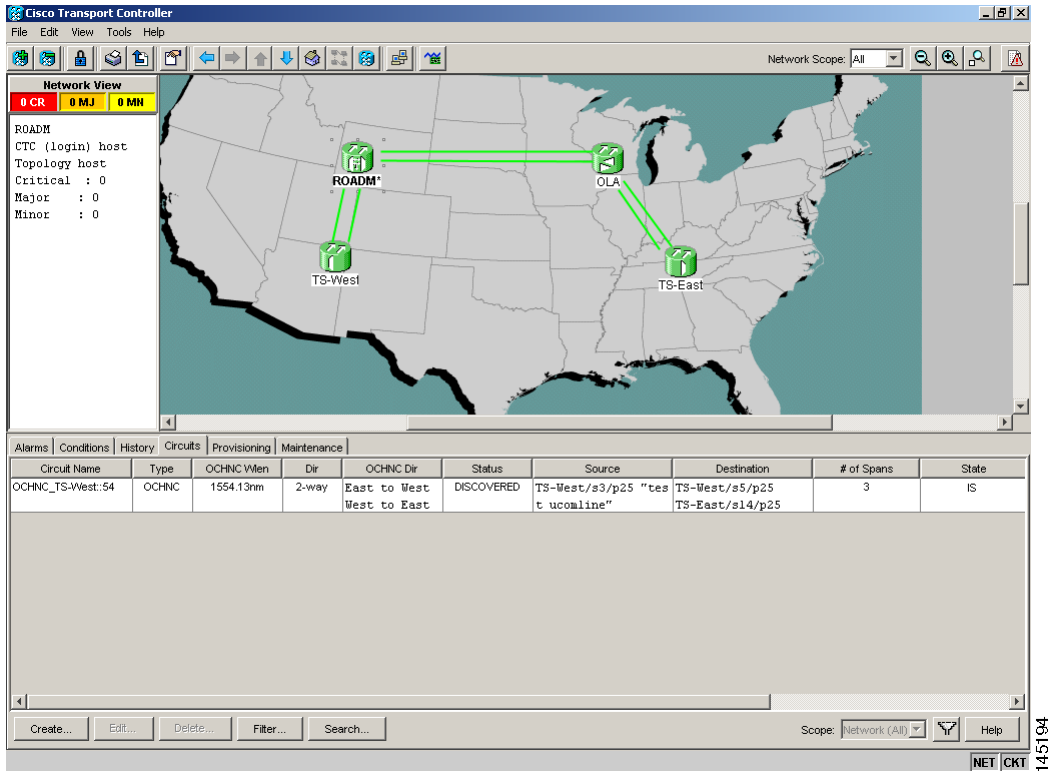
Figure 1-29 OCHNC Circuit Successfully Completed

POCHNC circuit creation is successfully completed when the CTC circuit table reports the situation shown in [Figure 1-29](#).

- The Circuit Status has turned to DISCOVERED.
- The # of spans field shows the correct number of hops among different nodes that the OCHNC circuit passes through to reach the final destination.
- Circuit State reports IS (or unlocked).

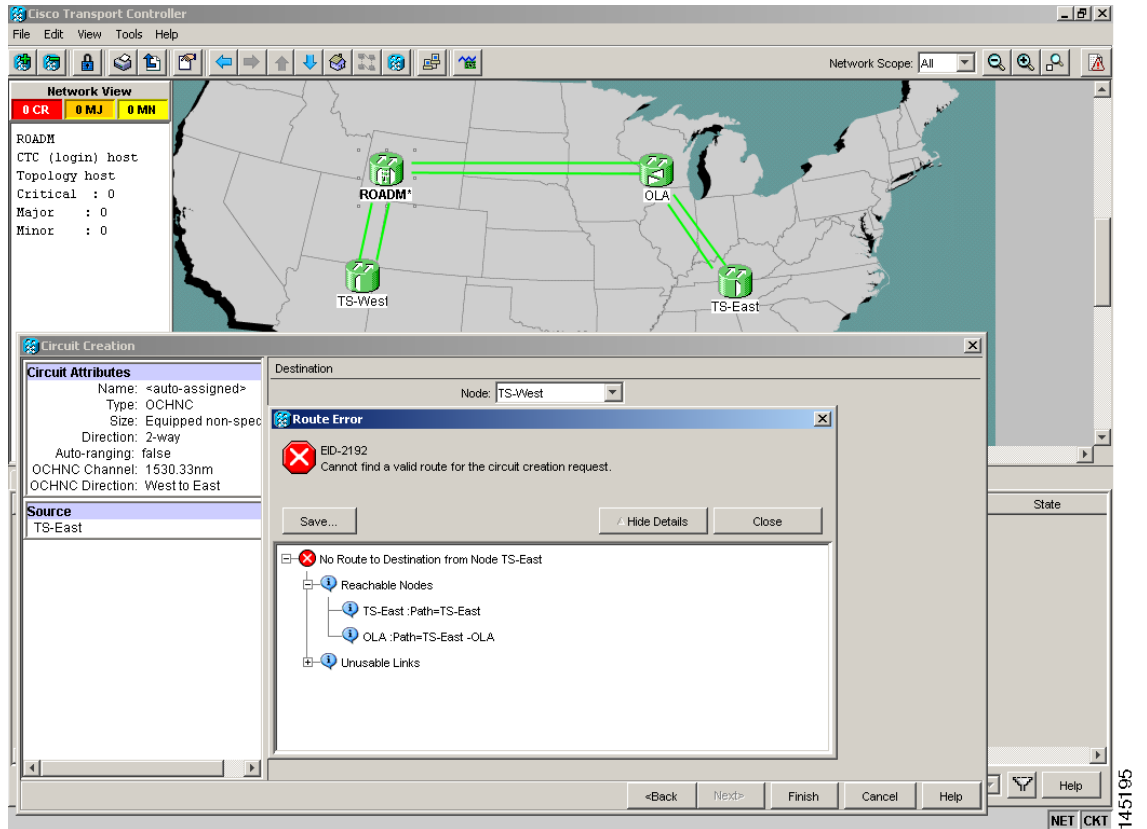
**Figure 1-30** Partial Circuit

- If the WPP wizard cannot complete the circuit creation procedure, CTC displays the error message shown in [Figure 1-30](#). In the message, click **Details** to see the partial connections that WPP can set up. Start troubleshooting the problem in the first node that is unreachable along the path.

To troubleshoot and eventually fix issues related to the faulty OCHNC circuit creation shown in [Figure 1-30 on page 1-81](#), the following procedure must be performed.

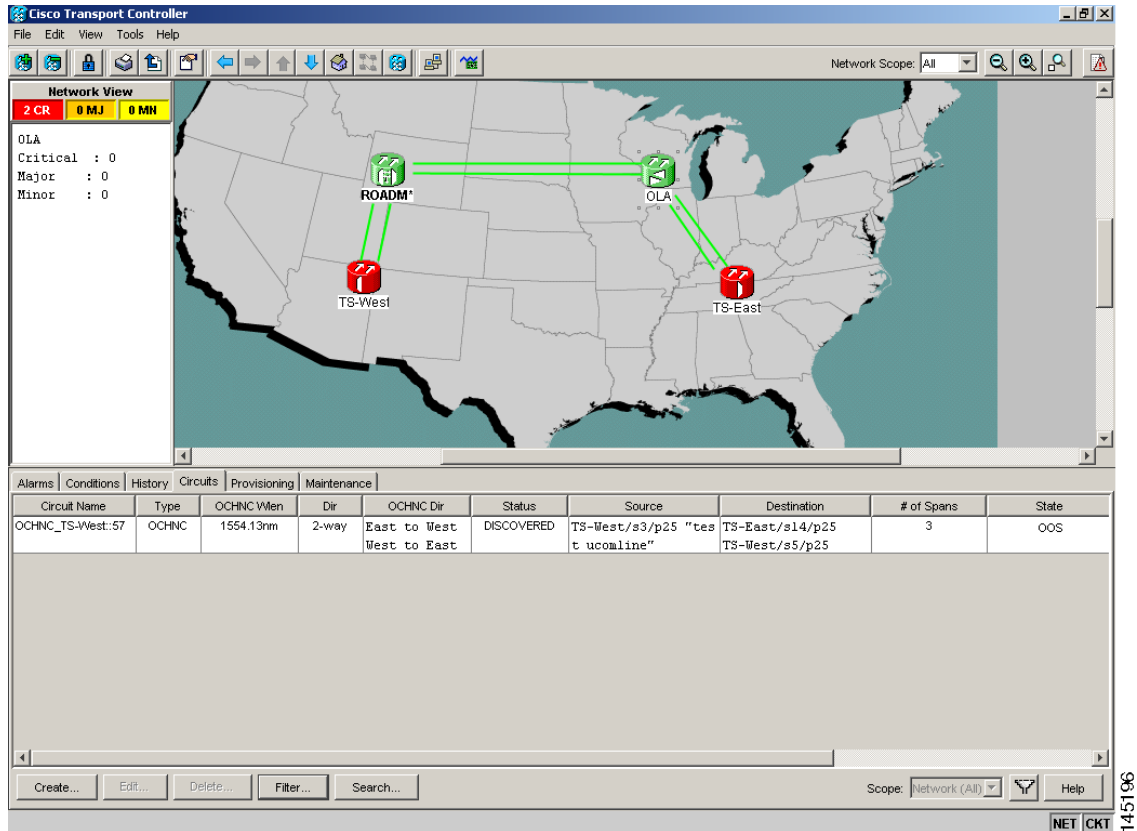
**Figure 1-31** Circuit Discovered, State OSS

- The circuit is successfully created and reported under the Circuits tab, the Status field turns to DISCOVERED, but the Circuit State is OOS (locked). The condition is shown in [Figure 1-31](#).

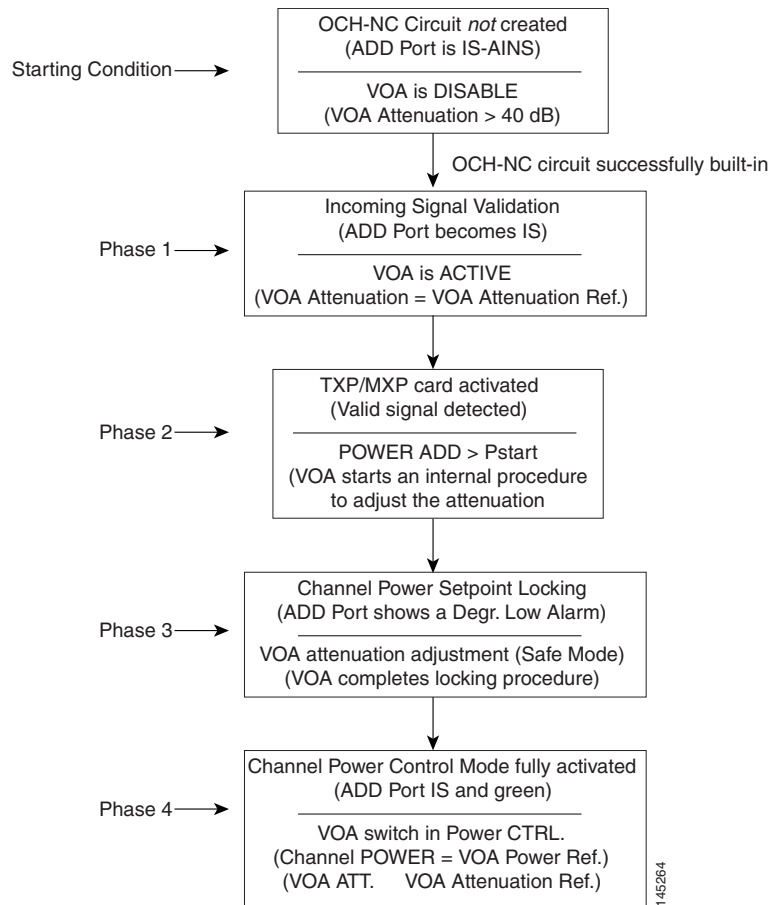
**Figure 1-32 VOA Startup Procedure**

The final VOA condition is achieved through a startup procedure divided into the four sequential phases shown in [Figure 1-32](#).

Until the VOA has completed all the phases shown in [Figure 1-32](#), the power control mode is not fully activated.

When the power is lower than expected, the start-up procedure can stop at Phase 1, Phase 2, or Phase 3 (see [Figure 1-32](#)). The point at which the start-up procedure stops depends on the amount of power missing.

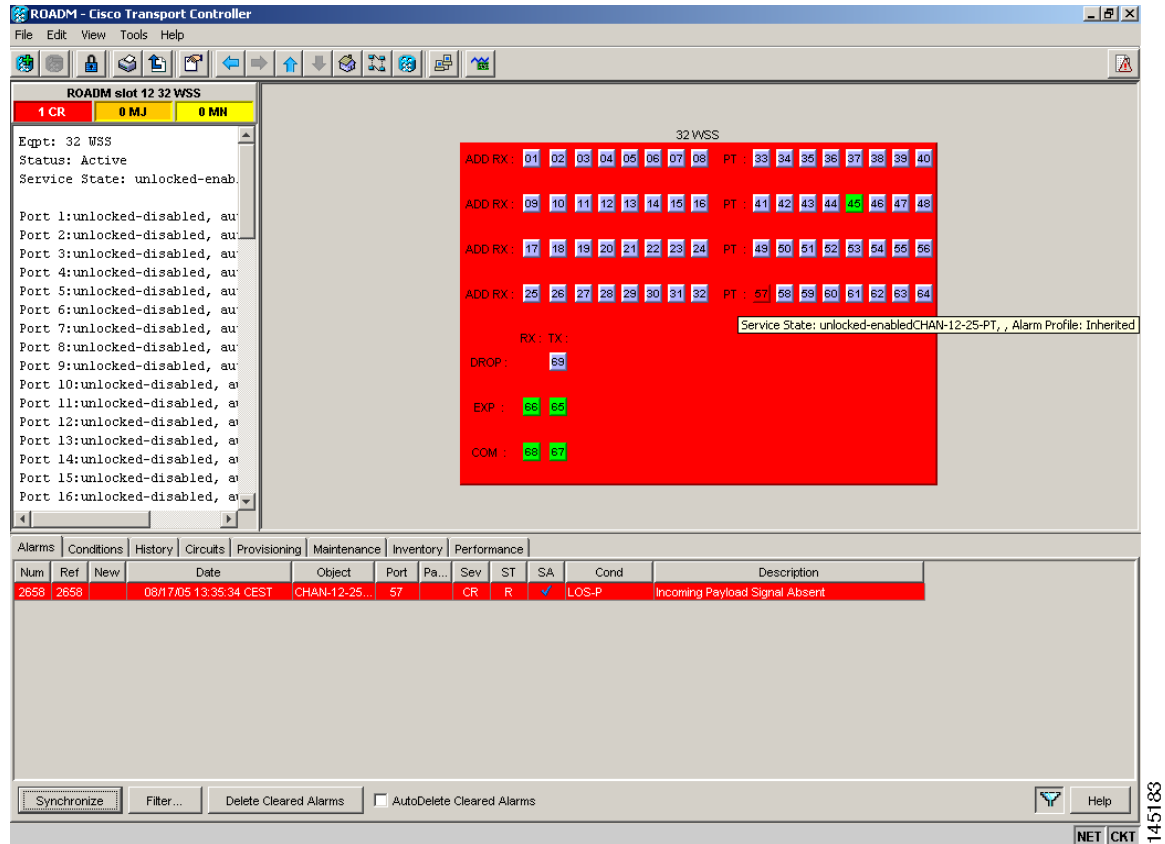
**Figure 1-33** LOS-P Indication on the VOA Port

If the incoming power level is lower than the minimum allowed, the startup procedure always stops at Phase 1 (see [Figure 1-33](#)). This is the case even if the final VOA Power Reference reported in CTC is reachable.

- A LOS-P (OCH layer) alarm on the port associated with the VOA (see [Figure 1-33](#))
- A valid optical power value (different from the end of scale value of  $-50$  dBm) in the Power field, but the value for Power is less than  $-33$  dBm. (To view the Power field, in card view, click the **Provisioning > Parameters** tabs.)

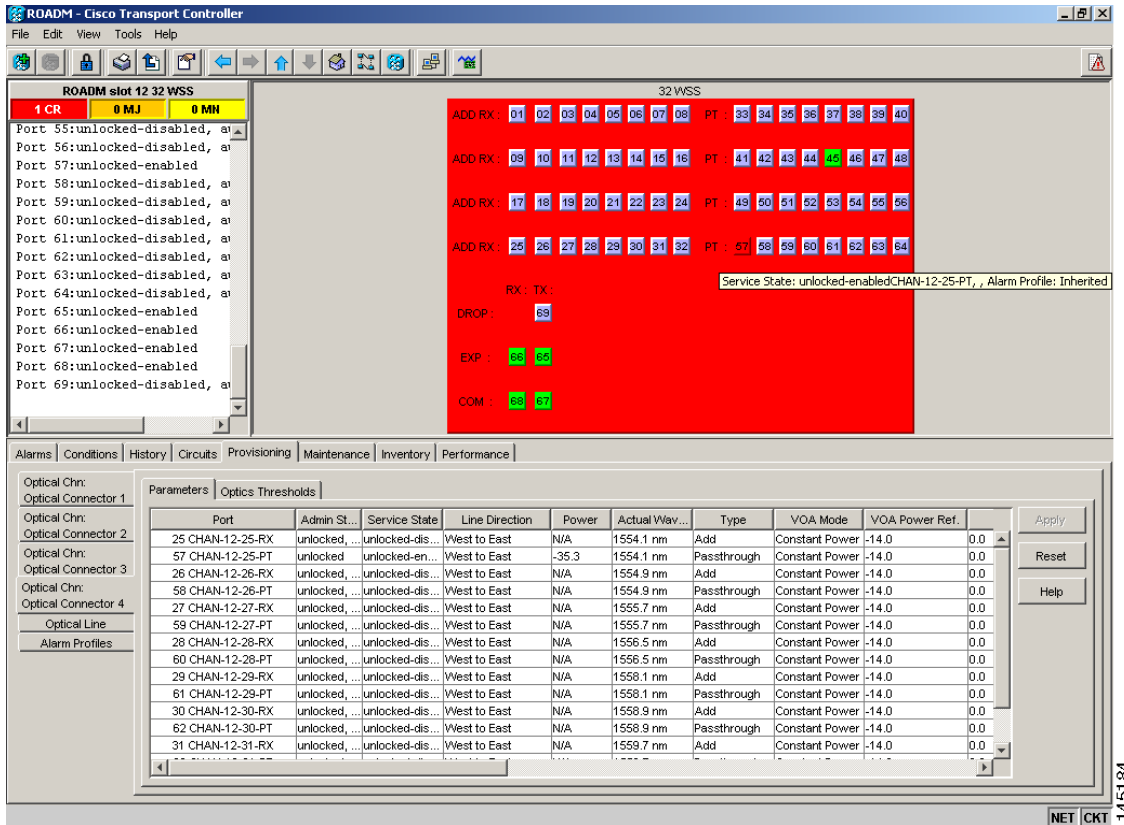
Figure 1-34 Power Level of Incoming Signal Less than -33 dBm

- A LOS-P (OCH layer) alarm is present on the port associated with the VOA.
- A valid optical power value (different from the end of scale value of – 50 dBm) can be read in the Power field, but the value for Power is less than –33 dBm (see [Figure 1-34](#)). (To access this value, in card view, click the **Provisioning** > **Parameters** tabs.)

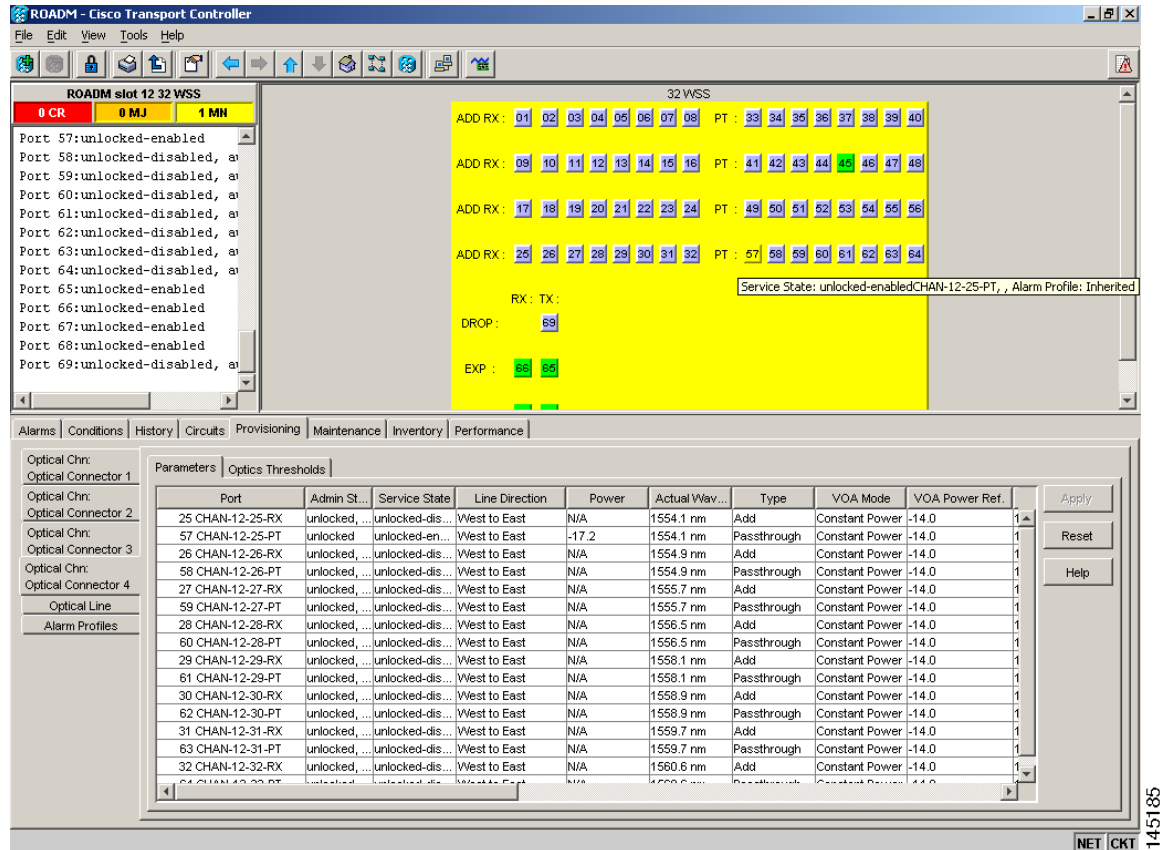
Figure 1-35 Optical Power Less than 6 dB Lower than Expected

When the optical power is less than 6 dB lower than the expected value, even if a valid incoming signal is present, the final VOA Power Reference setpoint value that is reported in the CTC is not reachable and the VOA startup procedure is stopped at Phase 3.

- An OPWR-LowDEGrade (OCH layer) alarm is present on the port associated with the VOA.
- A valid optical power value (different from the end of scale value of -50 dBm) can be read in the Power field, but the value is (VOA Power Ref - 6 dBm) < Power < VOA Power Ref (see Figure 1-35). To access this value, in card view, click the **Provisioning > Parameters** tabs.

- An OPWR-LowDEGrade (OCH layer) alarm is present on the port associated with the VOA.
- A valid optical power value (different from the end of scale value of  $-50$  dBm) can be read in the CTC Power field, but the value is  $(\text{VOA Power Ref} - 6 \text{ dBm}) < \text{Power} < \text{VOA Power Ref}$  (Figure 1-35). To view this value in card view, click the **Provisioning > Parameters** tabs.

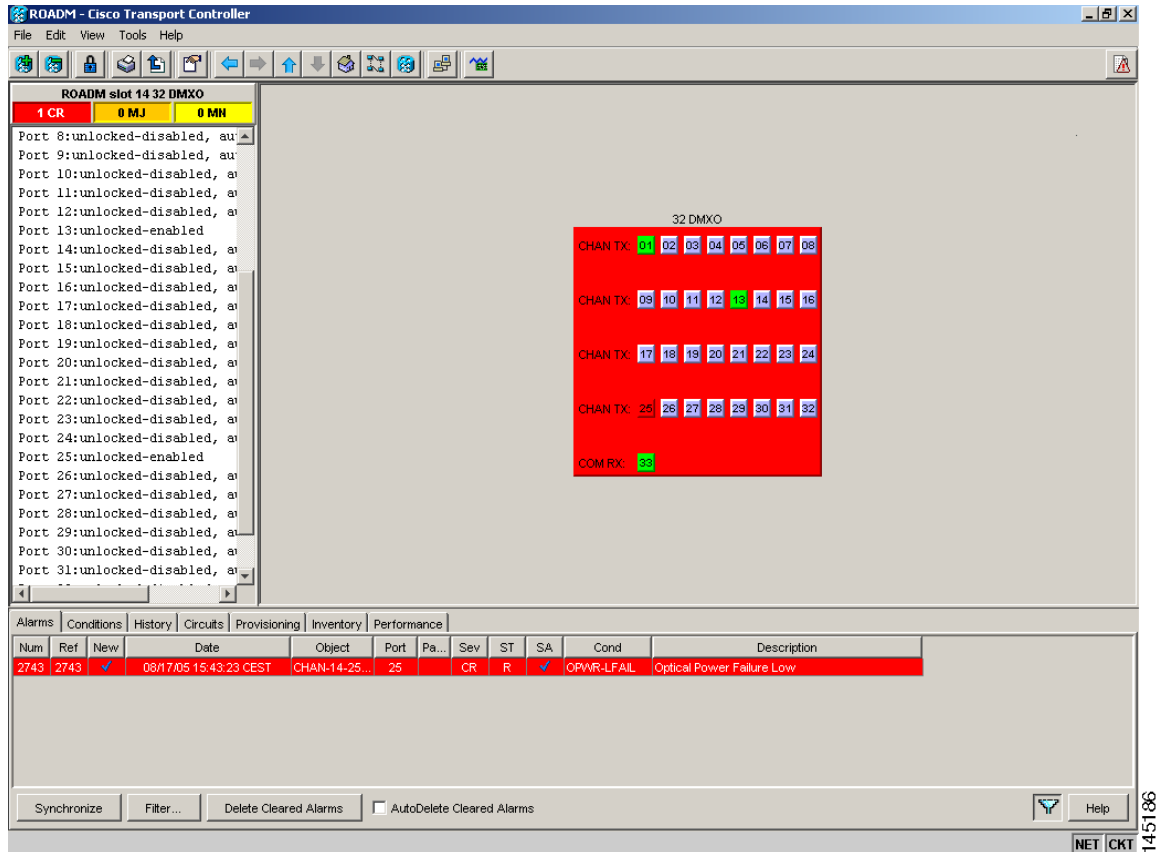
**Figure 1-36** Optical Drop Power More than 6 dB Lower than Expected

- An OPWR-LFAIL (OCH layer) alarm is present on the port associated with the VOA (see [Figure 1-36](#)).
- A valid optical power value (different from the end of scale value of –50 dBm) can be read in the CTC Power field, but the Power value is less than –33 dBm. (To view this value in card view, click the **Provisioning > Parameters** tabs.)

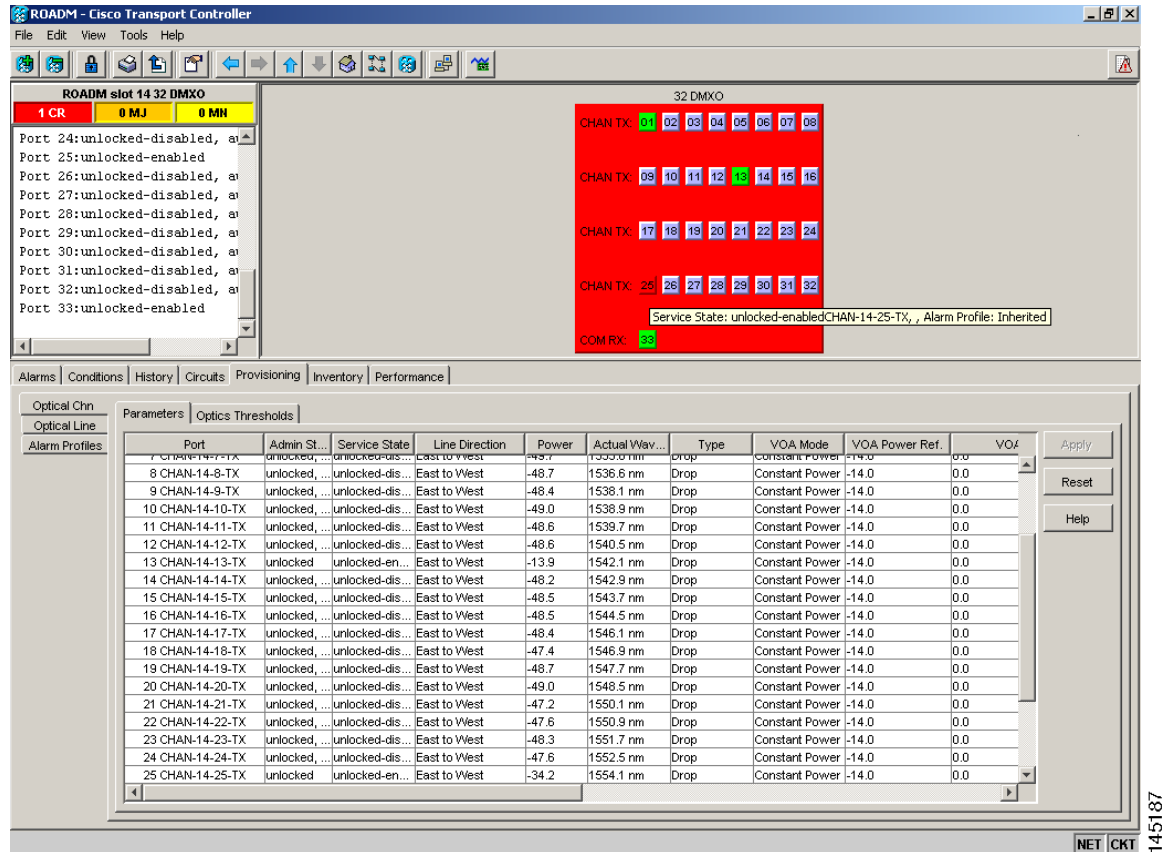
**Figure 1-37** Optical Drop Power Less than 6 dB Lower than Expected

A dirty connection or excessive loss of the incoming span are among the possible reasons that can lead to a fault condition. They are the most common and affect all wavelengths, whereas an excessive amplifier gain tilt or a wavelength misconfiguration on the far-end TXP or MXP card can lead to condition where only a single wavelength fails, such as the one (Channel 25) shown in Figure 1-37.

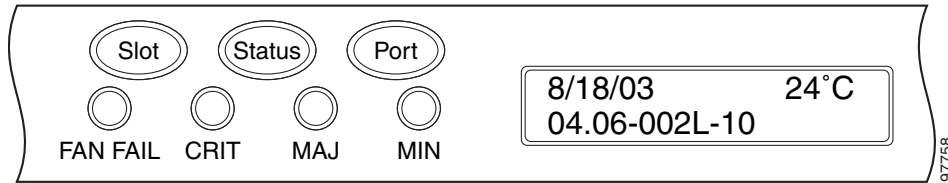
**Figure 2-1 Shelf LCD Panel**

- Step 1** View the temperature displayed on the ONS system LCD front panel. For example, the ONS 15454 front panel is illustrated in [Figure 2-1](#).

- Step 1** Check for any outstanding alarms that were raised against the active and standby TCC2/TCC2P and resolve them.
- Step 2** If the alarm does not clear, determine whether the LCD display on the fan tray ([Figure 2-1 on page 2-64](#)) is blank or if the text is garbled. If so, proceed to [Step 8](#). If not, continue with [Step 3](#).
- Step 3** At the earliest maintenance window, reset the standby TCC2/TCC2P:
