Cisco ONS 15454 DWDM Troubleshooting Guide

Product and Software Release 7.0.1
June 2012

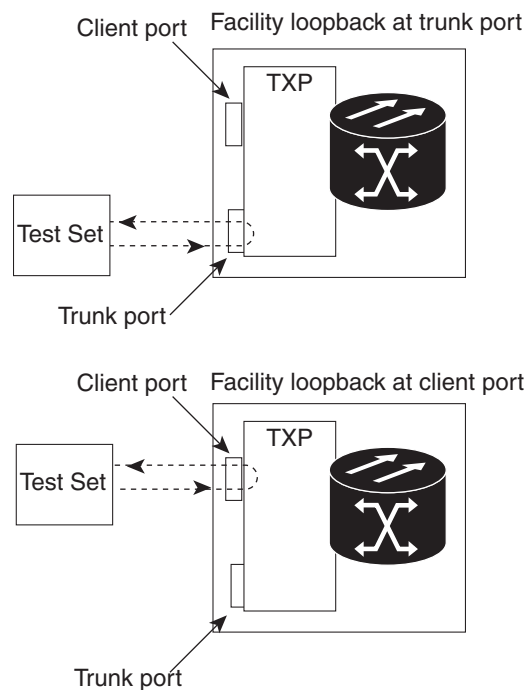
Figure 1-1 Facility Loopback Path on a Near-End Transponder Card

To test a card LIU, connect an optical test set to a trunk or client port and perform a facility loopback. Alternately, use a loopback or hairpin circuit on a card that is farther along the circuit path. For example, [Figure 1-1](#) shows a facility loopback at a trunk port and at a client port on a TXP card.

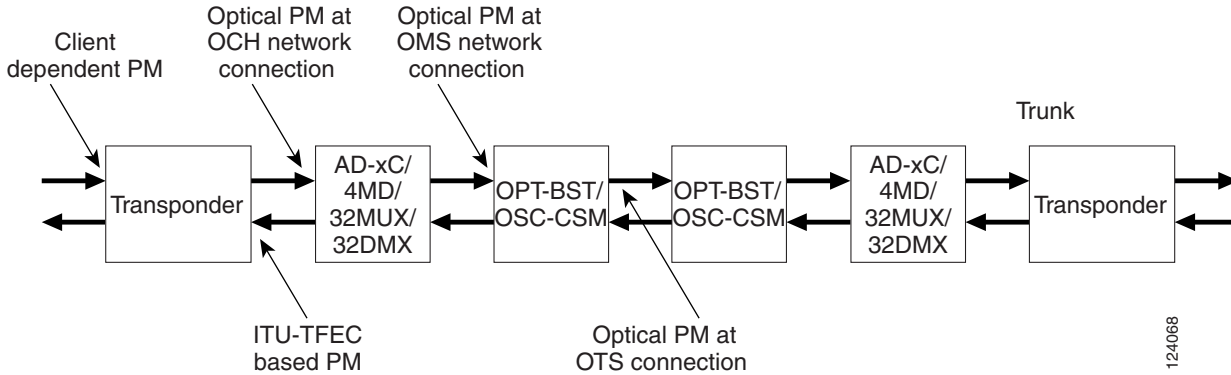
Figure 1-10 Performance Monitoring Points on ONS DWDM

Different PM count parameters are associated with different read points in a network. [Figure 1-10](#) illustrates the PM read points that are useful in identifying DWDM circuit points of failure. The “Performance Monitoring” chapter in the *Cisco ONS 15454 DWDM Reference Manual* lists all PM parameters and provides block diagrams of signal entry points, exit points, and interconnections between the individual circuit cards. Consult these specifications to determine which PM parameters are associated with the system points you want to monitor or provision with CTC or TL1. The monitoring points might vary according to your configuration.

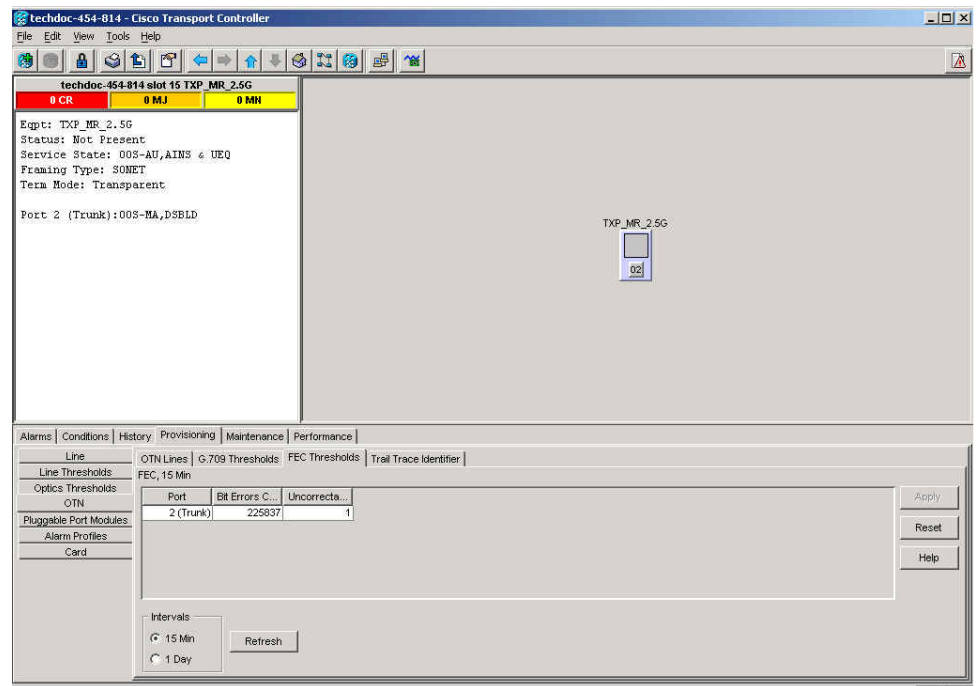
**Figure 1-14 Provision Card FEC Thresholds**

- Step 1** In node view (single-shelf mode) or shelf view (multishelf mode), double-click a transponder or muxponder card to open the card view. (In this example, cards such as the TXP\_MR\_10G, TXPP\_MR\_2.5G, and MXP\_2.5G\_10G are applicable.)
- Step 2** Click the **Provisioning > OTN > FEC Thresholds** tabs (Figure 1-14).

- Step 3** In the Bit Errors Corrected field, enter a threshold number, for example 225837.
- Step 4** In the Uncorrectable Words field, enter a threshold number, for example, 2.
- Step 5** In the Intervals area, click **15 Min**.

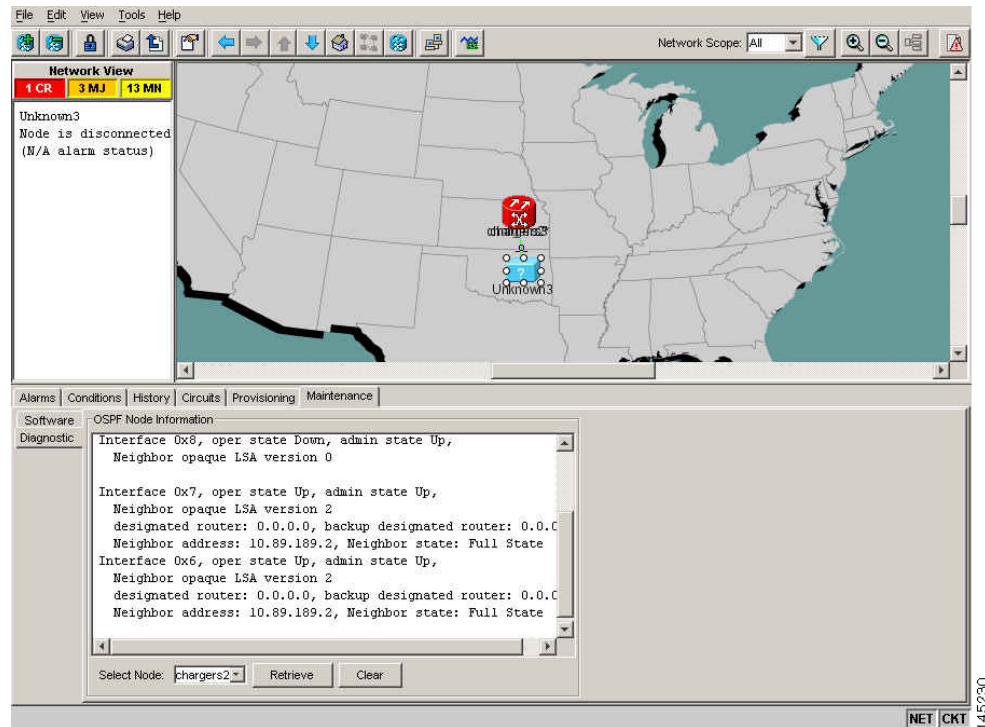
**Figure 1-16** DCN Tools OSPF Dump

CTC contains a data communications network (DCN) tool that assists with network troubleshooting for Open Shortest Path First (OSPF) networks. This tool, located in network view, is shown in [Figure 1-16](#). It executes an internal dump command to retrieve information about all nodes accessible from the entry point.

The dump, which provides the same information as a dump executed by special networking commands, is available at the network view in the Maintenance > Diagnostic tab. You can select the access point node in the Select Node drop-down list. To create the dump, click Retrieve. (To clear the dump, click Clear.)

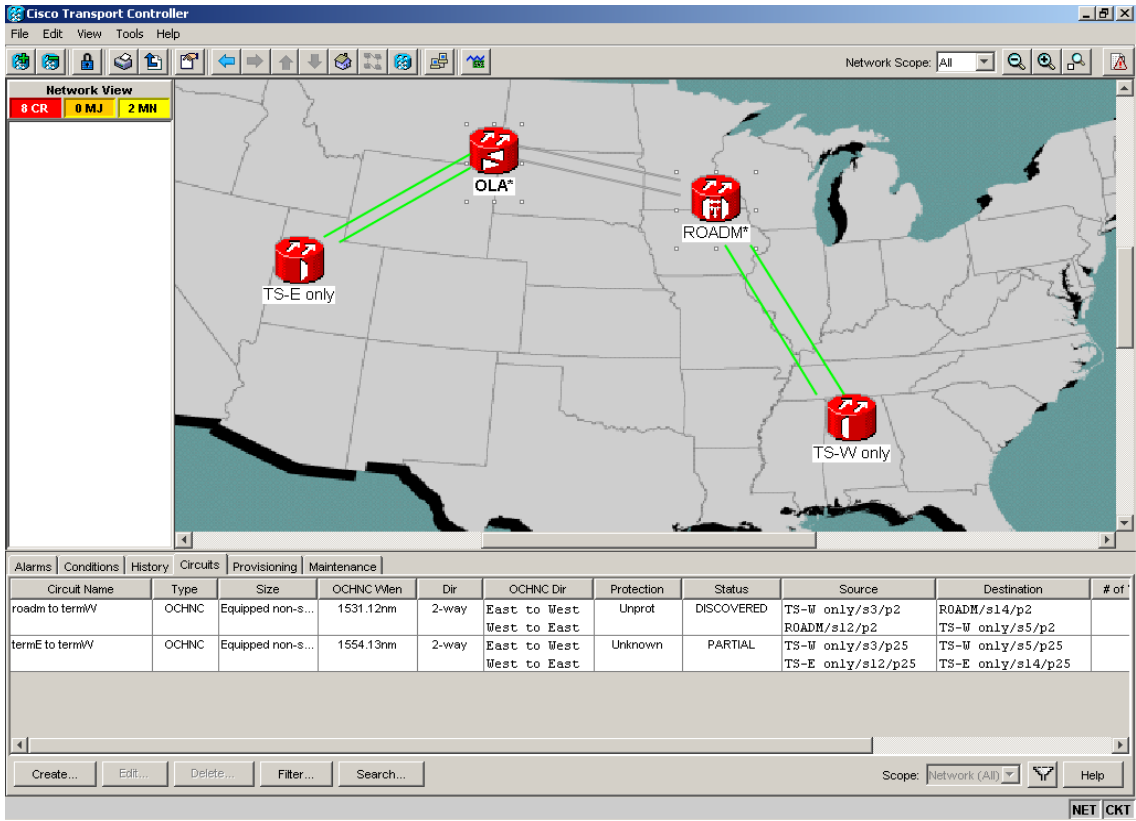
Figure 1-22 Fiber Cut with ALS MODE = Auto Restart

The final fault condition of the network is shown in [Figure 1-22](#).

In network view, both of the lines representing the span were formerly green and have now changed to gray. Notice also that the status of all the OCHNC circuits on the broken span have changed from Discovered to Partial.

The basic assumption is that the network ALS feature (for feature details, refer to the “Network Optical Safety—Automatic Laser Shutdown” section in the *Cisco ONS 15454 DWDM Reference Manual*) is active (ALS Mode = Auto Restart on the OPT-BST [+ OSCM] and OSC-CSM). Given this assumption, the starting condition is as shown in [Figure 1-22 on page 1-62](#).

An EOC condition is always present on both nodes because the OSC optical link is down due to an incoming power level lower than the optical sensitivity limit (–42 dBm). The system condition remains unchanged as illustrated in Figure 1-22.

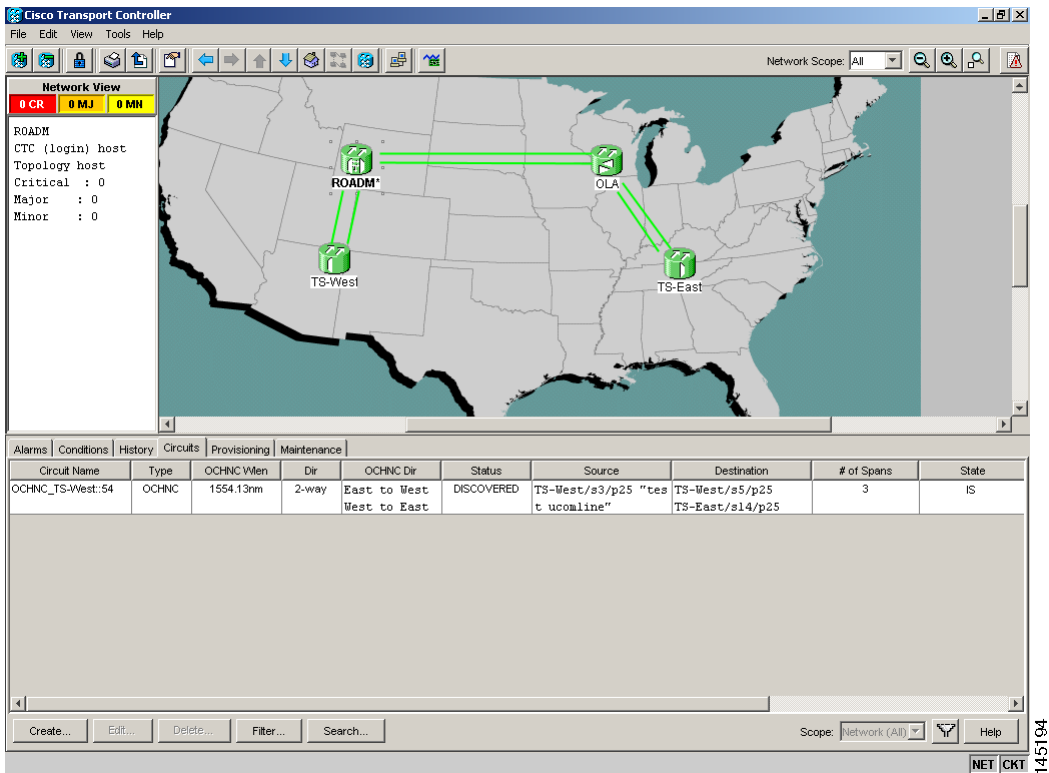
Figure 1-29 OCHNC Circuit Successfully Completed

POCHNC circuit creation is successfully completed when the CTC circuit table reports the situation shown in [Figure 1-29](#).

- The Circuit Status has turned to DISCOVERED.
- The # of spans field shows the correct number of hops among different nodes that the OCHNC circuit passes through to reach the final destination.
- Circuit State reports IS (or unlocked).

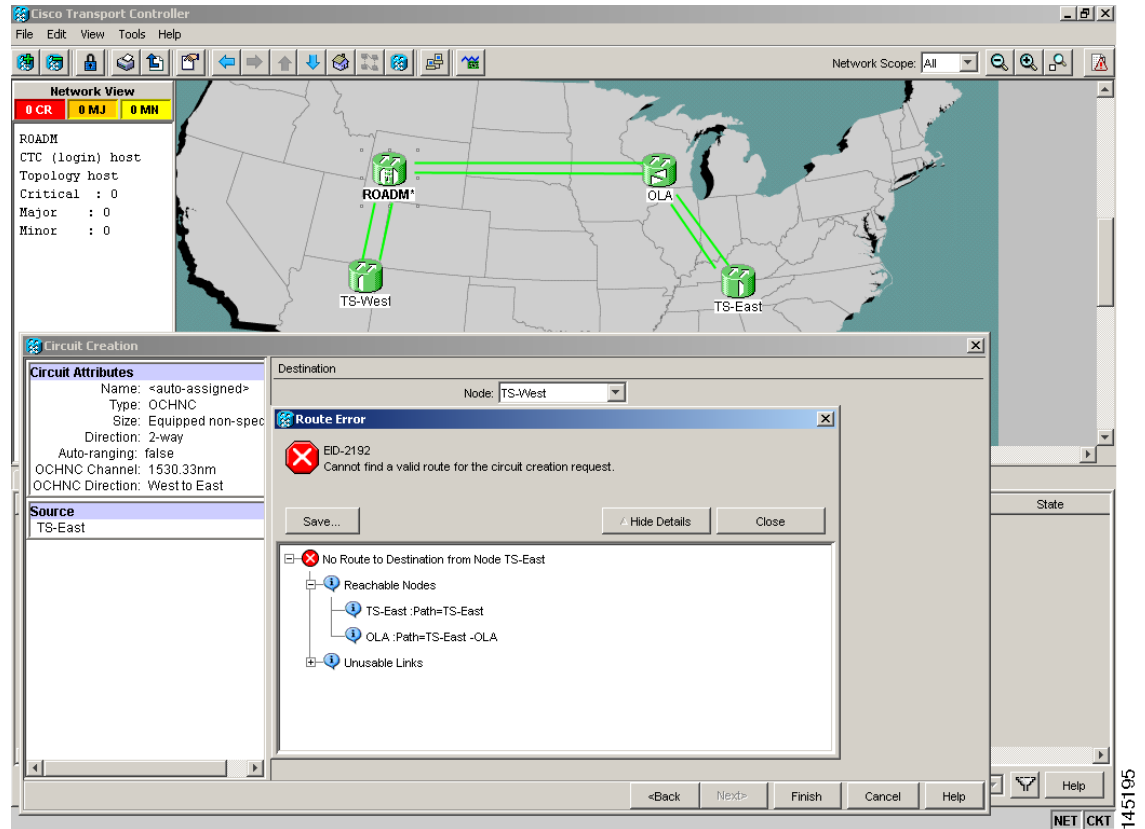
**Figure 1-30** Partial Circuit

- If the WPP wizard cannot complete the circuit creation procedure, CTC displays the error message shown in Figure 1-30. In the message, click **Details** to see the partial connections that WPP can set up. Start troubleshooting the problem in the first node that is unreachable along the path.

To troubleshoot and eventually fix issues related to the faulty OCHNC circuit creation shown in [Figure 1-30 on page 1-81](#), the following procedure must be performed.

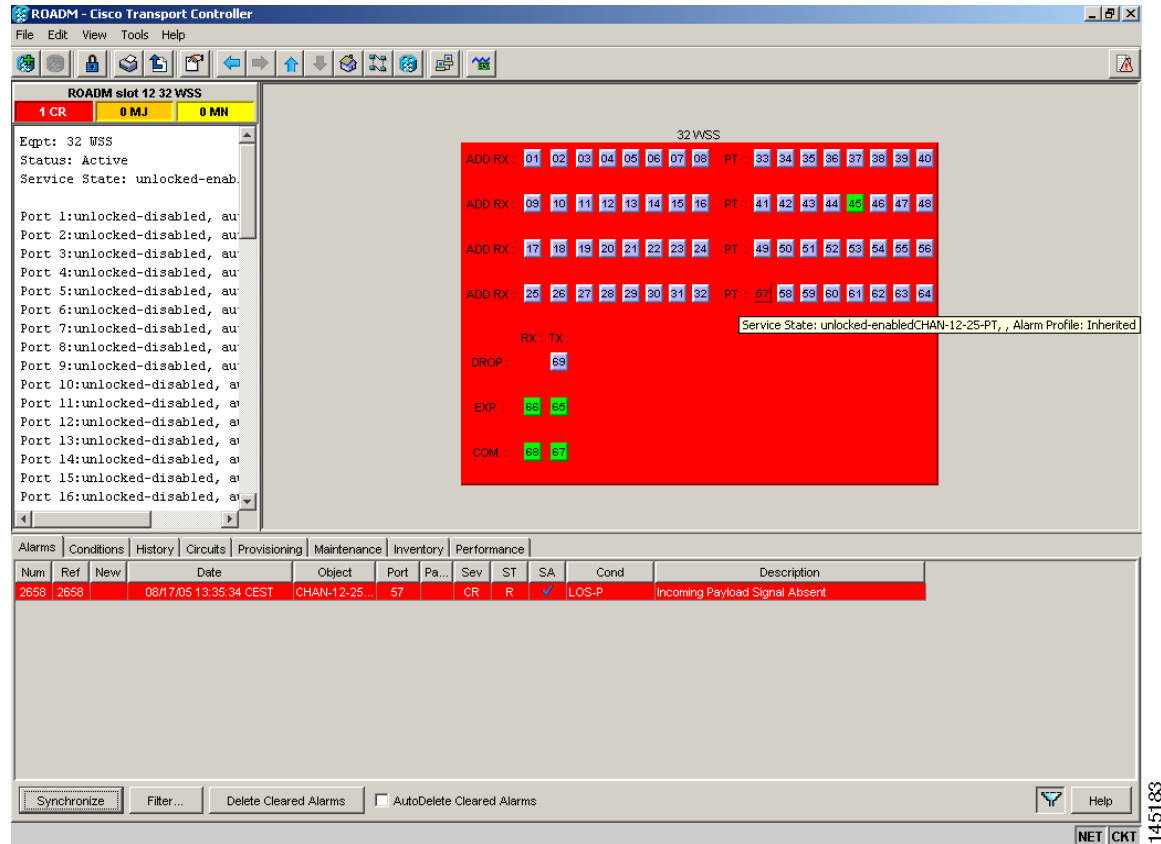
**Figure 1-33** LOS-P Indication on the VOA Port

If the incoming power level is lower than the minimum allowed, the startup procedure always stops at Phase 1 (see [Figure 1-33](#)). This is the case even if the final VOA Power Reference reported in CTC is reachable.

- A LOS-P (OCH layer) alarm on the port associated with the VOA (see [Figure 1-33](#))
- A valid optical power value (different from the end of scale value of  $-50$  dBm) in the Power field, but the value for Power is less than  $-33$  dBm. (To view the Power field, in card view, click the **Provisioning > Parameters** tabs.)

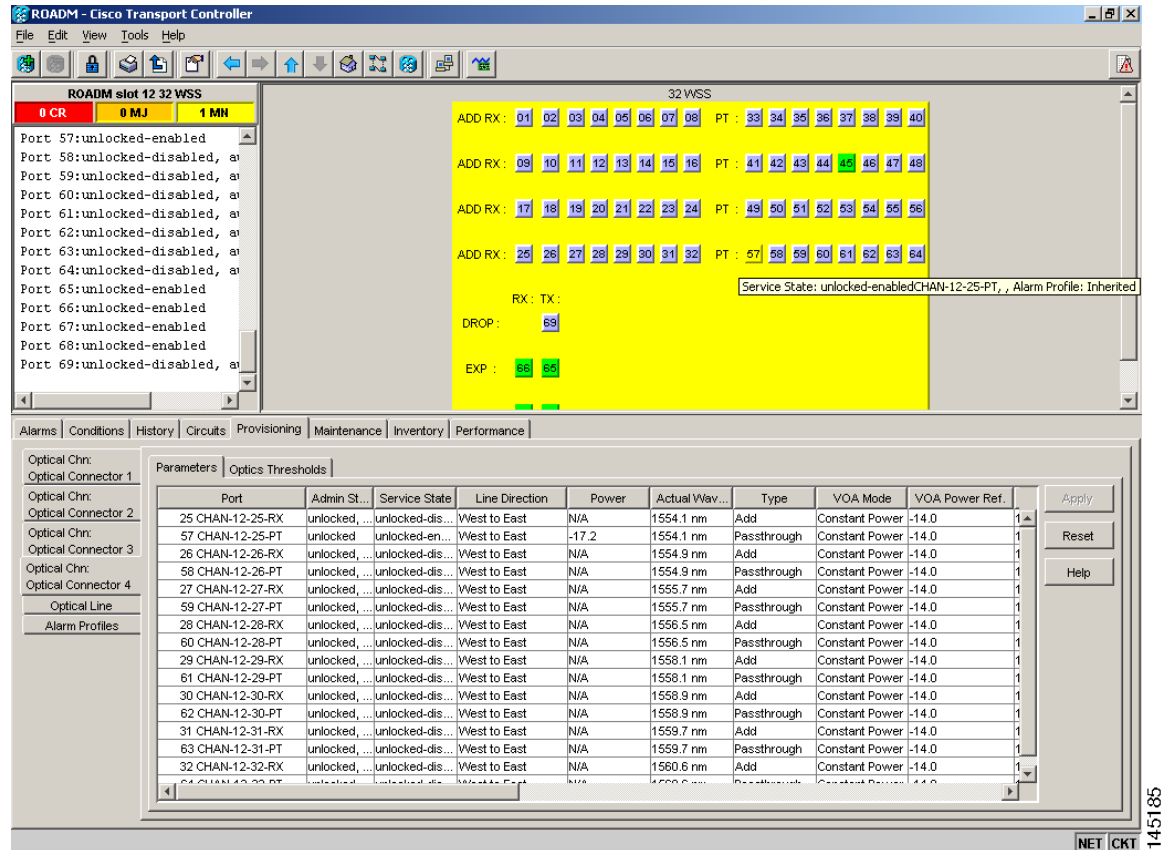
Figure 1-35 Optical Power Less than 6 dB Lower than Expected

When the optical power is less than 6 dB lower than the expected value, even if a valid incoming signal is present, the final VOA Power Reference setpoint value that is reported in the CTC is not reachable and the VOA startup procedure is stopped at Phase 3.

- An OPWR-LowDEGrade (OCH layer) alarm is present on the port associated with the VOA.
- A valid optical power value (different from the end of scale value of -50 dBm) can be read in the Power field, but the value is  $(\text{VOA Power Ref} - 6 \text{ dBm}) < \text{Power} < \text{VOA Power Ref}$  (see [Figure 1-35](#)). To access this value, in card view, click the **Provisioning > Parameters** tabs.

- An OPWR-LowDEGrade (OCH layer) alarm is present on the port associated with the VOA.
- A valid optical power value (different from the end of scale value of  $-50$  dBm) can be read in the CTC Power field, but the value is  $(\text{VOA Power Ref} - 6 \text{ dBm}) < \text{Power} < \text{VOA Power Ref}$  (Figure 1-35). To view this value in card view, click the **Provisioning > Parameters** tabs.

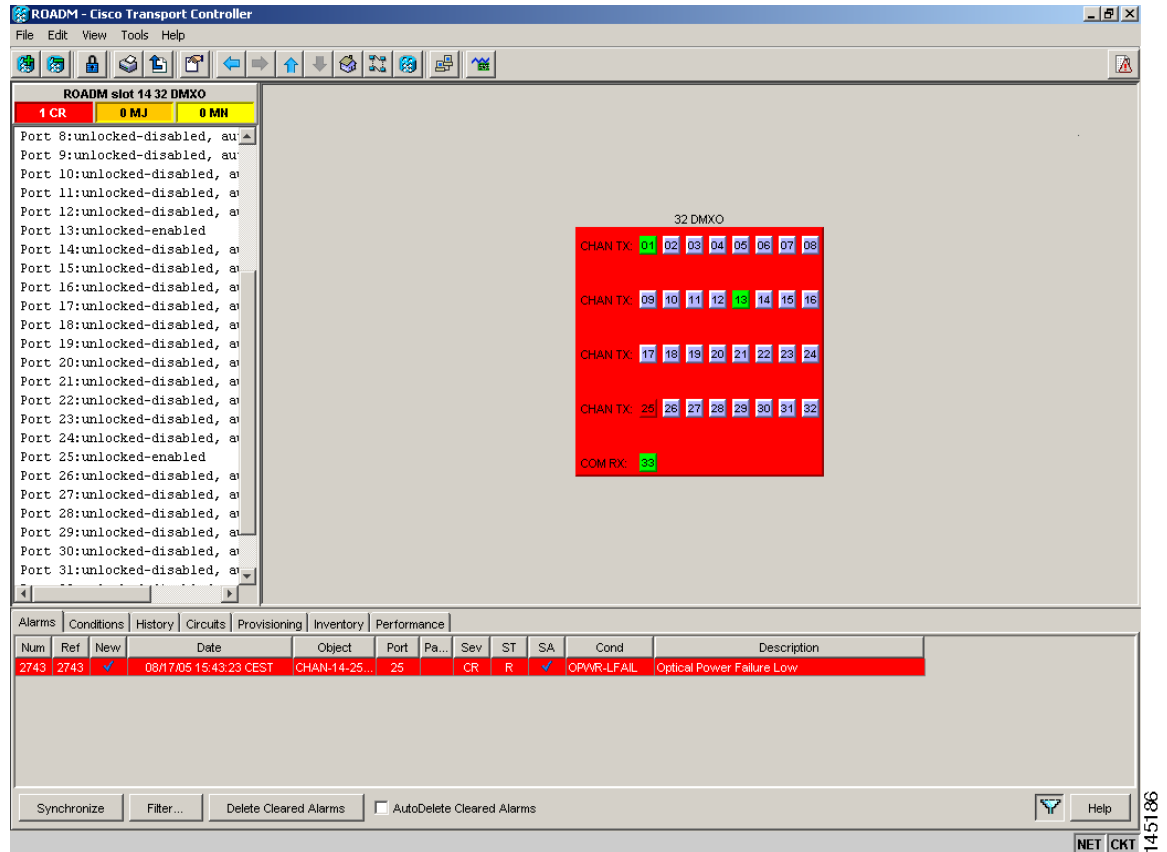
**Figure 1-36** Optical Drop Power More than 6 dB Lower than Expected

- An OPWR-LFAIL (OCH layer) alarm is present on the port associated with the VOA (see [Figure 1-36](#)).
- A valid optical power value (different from the end of scale value of –50 dBm) can be read in the CTC Power field, but the Power value is less than –33 dBm. (To view this value in card view, click the **Provisioning > Parameters** tabs.)

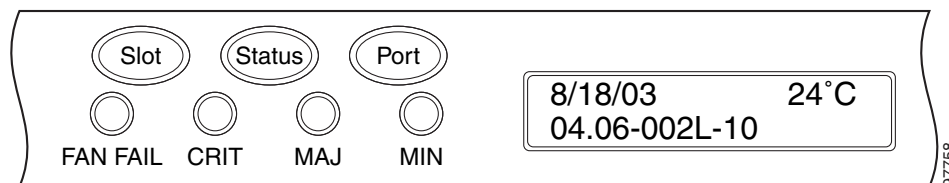
| Num | Ref | New | Date | Object | Egpt Type | Slot | Port | Pa | Sev | ST | SA | Cond | Description |

- Step 1** View the temperature displayed on the ONS system LCD front panel. For example, the ONS 15454 front panel is illustrated in [Figure 2-1](#).

- Step 1** Check for any outstanding alarms that were raised against the active and standby TCC2/TCC2P and resolve them.
- Step 2** If the alarm does not clear, determine whether the LCD display on the fan tray ([Figure 2-1 on page 2-63](#)) is blank or if the text is garbled. If so, proceed to [Step 8](#). If not, continue with [Step 3](#).
- Step 3** At the earliest maintenance window, reset the standby TCC2/TCC2P:
