# General Troubleshooting

This chapter provides procedures for troubleshooting the most common problems encountered when operating a Cisco ONS 15454 DWDM shelf in ANSI or ETSI platforms. To troubleshoot specific alarms, see [Chapter 2, “Alarm Troubleshooting.”](#) If you cannot find what you are looking for, contact Cisco Technical Support (1-800-553-2447).

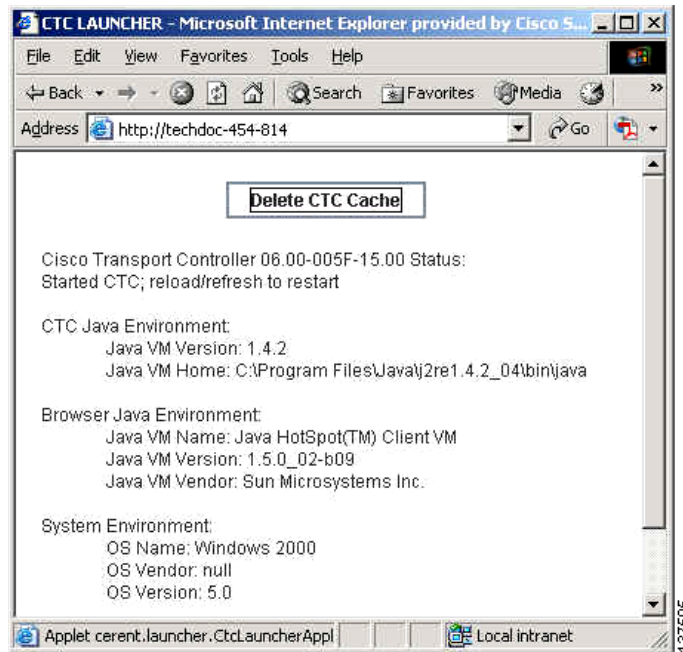
- 
- Step 1** Enter an ONS 15454 IP address into the browser URL field. The initial browser window shows a **Delete CTC Cache** button.
- Step 2** Close all open CTC sessions and browser windows. The PC operating system does not allow you to delete files that are in use.
- Step 3** Click **Delete CTC Cache** in the initial browser window to clear the CTC cache. [Figure 1-17](#) shows the Delete CTC Cache window.

**Figure 1-17** Deleting the CTC Cache
