# CHAPTER 2

## Alarm Troubleshooting

This chapter gives a description, severity, and troubleshooting procedure for each commonly encountered Cisco DWDM alarm and condition. Tables 2-1 through 2-5 provide lists of DWDM alarms organized by severity. Table 2-6 on page 2-8 provides a list of alarms organized alphabetically. Table 2-7 gives definitions of all DWDM alarm logical objects, which are the basis of the alarm profile list in Table 2-8 on page 2-16. For a comprehensive list of all conditions and instructions for using TL1 commands, refer to the *Cisco ONS SONET TL1 Command Guide*.

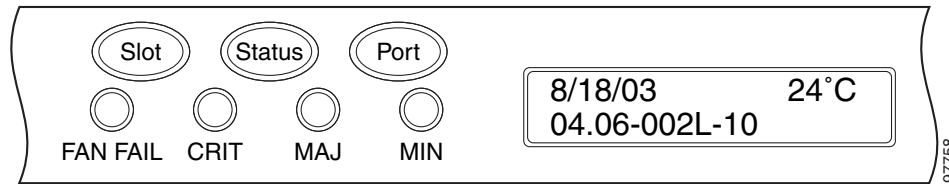
**Figure 2-1 Shelf LCD Panel**

- Step 1** View the temperature displayed on the ONS 15454 LCD front panel (Figure 2-2).

Figure 2-2 shows the shelf LCD panel.

- Step 2** If the temperature of the shelf exceeds 194 degrees F (90 degrees C), the alarm should clear if you solve the ONS 15454 temperature problem. Complete the “[Clear the HITEMP Alarm](#)” procedure on page 2-99.
- Step 3** If the temperature of the shelf is under 194 degrees F (90 degrees C), the HITEMP alarm is not the cause of the AUTOLSROFF alarm. Complete the “[Physically Replace a Card](#)” procedure on page 2-240 for the OC-192 card.

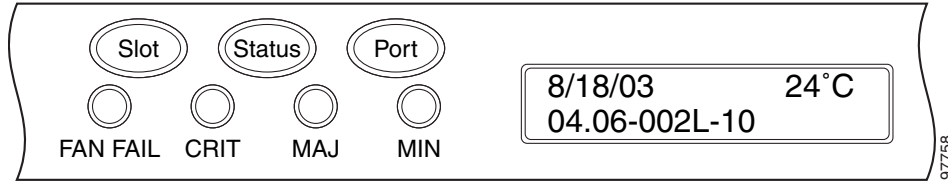
**Figure 2-2 Shelf LCD Panel**

- 
- Step 1** View the temperature displayed on the ONS system LCD front panel. For example, the ONS 15454 front panel is illustrated in [Figure 2-2](#).

- Step 2** Verify that the environmental temperature of the room is not abnormally high.
- Step 3** If the room temperature is not abnormal, physically ensure that nothing prevents the fan-tray assembly from passing air through the ONS system shelf.
- Step 4** If airflow is not blocked, physically ensure that blank faceplates fill the ONS system shelf empty slots. Blank faceplates help airflow.
- Step 5** If faceplates fill the empty slots, determine whether the air filter needs replacement. Refer to the [“Inspect, Clean, and Replace the Reusable Air Filter” procedure on page 2-243](#).
- Step 6** If the fan does not run or the alarm persists, complete the [“Replace the Fan-Tray Assembly” procedure on page 2-245](#).

- Step 1** Check for any outstanding alarms that were raised against the active and standby TCC2/TCC2P card and resolve them.
- Step 2** If the alarm does not clear, determine whether the LCD display on the fan tray ([Figure 2-2 on page 2-100](#)) is blank or if the text is garbled. If so, proceed to [Step 8](#). If not, continue with [Step 3](#).
- Step 3** At the earliest maintenance window, reset the standby TCC2/TCC2P card:
