CHAPTER 2

Alarm Troubleshooting

This chapter gives a description, severity, and troubleshooting procedure for each commonly encountered Cisco DWDM alarm and condition. Tables 2-1 through 2-5 provide lists of DWDM alarms organized by severity. Table 2-6 on page 2-8 provides a list of alarms organized alphabetically. Table 2-7 gives definitions of all DWDM alarm logical objects, which are the basis of the alarm profile list in Table 2-8 on page 2-17. For a comprehensive list of all conditions and instructions for using TL1 commands, refer to the *Cisco ONS SONET TL1 Command Guide*.

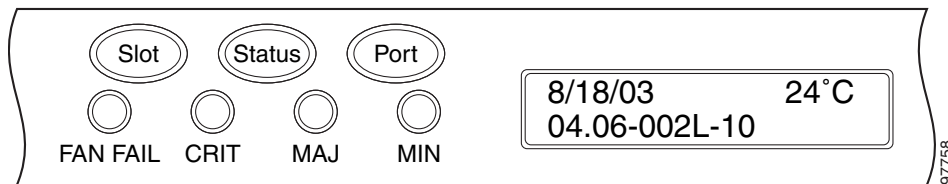
Figure 2-1 Shelf LCD Panel

- Step 1** View the temperature displayed on the ONS 15454 LCD front panel (Figure 2-2).

Figure 2-2 shows the shelf LCD panel.

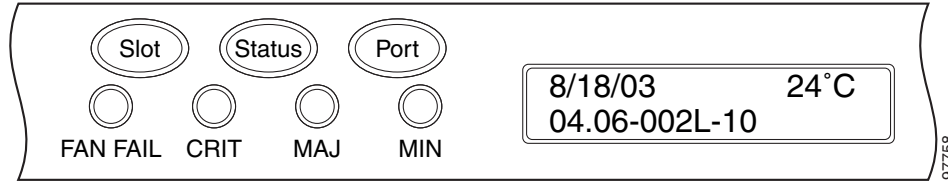
**Figure 2-2 Shelf LCD Panel**

- 
- Step 1** View the temperature displayed on the ONS system LCD front panel. For example, the ONS 15454 front panel is illustrated in [Figure 2-2](#).

- Step 1** Check for any outstanding alarms that were raised against the active and standby TCC2/TCC2P card and resolve them.
- Step 2** If the alarm does not clear, determine whether the LCD display on the fan tray ([Figure 2-2 on page 2-101](#)) is blank or if the text is garbled. If so, proceed to [Step 8](#). If not, continue with [Step 3](#).
- Step 3** At the earliest maintenance window, reset the standby TCC2/TCC2P card:
