CHAPTER 2

Alarm Troubleshooting

This chapter gives a description, severity, and troubleshooting procedure for each commonly encountered Cisco DWDM alarm and condition. Tables 2-1 through 2-5 provide lists of DWDM alarms organized by severity. Table 2-6 on page 2-8 provides a list of alarms organized alphabetically. Table 2-7 gives definitions of all DWDM alarm logical objects, which are the basis of the alarm profile list in Table 2-8 on page 2-17. For a comprehensive list of all conditions and instructions for using TL1 commands, refer to the *Cisco SONET TL1 Command Guide*.

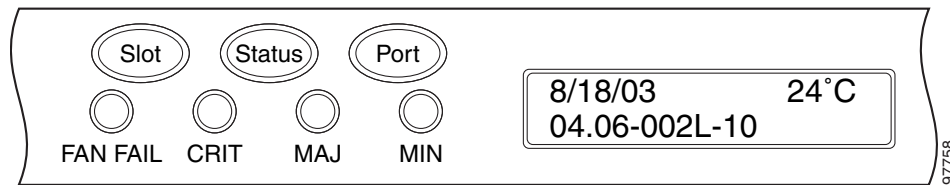
Figure 2-2 Shelf LCD Panel

- Step 1** View the temperature displayed on the ONS system LCD front panel. For example, the ONS 15454 front panel is illustrated in [Figure 2-2](#).

| Step 2 | If the alarm does not clear, determine whether the LCD display on the fan tray (Figure 2-2 on page 2-102) is blank or if the text is garbled. If so, proceed to Step 8 . If not, continue with Step 3 . |
