## **Cisco ONS 15454 DWDM Troubleshooting Guide, Release 9.2**

**First Published:** May 07, 2010

**Last Modified:** July 22, 2012

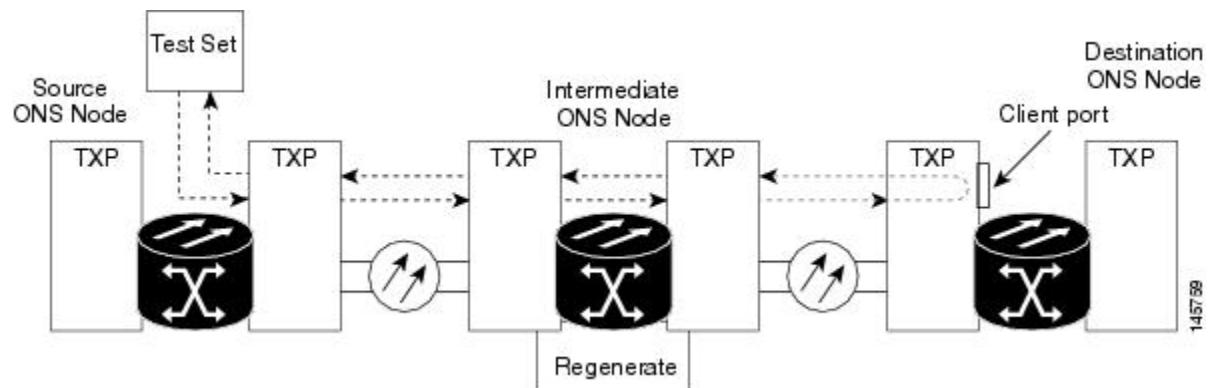
**Figure 8: Terminal Loopback on a Destination-Node MXP or TXP Port**

The terminal loopback at the destination-node port is the final local hardware error elimination in the circuit troubleshooting process. If this test is completed successfully, you have verified that the circuit is good up to the destination port. The example in [Figure 8: Terminal Loopback on a Destination-Node MXP or TXP Port](#), on page 23 shows a terminal loopback on an destination node TXP port.

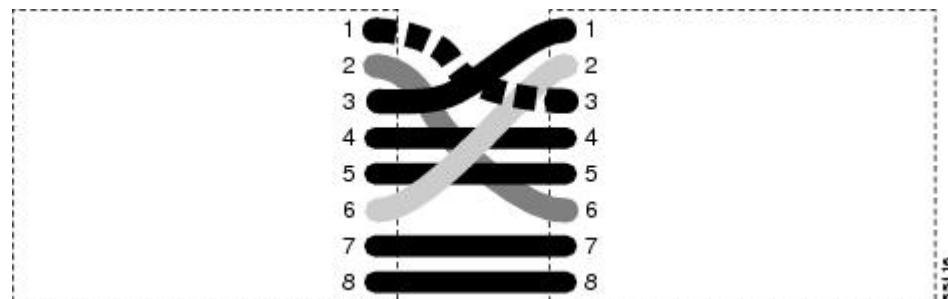
**Figure 12: LAN Cable Layout**

You can crimp your own LAN cables for use with the ONS 15454. Use a cross-over cable when connecting an ONS 15454 to a hub, LAN modem, or switch, and use a LAN cable when connecting an ONS 15454 to a router or workstation. Use CAT-5 cable RJ-45 T-568B, Color Code (100 Mbps), and a crimping tool. [Figure 11: RJ-45 Pin Numbers](#), on page 58 shows the wiring of an RJ-45 connector. [Table 9: LAN Cable Pinout](#), on page 58 [Figure 13: Cross-Over Cable Layout](#), on page 59 shows a LAN cable layout, and [Table 9: LAN](#)

[Cable Pinout](#), on page 58 shows the cable pinouts. [Figure 13: Cross-Over Cable Layout](#), on page 59 shows a cross-over cable layout, and [Table 10: Cross-Over Cable Pinout](#), on page 59 shows the cross-over pinouts.

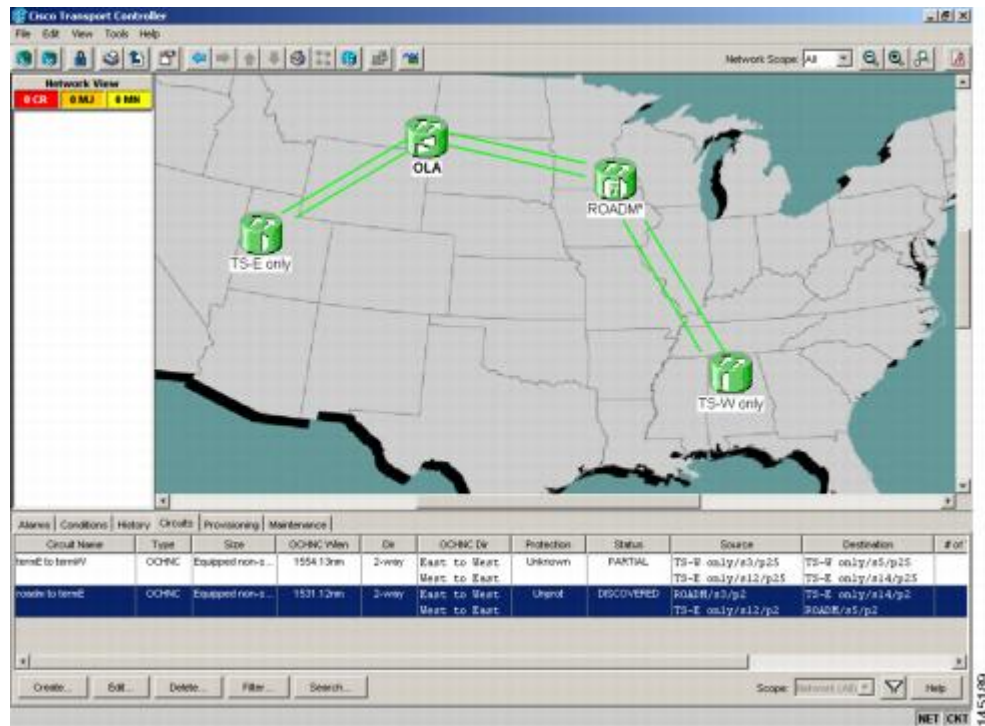
**Figure 14: Linear Network, With No Fiber Cut**

Different symptoms and scenarios can occur, depending on the network ALS settings. Consider the linear network (four nodes) in [Figure 14: Linear Network, With No Fiber Cut](#), on page 64 as a reference. The scenarios are presented after the figure.

The symptoms of the possible span loss scenarios (except for span loss decrease) are described in the following paragraphs. Refer to the linear network in [Figure 14: Linear Network, With No Fiber Cut](#), on page 64 during the discussion of the scenarios.

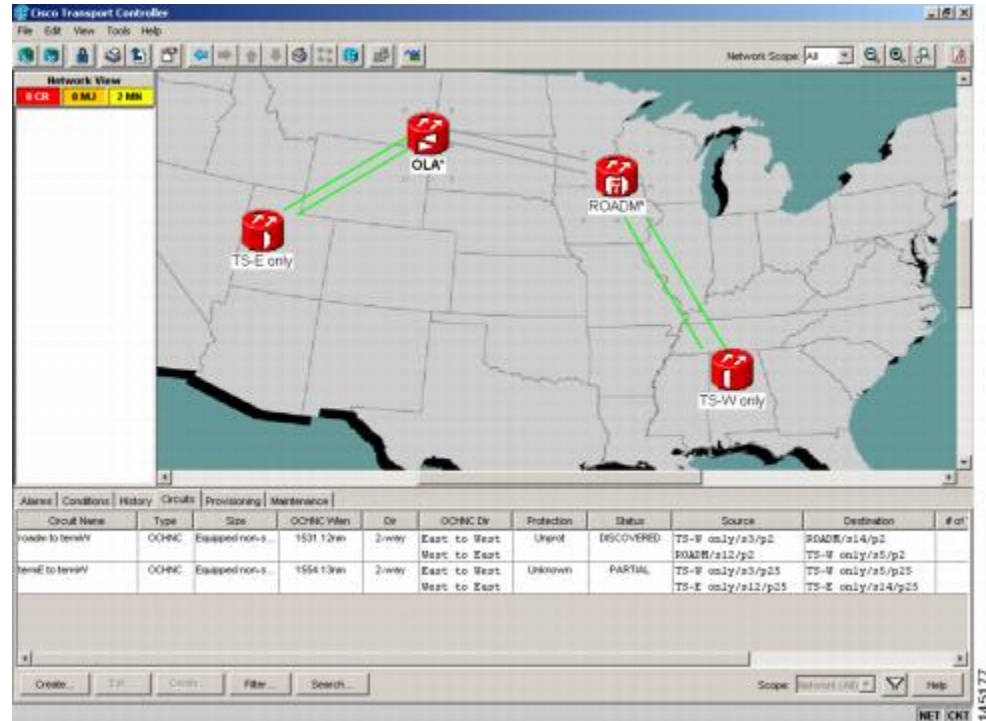
**Figure 15: Fiber Cut with ALS MODE = Auto Restart**

The final fault condition of the network is shown in [Figure 15: Fiber Cut with ALS MODE = Auto Restart](#), on page 65.

In network view, both of the lines representing the span were formerly green and have now changed to gray. Notice also that the status of all the OCHNC circuits on the broken span have changed from Discovered to Partial.

The basic assumption is that the network ALS feature (for feature details, refer to the Network Optical Safety—Automatic Laser Shutdown section in the Network Reference chapter of the *Cisco ONS 15454 DWDM Reference Manual*) is active (ALS Mode = Auto Restart on the OPT-BST, OPT-AMP-x-C, [+ OSCM] and OSC-CSM). Given this assumption, the starting condition is as shown in [Figure 15: Fiber Cut with ALS MODE = Auto Restart](#), on page 65.

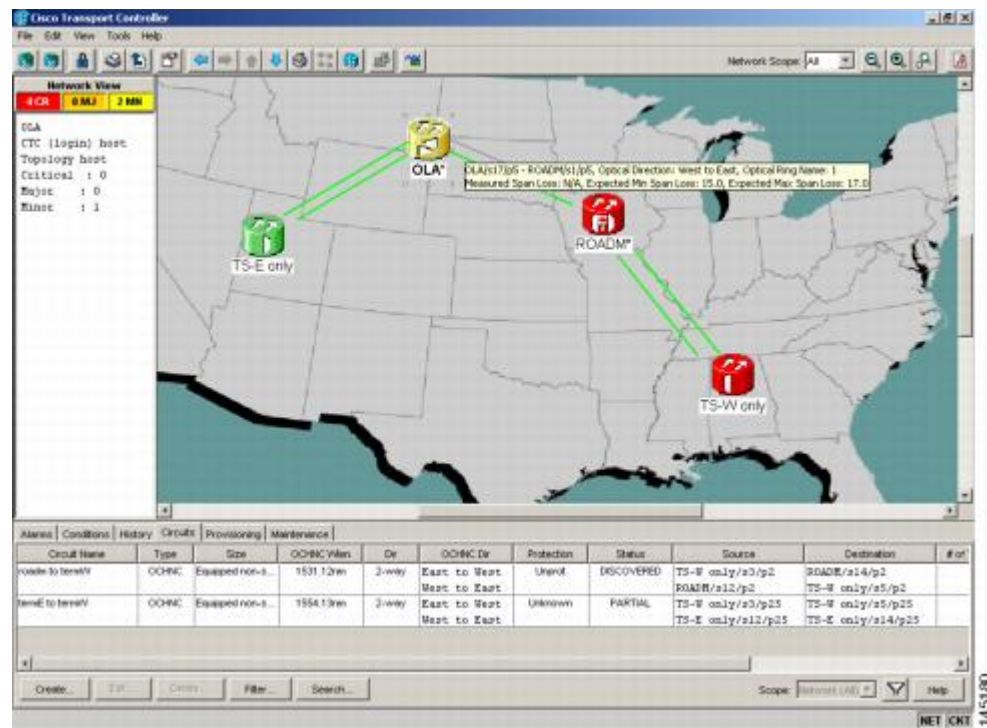
**Figure 18: Network View Fault Condition for Fiber Cut with ALS Mode Disabled**

The LOS (OTS or AOTS) alarm is raised by the ROADM-RX node that was receiving the signal coming from the broken fiber. The final fault condition of the network is shown in [Figure 18: Network View Fault Condition for Fiber Cut with ALS Mode Disabled](#), on page 68.

In network view ([Figure 18: Network View Fault Condition for Fiber Cut with ALS Mode Disabled](#), on page 68), only the actual affected fiber becomes gray, whereas the traffic (and OSC signal as well) on the good fiber is active and fault identification is immediate.

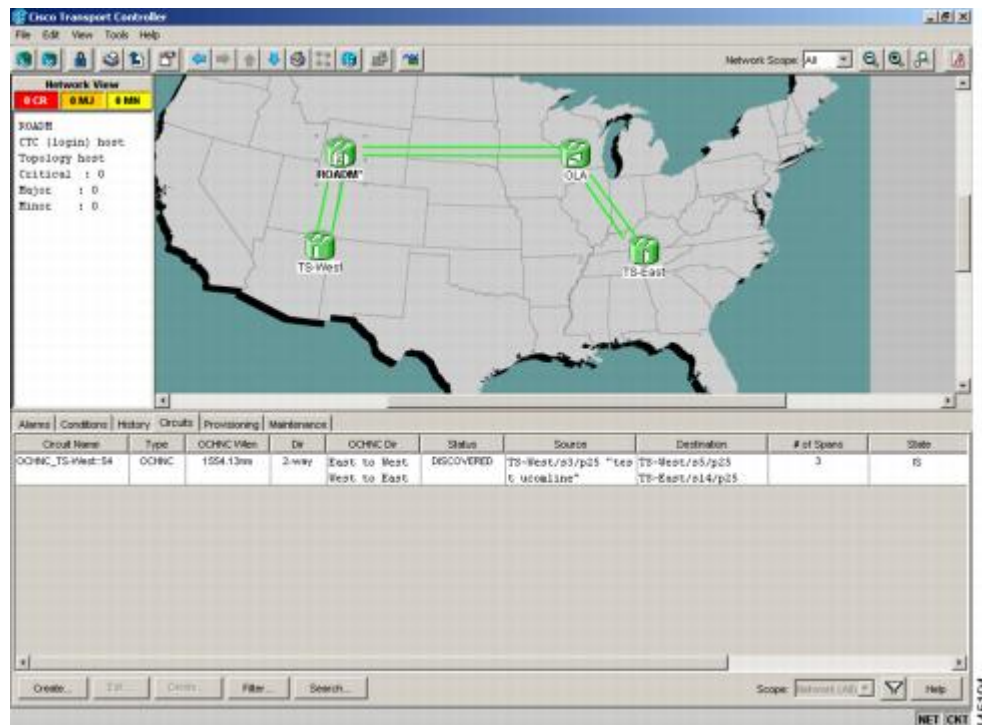
**Figure 22: OCHNC Circuit Successfully Completed**

OCHNC circuit creation is successfully completed when the CTC circuit table reports the situation shown in [Figure 22: OCHNC Circuit Successfully Completed](#), on page 82.

- Circuit State reports IS (or unlocked).

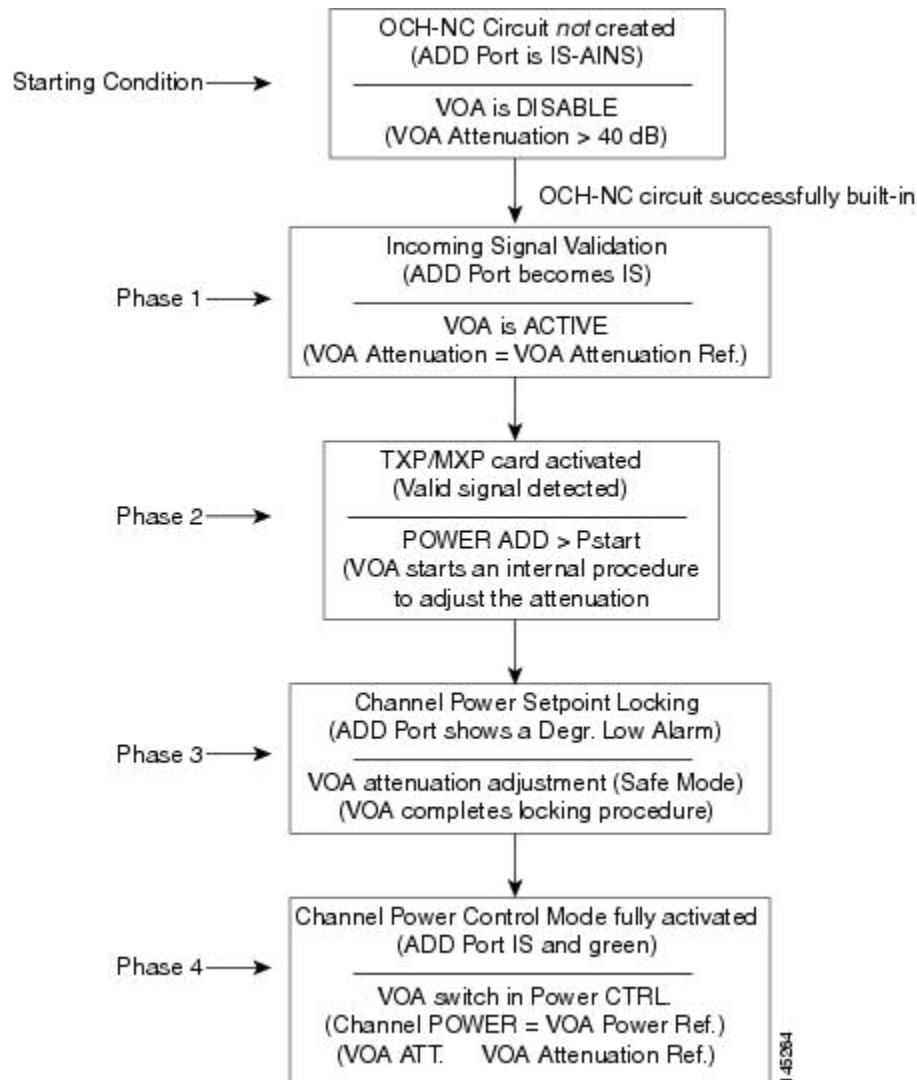
**Figure 25: VOA Startup Procedure**

The final VOA condition is achieved through a startup procedure divided into the four sequential phases shown in [Figure 25: VOA Startup Procedure, on page 85](#).

Until the VOA has completed all the phases shown in [Figure 25: VOA Startup Procedure, on page 85](#), the power control mode is not fully activated.

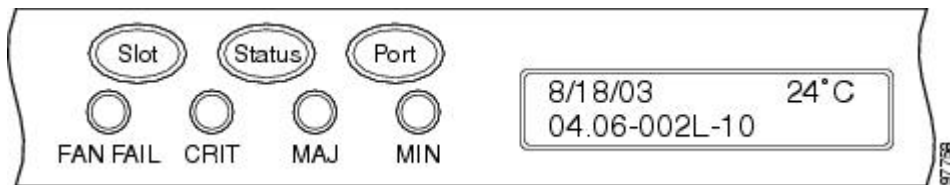
**Figure 27: Shelf LCD Panel**

- Step 1** View the temperature displayed on the ONS 15454 LCD front panel (Figure 28: Shelf LCD Panel, on page 238).  
Figure 28: Shelf LCD Panel, on page 238 shows the shelf LCD panel.

- Step 1** View the temperature displayed on the ONS system LCD front panel. For example, the ONS 15454 front panel is illustrated in [Figure 28: Shelf LCD Panel](#), on page 238.

- 
- Step 1** Check for any outstanding alarms that were raised against the active and standby TCC2/TCC2P/TCC3 and resolve them.
- Step 2** If the alarm does not clear, determine whether the LCD display on the fan tray ([Figure 28: Shelf LCD Panel, on page 238](#)) is blank or if the text is garbled. If so, proceed to [Step 8, on page 253](#). If not, continue with [Step 3, on page 252](#).
