## General Troubleshooting

This chapter provides procedures for troubleshooting the most common problems encountered when operating a Cisco ONS 15454 DWDM shelf in ANSI or ETSI platforms. To troubleshoot specific alarms, see [Alarm Troubleshooting](#). If you cannot find what you are looking for, contact Cisco Technical Support (1 800 553-2447).

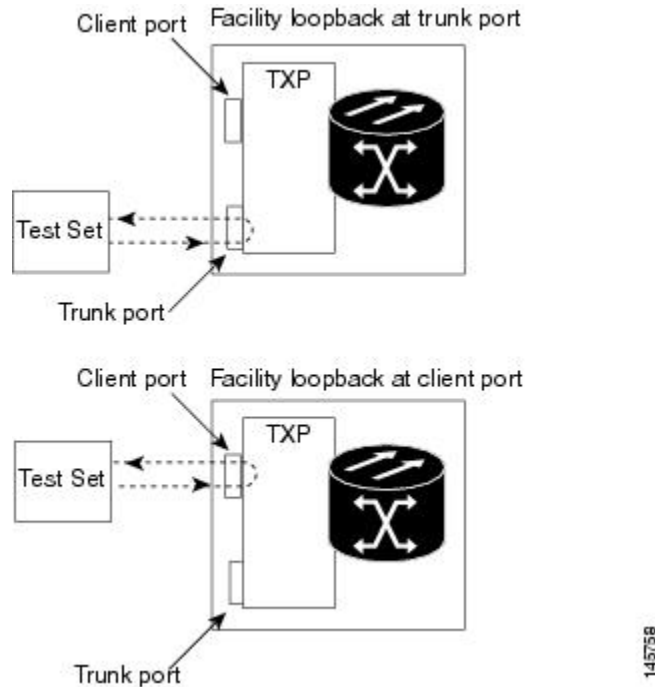
Figure 1: Facility Loopback Path on a Near-End Transponder Card, on page 3 shows a facility loopback at a trunk port and at a client port on a TXP card.

**Figure 1: Facility Loopback Path on a Near-End Transponder Card**

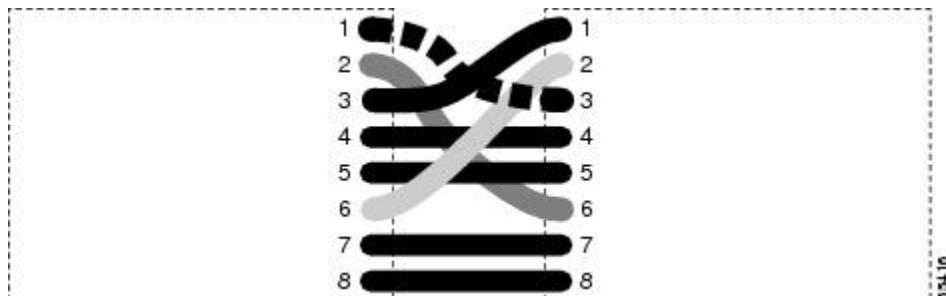
**Figure 12: LAN Cable Layout**

Pin	Color	Pair	Name	Pin
1	white/orange	2	Transmit Data +	1
2	orange	2	Transmit Data –	2
3	white/green	3	Receive Data +	3
4	blue	1	—	4
5	white/blue	1	—	5
6	green	3	Receive Data –	6
7	white/brown	4	—	7
8	brown	4	—	8
