## Alarm Troubleshooting

This chapter gives a description, severity, and troubleshooting procedure for each commonly encountered Cisco DWDM alarm and condition. Tables [Table 1: Critical DWDM Alarm List, on page 2](#) through [Table 5: NR DWDM Conditions List, on page 13](#) provide lists of DWDM alarms organized by severity. [Table 7: Alarm Logical Object Type Definitions, on page 26](#) provides a list of alarms organized alphabetically. [Table 7: Alarm Logical Object Type Definitions, on page 26](#) gives definitions of all DWDM alarm logical objects, which are the basis of the alarm profile list in [Table 8: Alarm List by Logical Object in Alarm Profile, on page 27](#). For a comprehensive list of all conditions and instructions for using TL1 commands, refer to the *Cisco ONS SONET TL1 Command Guide*. An alarm troubleshooting procedure applies to both the Cisco Transport Controller (CTC) and TL1 version of that alarm.

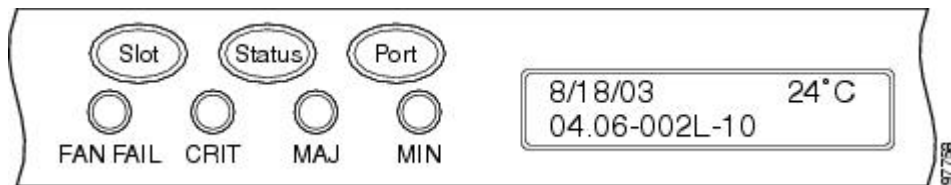
**Figure 1: Shelf LCD Panel**

- Step 1** View the temperature displayed on the ONS 15454 LCD front panel (Figure 2: Shelf LCD Panel, on page 134).  
Figure 2: Shelf LCD Panel, on page 134 shows the shelf LCD panel.

- Step 1** View the temperature displayed on the ONS system LCD front panel. For example, the ONS 15454 front panel is illustrated in [Figure 2: Shelf LCD Panel](#), on page 134.

- 
- Step 1** Check for any outstanding alarms that were raised against the active and standby TCC2/TCC2P/TCC3 and resolve them.
- Step 2** If the alarm does not clear, determine whether the LCD display on the fan tray ([Figure 2: Shelf LCD Panel, on page 134](#)) is blank or if the text is garbled. If so, proceed to [Step 8, on page 149](#). If not, continue with [Step 3, on page 148](#).
