## **Cisco ONS 15454 DWDM Troubleshooting Guide, Releases 9.2.1 and 9.2.2**

Text Part Number: 78-19696-03

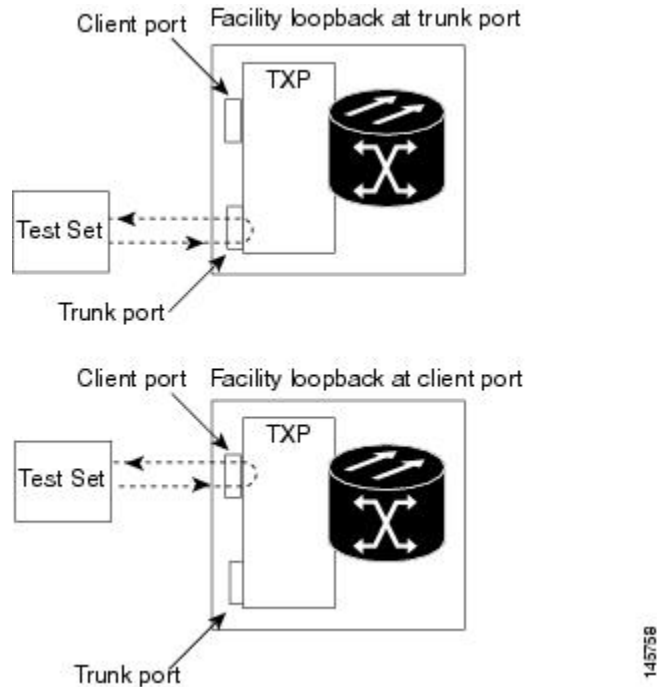
**Figure 1: Facility Loopback Path on a Near-End Transponder Card**

Figure 1: Facility Loopback Path on a Near-End Transponder Card, on page 3 shows a facility loopback at a trunk port and at a client port on a TXP card.

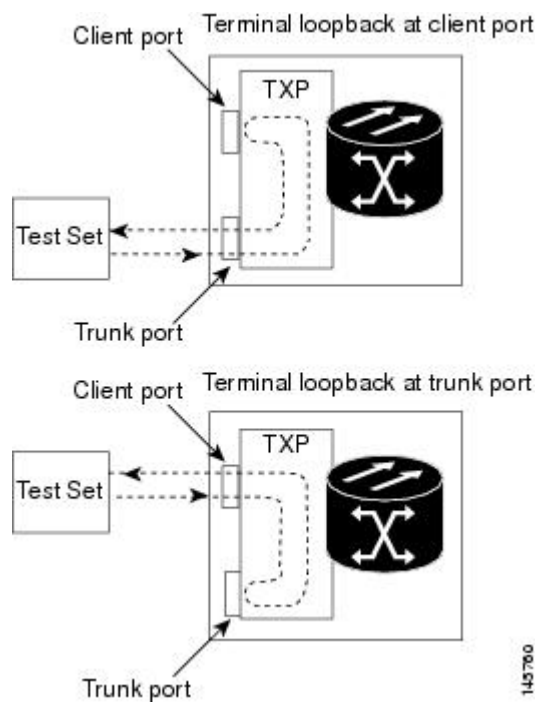
**Figure 4: Terminal Loopback on a Source-Node MXP or TXP Port**

The terminal loopback test is performed on the node source MXP, TXP, XP, or ADM-10G port. For the circuit in this example, it is the source TXP trunk port or a client port in the source node. Completing a successful terminal loopback to a node source port verifies that the circuit is through the source port. [Figure 4: Terminal Loopback on a Source-Node MXP or TXP Port](#), on page 12 shows an example of a terminal loopback on a source TXP port and a client TXP port.

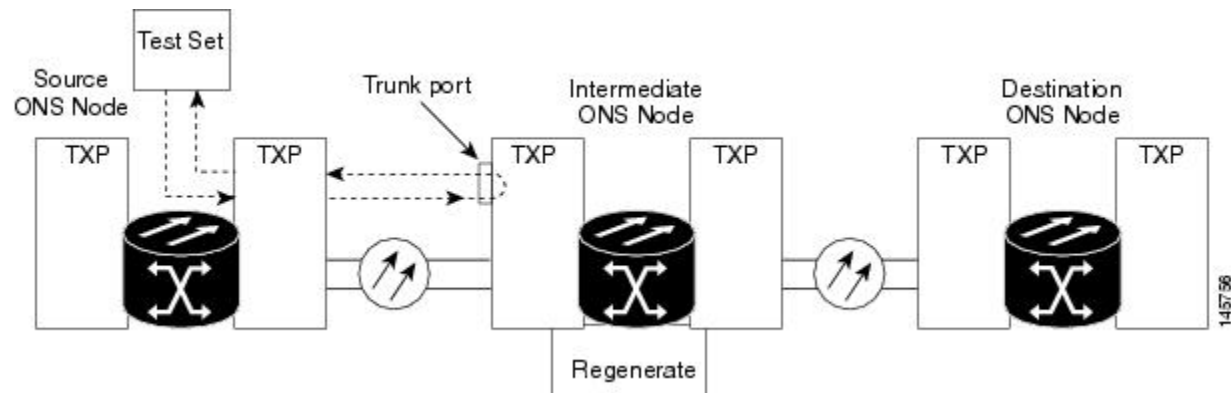
**Figure 5: Facility Loopback on an Intermediate-Node MXP or TXP Port**

Performing the facility loopback test on an intermediate port isolates whether this node is causing circuit failure. In the situation shown in [Figure 5: Facility Loopback on an Intermediate-Node MXP or TXP Port, on page 15](#), the test is being performed on an intermediate MXP or TXP port.

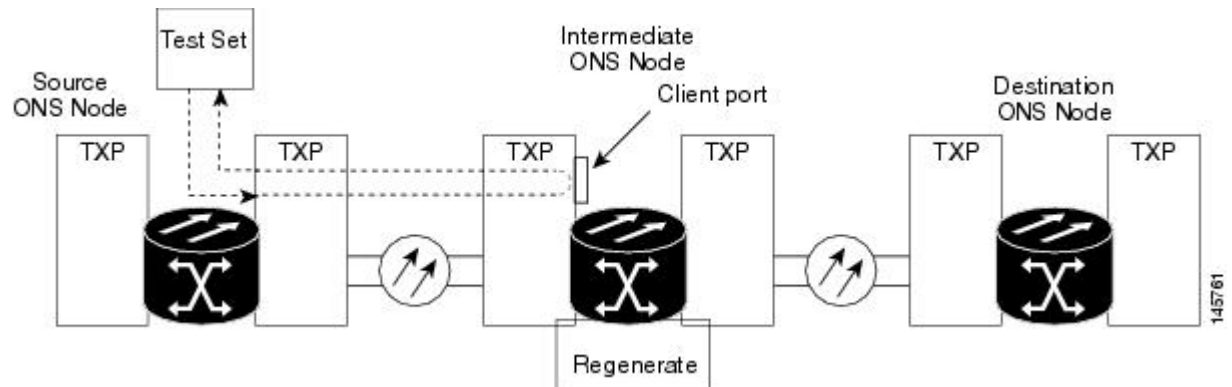
**Figure 6: Terminal Loopback on an Intermediate-Node MXP or TXP Port**

In the next troubleshooting test, you perform a terminal loopback on the intermediate-node port to isolate whether the intermediate client or trunk port is causing circuit trouble. In the example situation in [Figure 6: Terminal Loopback on an Intermediate-Node MXP or TXP Port](#), on page 18, the terminal loopback is

performed on an intermediate MXP or TXP port in the circuit. If you successfully complete a terminal loopback on the node, this node is excluded from possible sources of circuit trouble.

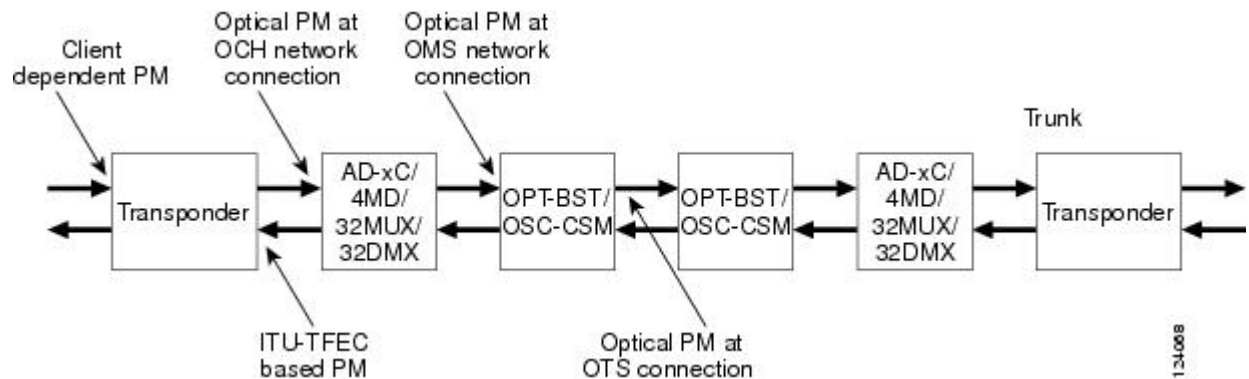
**Figure 10: Performance Monitoring Points on ONS DWDM**

Different PM count parameters are associated with different read points in a network. [Figure 10: Performance Monitoring Points on ONS DWDM](#), on page 28 illustrates the PM read points that are useful in identifying DWDM circuit points of failure. The Performance Monitoring chapter in the *Cisco ONS 15454 DWDM Reference Manual* lists all PM parameters and provides block diagrams of signal entry points, exit points, and interconnections between the individual circuit cards. Consult these specifications to determine which PM parameters are associated with the system points you want to monitor or provision with CTC or TL1. The monitoring points might vary according to your configuration.

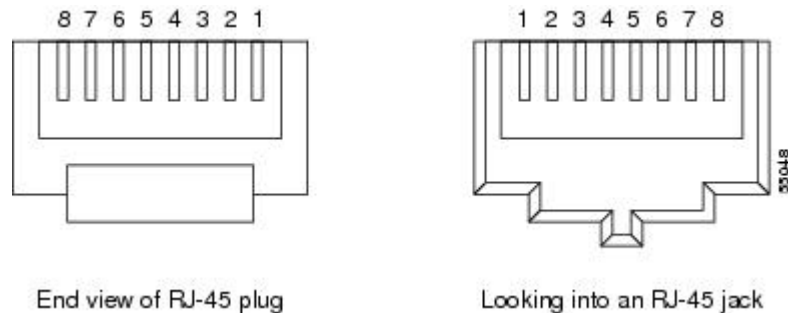
**Figure 11: RJ-45 Pin Numbers**

You can crimp your own LAN cables for use with the ONS 15454. Use a cross-over cable when connecting an ONS 15454 to a hub, LAN modem, or switch, and use a LAN cable when connecting an ONS 15454 to a router or workstation. Use CAT-5 cable RJ-45 T-568B, Color Code (100 Mbps), and a crimping tool. [Figure 11: RJ-45 Pin Numbers](#), on page 58 shows the wiring of an RJ-45 connector. [Table 9: LAN Cable Pinout](#), on page 58 [Figure 13: Cross-Over Cable Layout](#), on page 59 shows a LAN cable layout, and [Table 9: LAN](#)

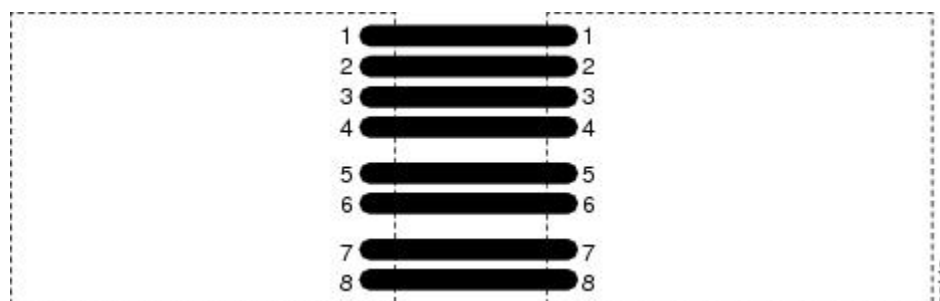
**Figure 13: Cross-Over Cable Layout**

[Cable Pinout](#), on page 58 shows the cable pinouts. [Figure 13: Cross-Over Cable Layout](#), on page 59 shows a cross-over cable layout, and [Table 10: Cross-Over Cable Pinout](#), on page 59 shows the cross-over pinouts.

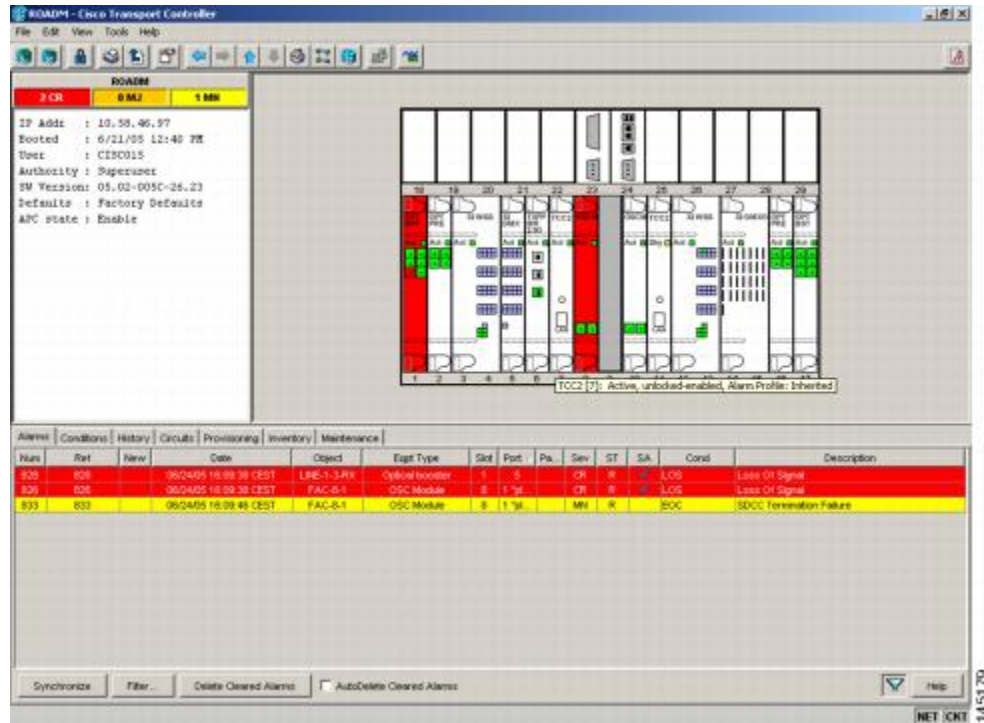
Figure 17: LOS Indication on the OLA Node OPT-BST

Node OSC-CSM, on page 66) and the LOS (OTS) on Port 5 of the OPT-BST (see Figure 17: LOS Indication on the OLA Node OPT-BST, on page 66).

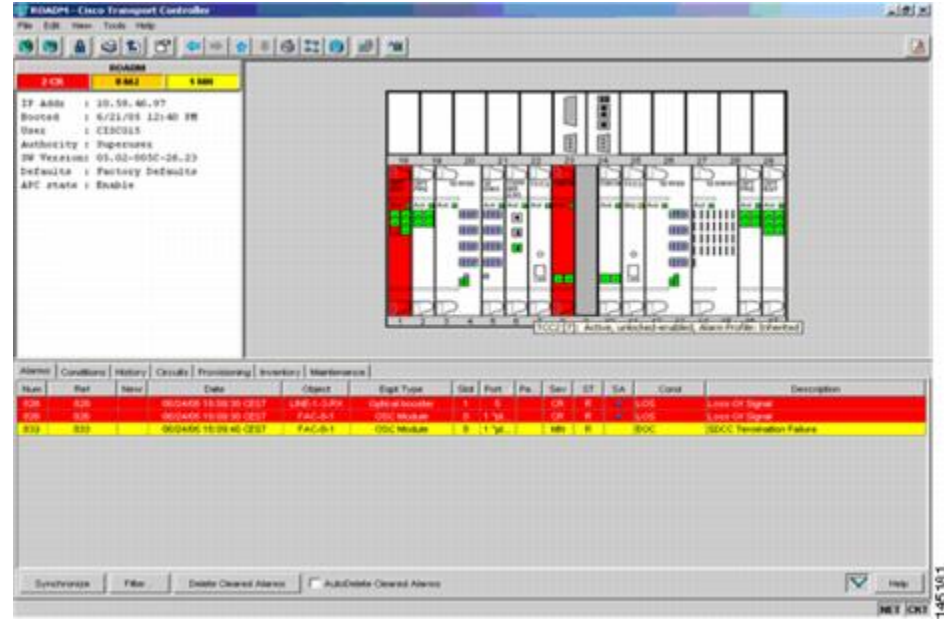
**Figure 19: ONS 15454 SDH ROADM Node View with Fault Condition for ALS MODE Disabled**

In node view (single-shelf mode) or shelf view (multishelf mode) ([Figure 19: ONS 15454 SDH ROADM Node View with Fault Condition for ALS MODE Disabled](#), on page 69 and [Figure 20: ONS 15454 SDH OLA Node View with Fault Condition for ALS MODE Disabled](#), on page 69), the alarm panel of the receiving

node (ROADM in this example) reports the LOS (OTS), while the transmitting node (OLA) reports only an EOC alarm.

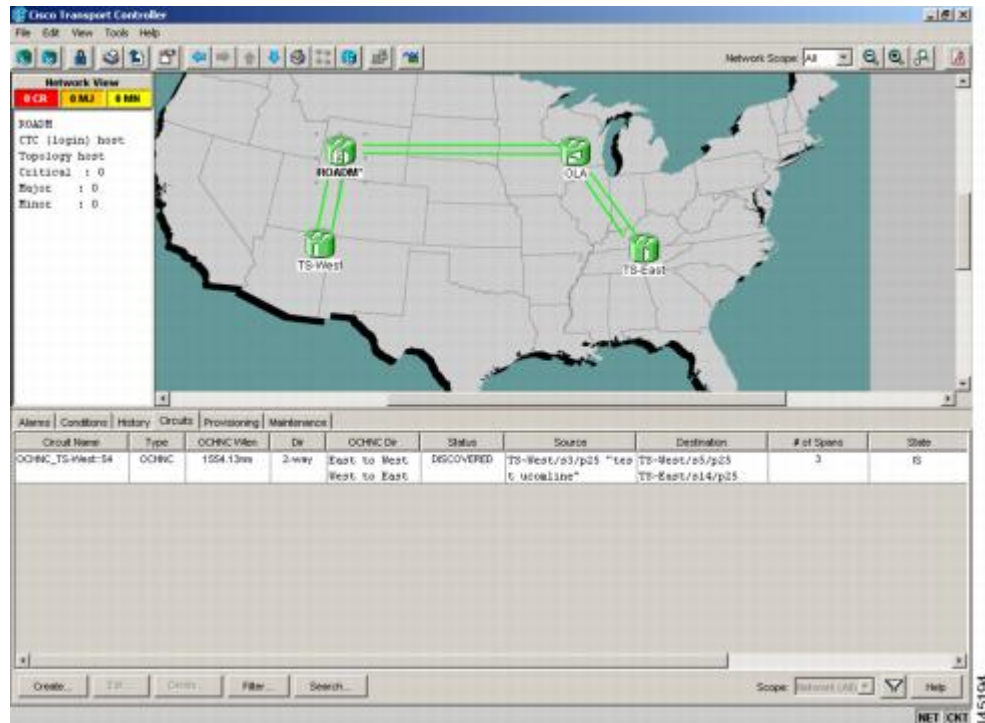
**Figure 22: OCHNC Circuit Successfully Completed**

OCHNC circuit creation is successfully completed when the CTC circuit table reports the situation shown in [Figure 22: OCHNC Circuit Successfully Completed](#), on page 82.

- Circuit State reports IS (or unlocked).

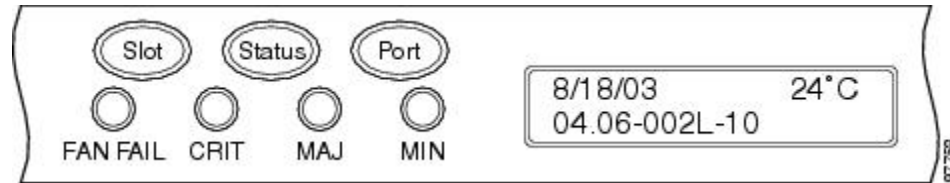
**Figure 27: Shelf LCD Panel**

- Step 1** View the temperature displayed on the ONS 15454 LCD front panel ([Figure 28: Shelf LCD Panel](#), on page 240).

Figure 28: Shelf LCD Panel, on page 240 shows the shelf LCD panel.

- Step 1** View the temperature displayed on the ONS system LCD front panel. For example, the ONS 15454 front panel is illustrated in [Figure 28: Shelf LCD Panel](#), on page 240.

- 
- Step 1** Check for any outstanding alarms that were raised against the active and standby TCC2/TCC2P/TCC3 and resolve them.
- Step 2** If the alarm does not clear, determine whether the LCD display on the fan tray ([Figure 28: Shelf LCD Panel, on page 240](#)) is blank or if the text is garbled. If so, proceed to [Step 8, on page 255](#). If not, continue with [Step 3, on page 254](#).
