## **Cisco ONS 15454 DWDM Troubleshooting Guide, Release 9.3**

**First Published:** May 24, 2011

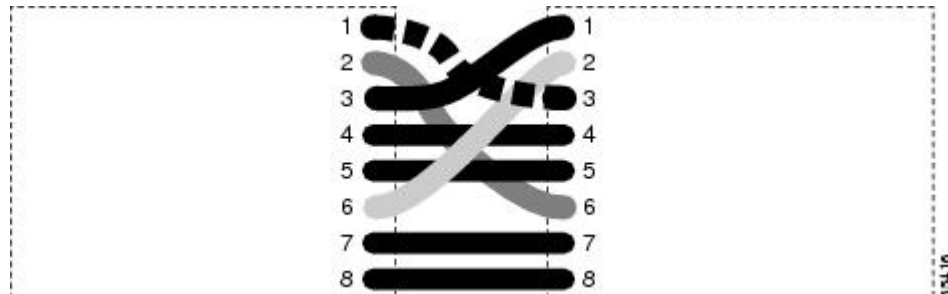
**Figure 12: LAN Cable Layout**
