## General Troubleshooting

This chapter provides procedures for troubleshooting the most common problems encountered when operating a Cisco ONS 15454 DWDM shelf in ANSI or ETSI platforms. To troubleshoot specific alarms, see [Alarm Troubleshooting](#). If you cannot find what you are looking for, contact Cisco Technical Support (1 800 553-2447).

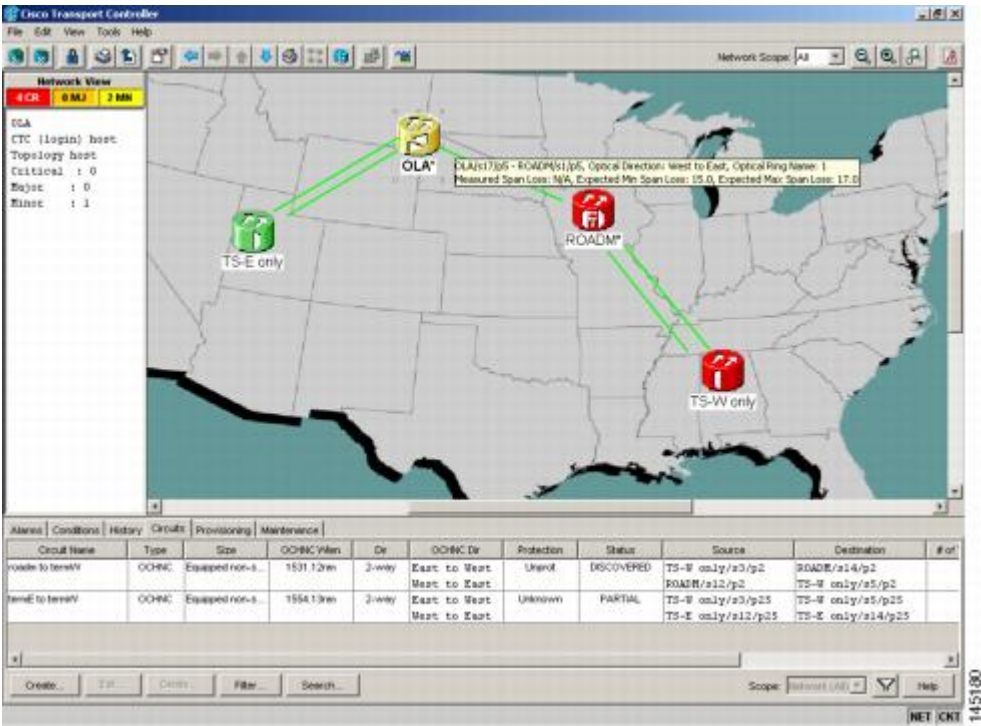
**Figure 18: Network View Fault Condition for Fiber Cut with ALS Mode Disabled**

The LOS (OTS or AOTS) alarm is raised by the ROADM-RX node that was receiving the signal coming from the broken fiber. The final fault condition of the network is shown in [Figure 18: Network View Fault Condition for Fiber Cut with ALS Mode Disabled](#), on page 68.

In network view ([Figure 18: Network View Fault Condition for Fiber Cut with ALS Mode Disabled](#), on page 68), only the actual affected fiber becomes gray, whereas the traffic (and OSC signal as well) on the good fiber is active and fault identification is immediate.
