General Troubleshooting

This chapter provides procedures for troubleshooting the most common problems encountered when operating a Cisco ONS 15454 DWDM shelf in ANSI or ETSI platforms. To troubleshoot specific alarms, see [Alarm Troubleshooting](#). If you cannot find what you are looking for, contact Cisco Technical Support (1 800 553-2447).

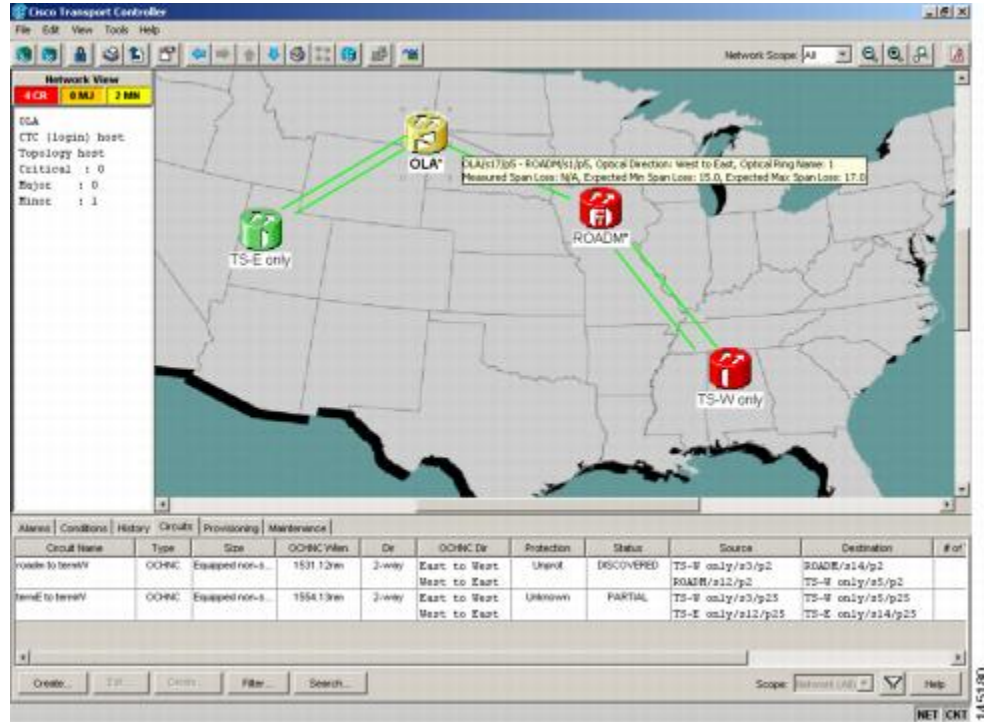
**Figure 18: Network View Fault Condition for Fiber Cut with ALS Mode Disabled**

The LOS (OTS or AOTS) alarm is raised by the ROADM-RX node that was receiving the signal coming from the broken fiber. The final fault condition of the network is shown in [Figure 18: Network View Fault Condition for Fiber Cut with ALS Mode Disabled](#), on page 69.

In network view ([Figure 18: Network View Fault Condition for Fiber Cut with ALS Mode Disabled](#), on page 69), only the actual affected fiber becomes gray, whereas the traffic (and OSC signal as well) on the good fiber is active and fault identification is immediate.
