## **Cisco ONS 15454 DWDM Troubleshooting Guide, Release 9.6.x**

Text Part Number: 78-20789-02

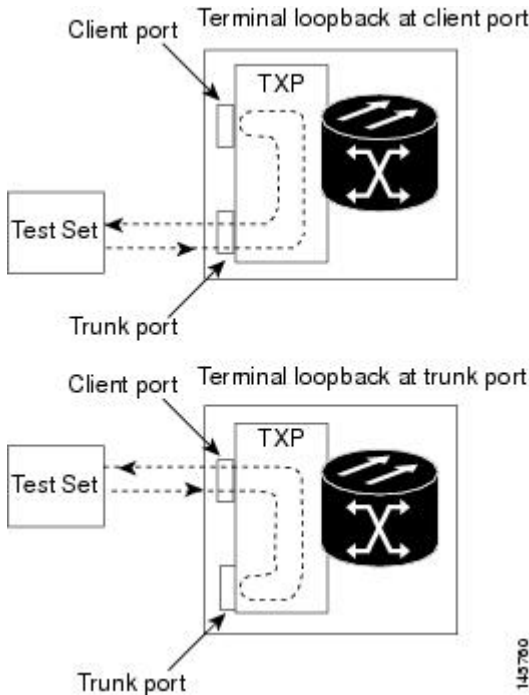
**Figure 2: Terminal Loopback on a TXP Card**

A terminal loopback tests a circuit path as it passes through a TXP, MXP, or ADM-10G card and loops back. For example, as shown in [Figure 2: Terminal Loopback on a TXP Card, on page 6](#), there are two types of terminal loopbacks shown for a TXP card.

This test verifies that the terminal circuit paths are valid, but does not test the LIU on the TXP card.

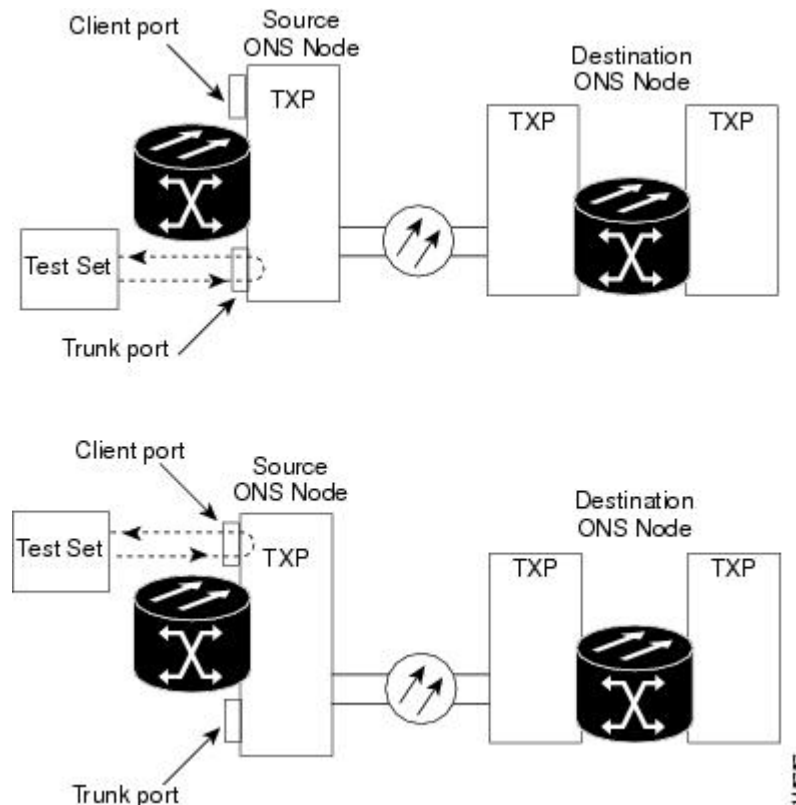
**Figure 3: Facility Loopback on a Circuit Source MXP or TXP Port**

failure point. [Figure 3: Facility Loopback on a Circuit Source MXP or TXP Port](#), on page 10 shows the facility loopback examples on source ONS node TXP ports (client and trunk).

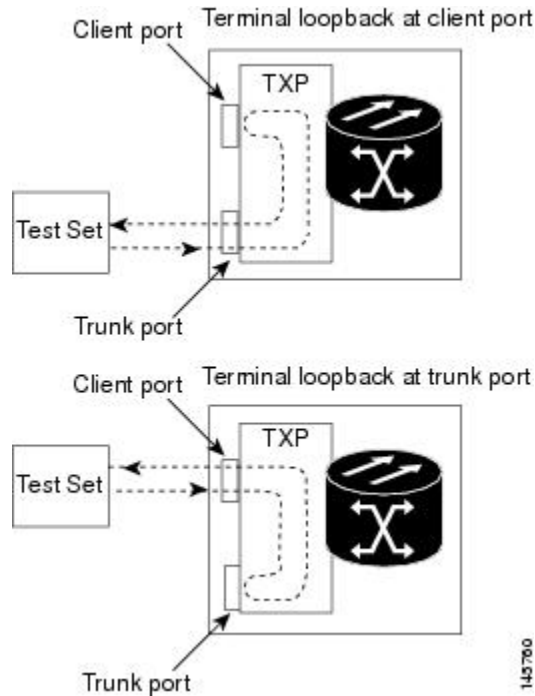
**Figure 4: Terminal Loopback on a Source-Node MXP or TXP Port**

The terminal loopback test is performed on the node source MXP, TXP, XP, or ADM-10G port. For the circuit in this example, it is the source TXP trunk port or a client port in the source node. Completing a successful terminal loopback to a node source port verifies that the circuit is through the source port. [Figure 4: Terminal](#)

[Loopback on a Source-Node MXP or TXP Port, on page 13](#) shows an example of a terminal loopback on a source TXP port and a client TXP port.

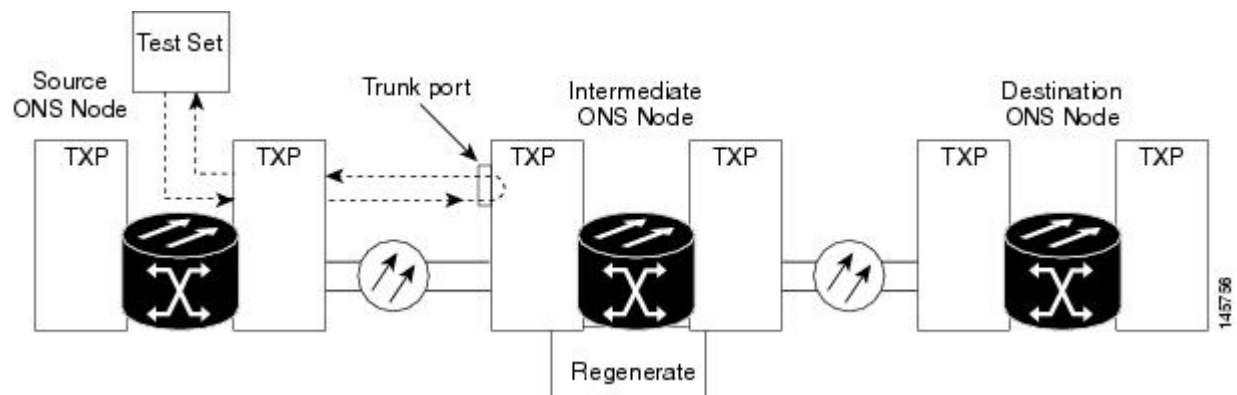
**Figure 5: Facility Loopback on an Intermediate-Node MXP or TXP Port**

Performing the facility loopback test on an intermediate port isolates whether this node is causing circuit failure. In the situation shown in [Figure 5: Facility Loopback on an Intermediate-Node MXP or TXP Port, on page 16](#), the test is being performed on an intermediate MXP or TXP port.

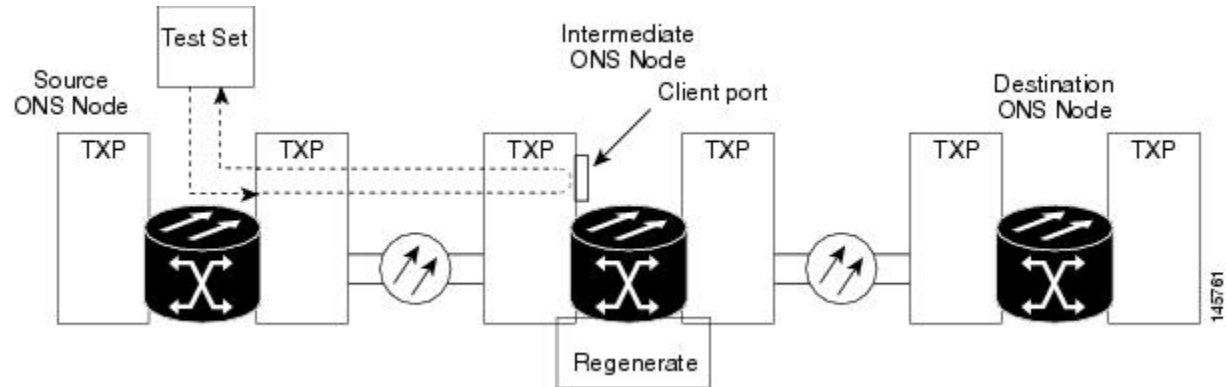
**Figure 6: Terminal Loopback on an Intermediate-Node MXP or TXP Port**

In the next troubleshooting test, you perform a terminal loopback on the intermediate-node port to isolate whether the intermediate client or trunk port is causing circuit trouble. In the example situation in [Figure 6: Terminal Loopback on an Intermediate-Node MXP or TXP Port](#), on page 19, the terminal loopback is

performed on an intermediate MXP or TXP port in the circuit. If you successfully complete a terminal loopback on the node, this node is excluded from possible sources of circuit trouble.

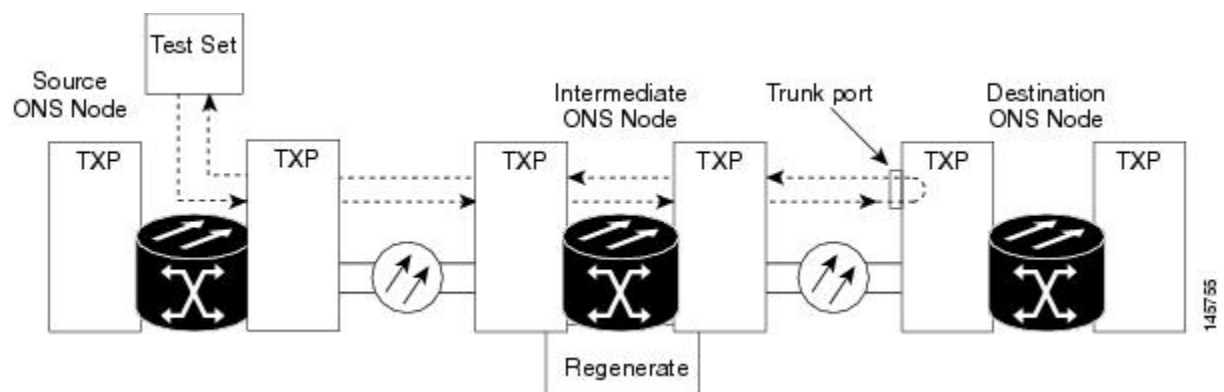
**Figure 7: Facility Loopback on a Destination-Node MXP or TXP Port**

You perform a facility loopback test at the destination port to determine whether this local port is the source of circuit trouble. The example in [Figure 7: Facility Loopback on a Destination-Node MXP or TXP Port](#), on page 21 shows a facility loopback being performed on a TXP client or trunk port at a destination node.

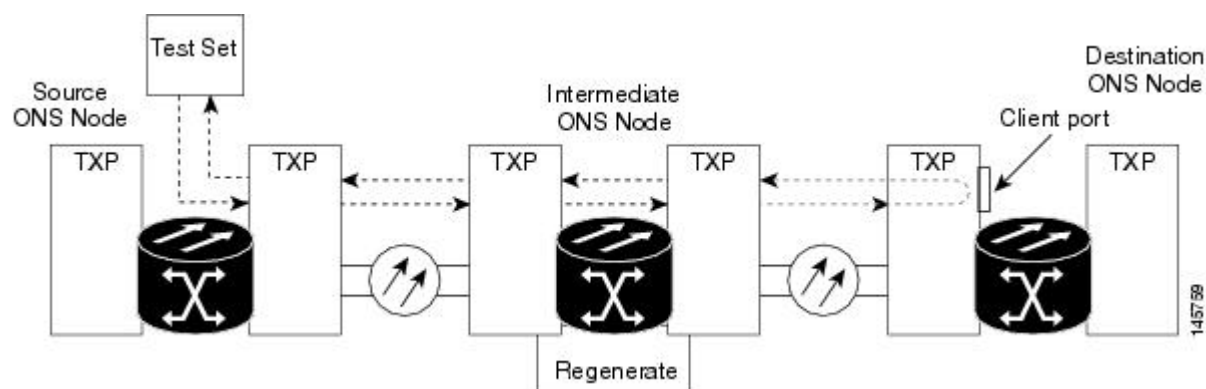
**Figure 8: Terminal Loopback on a Destination-Node MXP or TXP Port**

The terminal loopback at the destination-node port is the final local hardware error elimination in the circuit troubleshooting process. If this test is completed successfully, you have verified that the circuit is good up to the destination port. The example in [Figure 8: Terminal Loopback on a Destination-Node MXP or TXP Port](#), on page 24 shows a terminal loopback on an destination node TXP port.

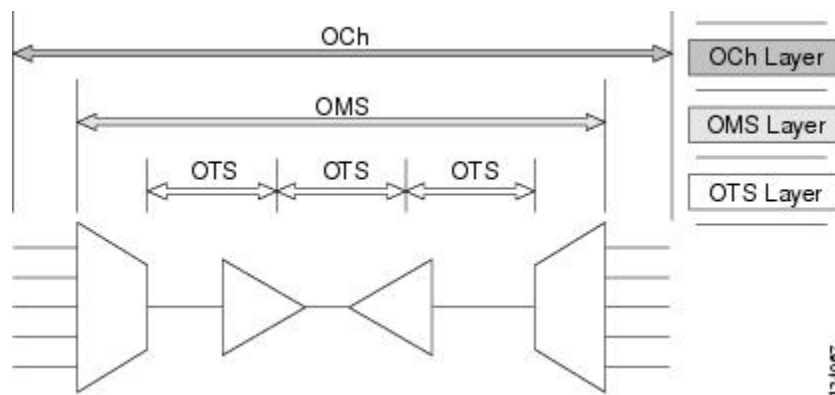
**Figure 9: Optical Transport Network Layers**

Like traditional SONET networks, ITU-T G.709 optical networks have a layered design ([Figure 9: Optical Transport Network Layers, on page 27](#)). This structure enables localized monitoring that helps you isolate and troubleshoot network problems.

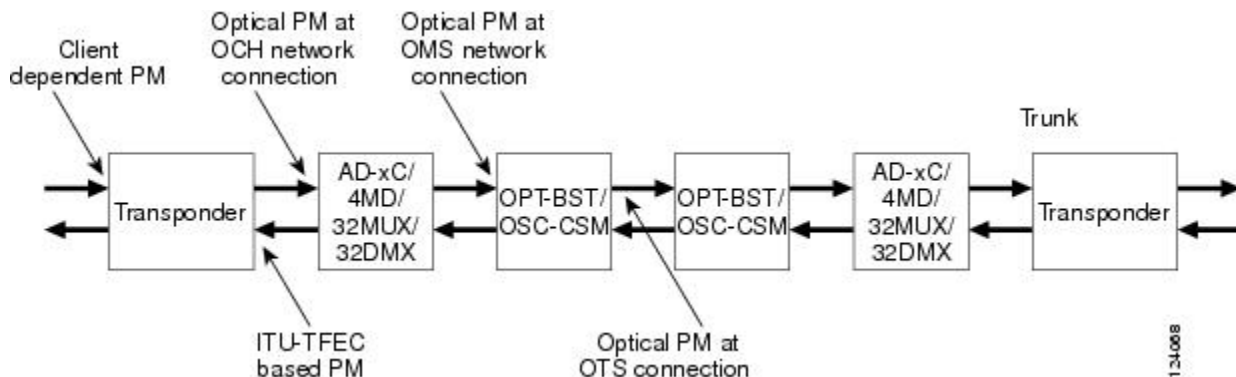
**Figure 10: Performance Monitoring Points on ONS DWDM**

Different PM count parameters are associated with different read points in a network. [Figure 10: Performance Monitoring Points on ONS DWDM](#), on page 29 illustrates the PM read points that are useful in identifying DWDM circuit points of failure. The [Monitor Performance](#) document lists all PM parameters and provides block diagrams of signal entry points, exit points, and interconnections between the individual circuit cards. Consult these specifications to determine which PM parameters are associated with the system points you want to monitor or provision with CTC or TL1. The monitoring points might vary according to your configuration.

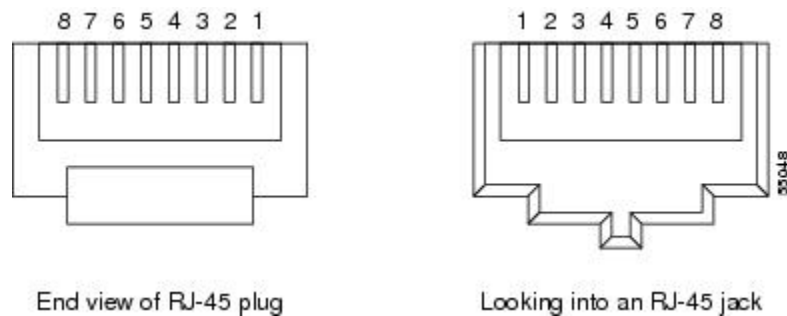
**Figure 11: RJ-45 Pin Numbers**

You can crimp your own LAN cables for use with the ONS 15454. Use a cross-over cable when connecting an ONS 15454 to a hub, LAN modem, or switch, and use a LAN cable when connecting an ONS 15454 to a router or workstation. Use CAT-5 cable RJ-45 T-568B, Color Code (100 Mbps), and a crimping tool. [Figure 11: RJ-45 Pin Numbers](#), on page 59 shows the wiring of an RJ-45 connector. [Table 10: LAN Cable Pinout](#), on page 60 [Figure 13: Cross-Over Cable Layout](#), on page 60 shows a LAN cable layout, and [Table 10: LAN Cable Pinout](#), on page 60 shows the cable pinouts. [Figure 13: Cross-Over Cable Layout](#), on page 60 shows a cross-over cable layout, and [Table 11: Cross-Over Cable Pinout](#), on page 60 shows the cross-over pinouts.

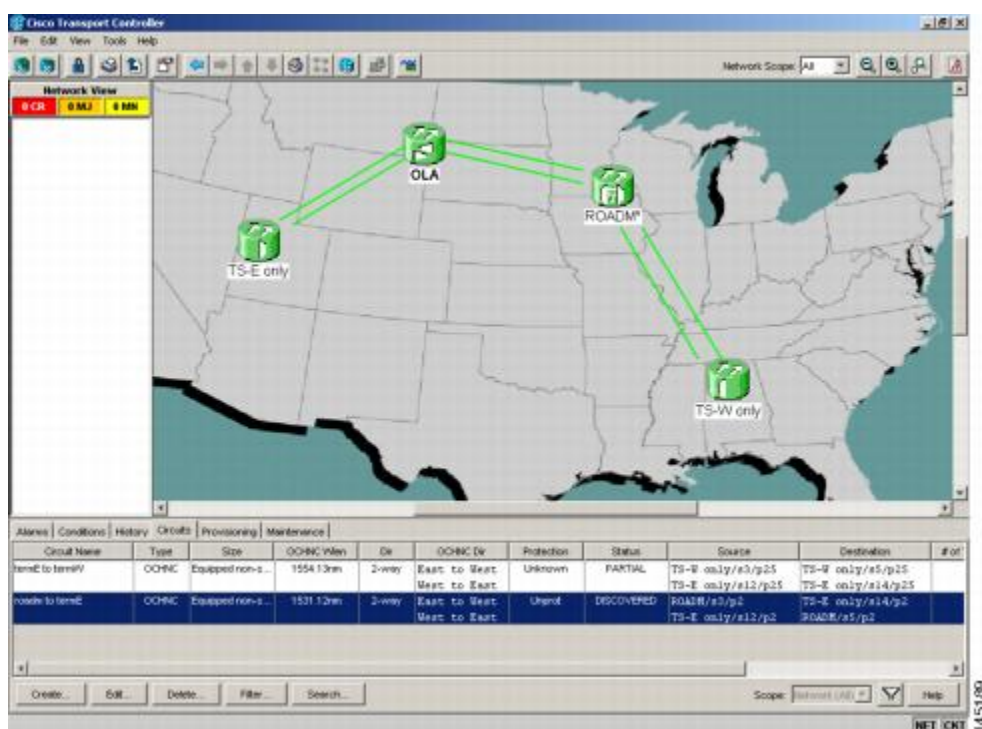
**Figure 14: Linear Network, With No Fiber Cut**

Different symptoms and scenarios can occur, depending on the network ALS settings. Consider the linear network (four nodes) in [Figure 14: Linear Network, With No Fiber Cut](#), on page 65 as a reference. The scenarios are presented after the figure.

The symptoms of the possible span loss scenarios (except for span loss decrease) are described in the following paragraphs. Refer to the linear network in [Figure 14: Linear Network, With No Fiber Cut](#), on page 65 during the discussion of the scenarios.

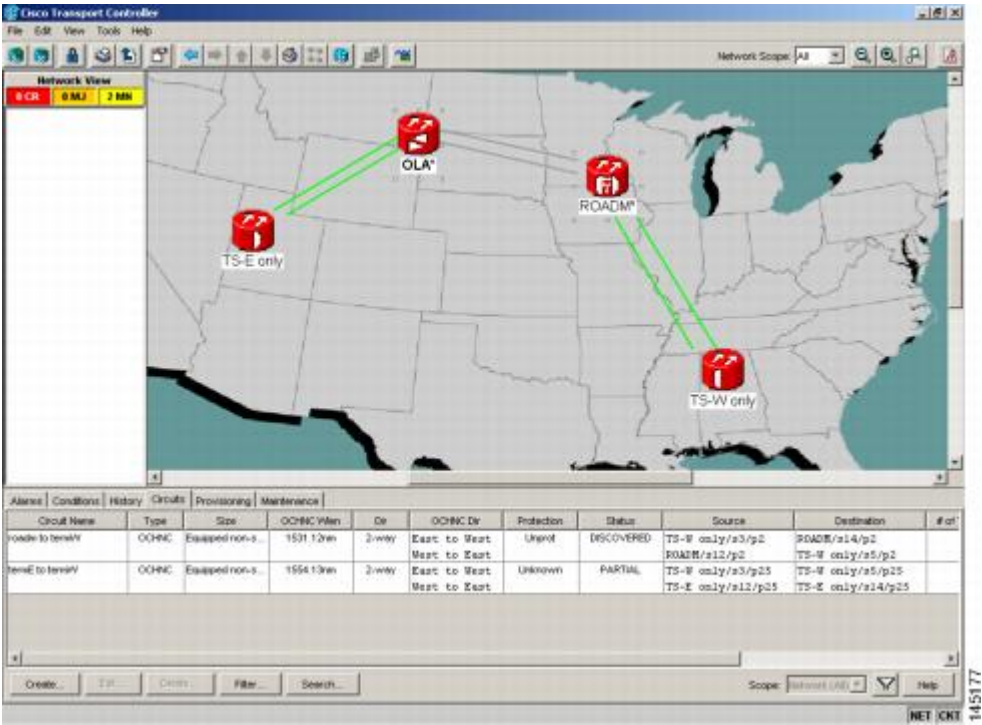
**Figure 15: Fiber Cut with ALS MODE = Auto Restart**

The final fault condition of the network is shown in [Figure 15: Fiber Cut with ALS MODE = Auto Restart](#), on page 66.

In network view, both of the lines representing the span were formerly green and have now changed to gray. Notice also that the status of all the OCHNC circuits on the broken span have changed from Discovered to Partial.

The basic assumption is that the network ALS feature (for feature details, refer to the Network Optical Safety—Automatic Laser Shutdown section in the Network Reference chapter of the *Cisco ONS 15454 DWDM Configuration Guide*) is active (ALS Mode = Auto Restart on the OPT-BST, OPT-AMP-x-C, [+ OSCM] and OSC-CSM). Given this assumption, the starting condition is as shown in [Figure 15: Fiber Cut with ALS MODE = Auto Restart](#), on page 66.

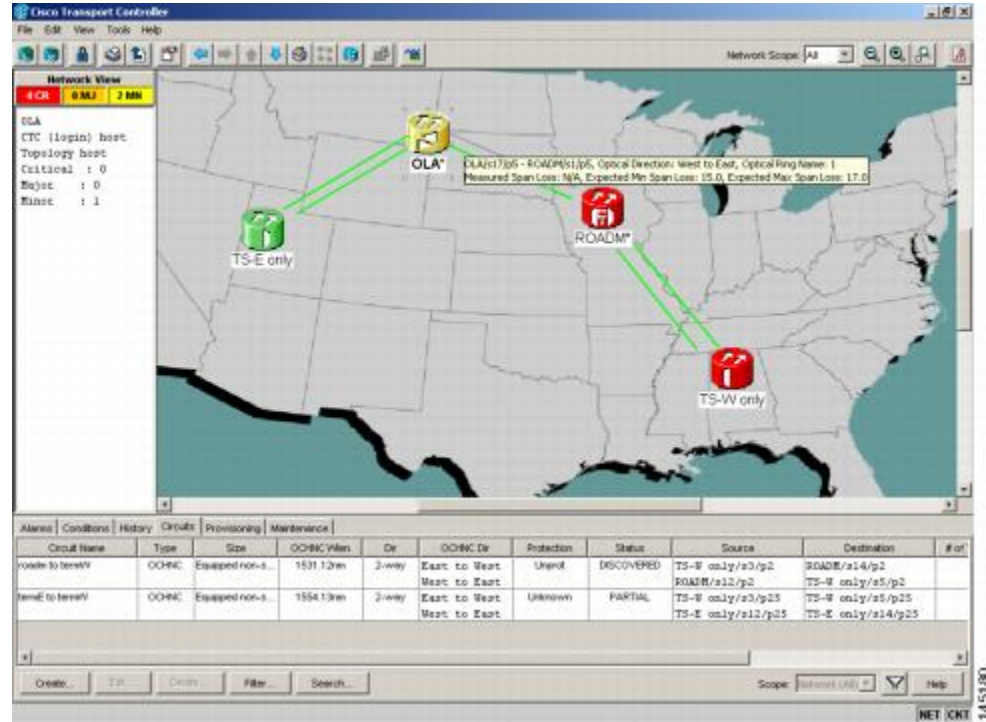
**Figure 18: Network View Fault Condition for Fiber Cut with ALS Mode Disabled**

The LOS (OTS or AOTS) alarm is raised by the ROADM-RX node that was receiving the signal coming from the broken fiber. The final fault condition of the network is shown in [Figure 18: Network View Fault Condition for Fiber Cut with ALS Mode Disabled](#), on page 69.

In network view ([Figure 18: Network View Fault Condition for Fiber Cut with ALS Mode Disabled](#), on page 69), only the actual affected fiber becomes gray, whereas the traffic (and OSC signal as well) on the good fiber is active and fault identification is immediate.

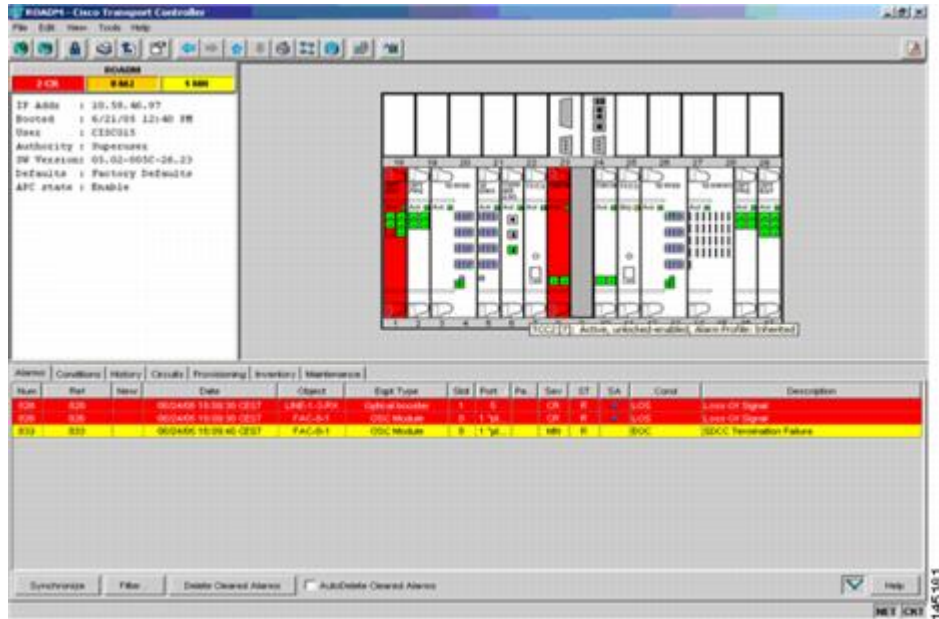
**Figure 19: ONS 15454 SDH ROADM Node View with Fault Condition for ALS MODE Disabled**

In node view (single-shelf mode) or shelf view (multishelf mode) ([Figure 19: ONS 15454 SDH ROADM Node View with Fault Condition for ALS MODE Disabled](#), on page 70 and [Figure 20: ONS 15454 SDH OLA Node View with Fault Condition for ALS MODE Disabled](#), on page 70), the alarm panel of the receiving

node (ROADM in this example) reports the LOS (OTS), while the transmitting node (OLA) reports only an EOC alarm.

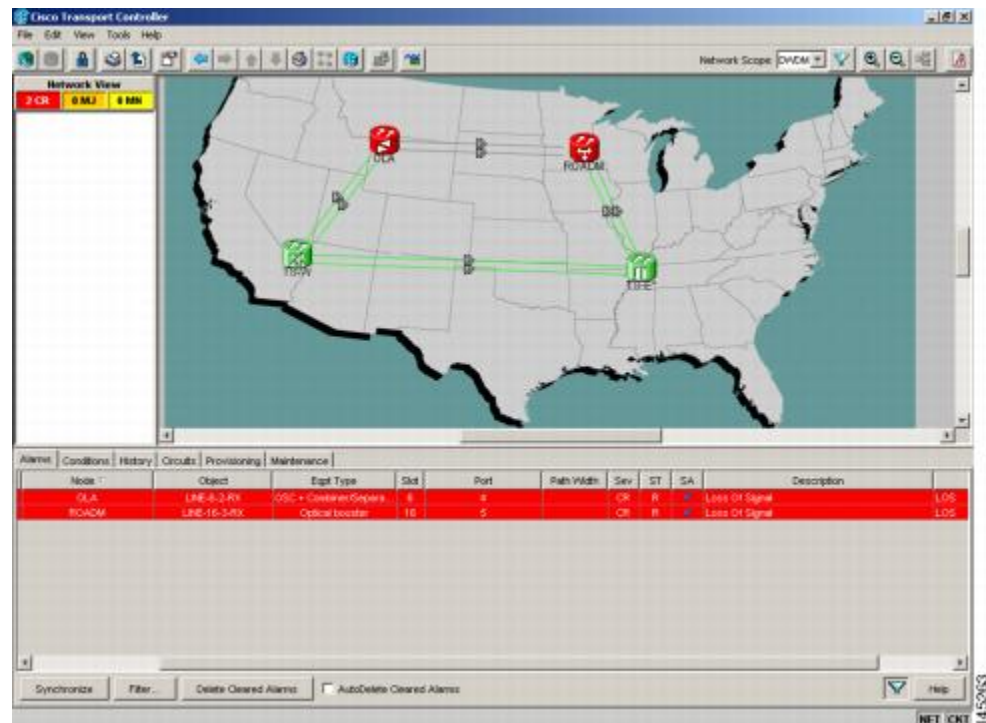
**Figure 21: Network View for Span Loss Change > 5 dBm and OSC Power Value at Receiver > -42 dBm**

This change is due to the fact the physical optical power value received by the OSC transceiver is above the sensitivity limit (-42 dBm) and consequently, the OSC optical link can be rebuilt, allowing the restoration of the Section DCC (SDCC) or multiplex section DCC (MS-DCC). The network view for this condition is shown in [Figure 21: Network View for Span Loss Change > 5 dBm and OSC Power Value at Receiver > -42 dBm, on page 75](#).

In node view (single-shelf mode) or shelf view (multishelf mode), the EOC condition is cleared, but the alarm panels of the two nodes (ROADM and OLA in the example) continue to show LOS (OTS or AOTS) on the LINE-RX port of the OPT-BST, OPT-AMP-x-C, or OSC-CSM.

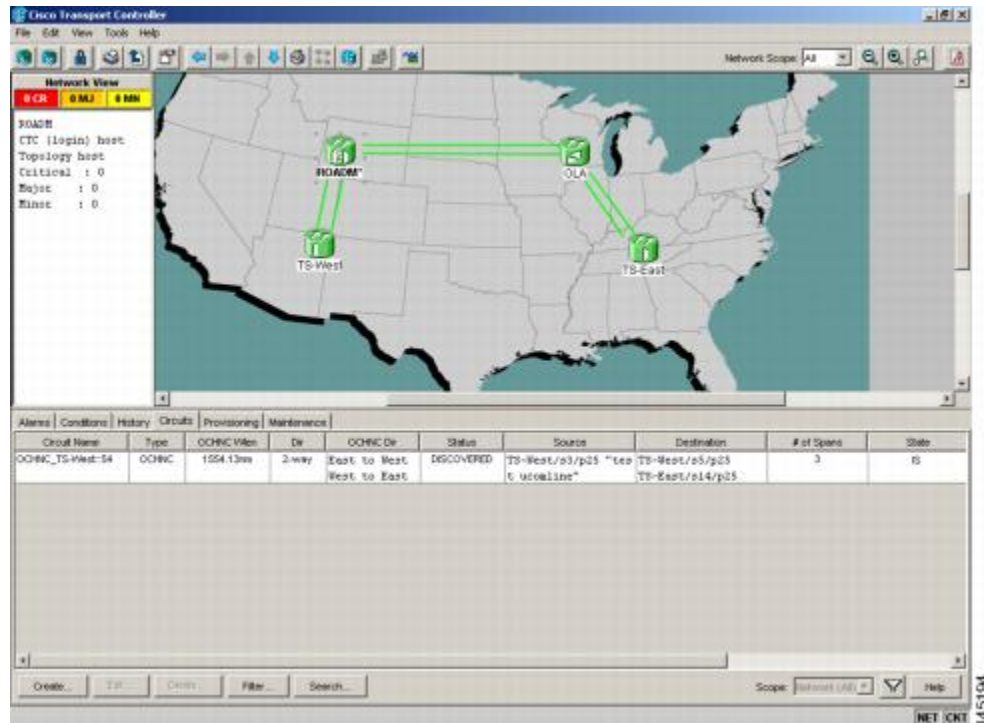
**Figure 22: OCHNC Circuit Successfully Completed**

OCHNC circuit creation is successfully completed when the CTC circuit table reports the situation shown in [Figure 22: OCHNC Circuit Successfully Completed](#), on page 83.

- Circuit State reports IS (or unlocked).

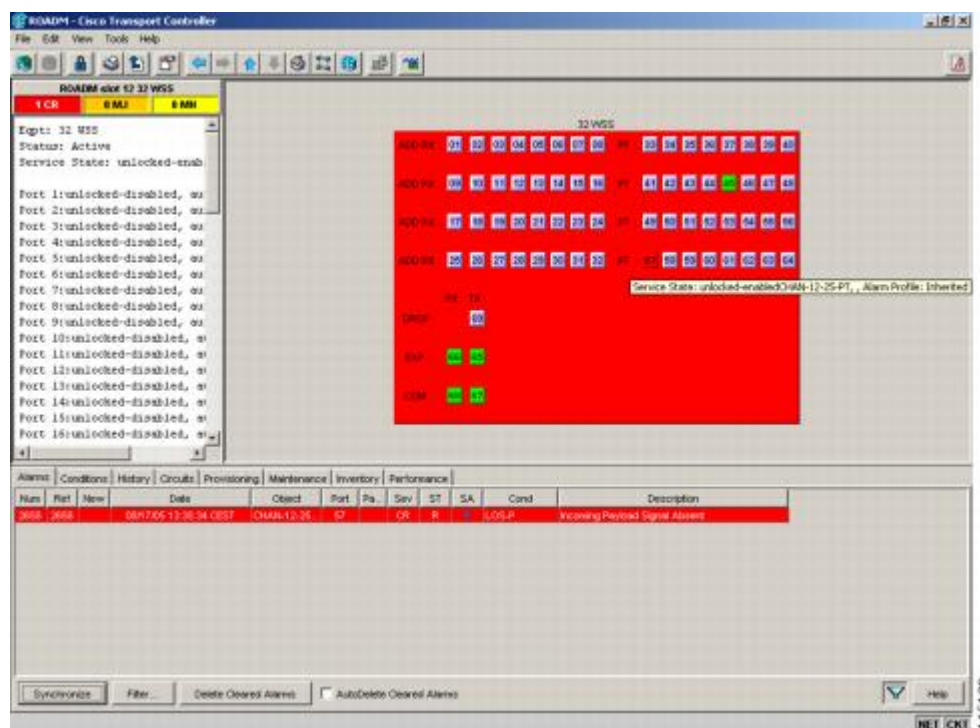
**Figure 26: LOS-P Indication on the VOA Port**

If the incoming power level is lower than the minimum allowed, the startup procedure always stops at Phase 1 (see [Figure 26: LOS-P Indication on the VOA Port, on page 88](#)). This is the case even if the final VOA Power Reference reported in CTC is reachable.

- A LOS-P (OCH layer) alarm on the port associated with the VOA (see [Figure 26: LOS-P Indication on the VOA Port, on page 88](#))
- A valid optical power value (different from the end of scale value of  $-50$  dBm) in the Power field, but the value for Power is less than  $-33$  dBm. (To view the Power field, in card view, click the **Provisioning** > **Parameters** tabs.)

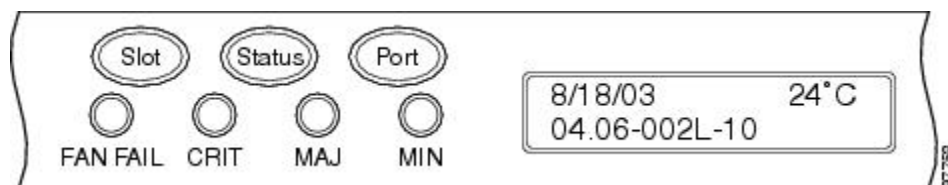
**Figure 27: Shelf LCD Panel**

- Step 1** View the temperature displayed on the ONS 15454 LCD front panel (Figure 28: Shelf LCD Panel, on page 248).  
Figure 28: Shelf LCD Panel, on page 248 shows the shelf LCD panel.

- Step 1** View the temperature displayed on the ONS system LCD front panel. For example, the ONS 15454 front panel is illustrated in [Figure 28: Shelf LCD Panel](#), on page 248.

- 
- Step 1** Check for any outstanding alarms that were raised against the active and standby TCC2/TCC2P/TCC3 and resolve them.
- Step 2** If the alarm does not clear, determine whether the LCD display on the fan tray ([Figure 28: Shelf LCD Panel, on page 248](#)) is blank or if the text is garbled. If so, proceed to [Step 8, on page 263](#). If not, continue with [Step 3, on page 262](#).
- Step 3** At the earliest maintenance window, reset the standby TCC2/TCC2P/TCC3:
- Note** The reset requires approximately five minutes. Do not perform any other step until the reset is complete.
- a) Log into a node on the network. If you are already logged in, continue with [Step 3.b, on page 262](#)
  - b) Identify the active TCC2/TCC2P/TCC3.

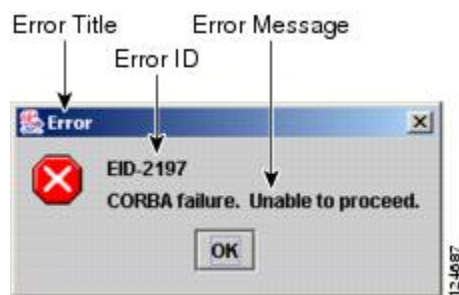
**Figure 29: Error Dialog Box**

This chapter lists the error messages for the Cisco ONS 15454 Multi-Service Transport Platform (MSTP). The error dialog box in [Figure 29: Error Dialog Box, on page 443](#) consists of three parts: the error title, error ID, and error message.
