General Troubleshooting

This chapter provides procedures for troubleshooting the most common problems encountered when operating a Cisco ONS 15454 DWDM shelf in ANSI or ETSI platforms. To troubleshoot specific alarms, see [Alarm Troubleshooting](#). If you cannot find what you are looking for, contact Cisco Technical Support (1 800 553-2447).

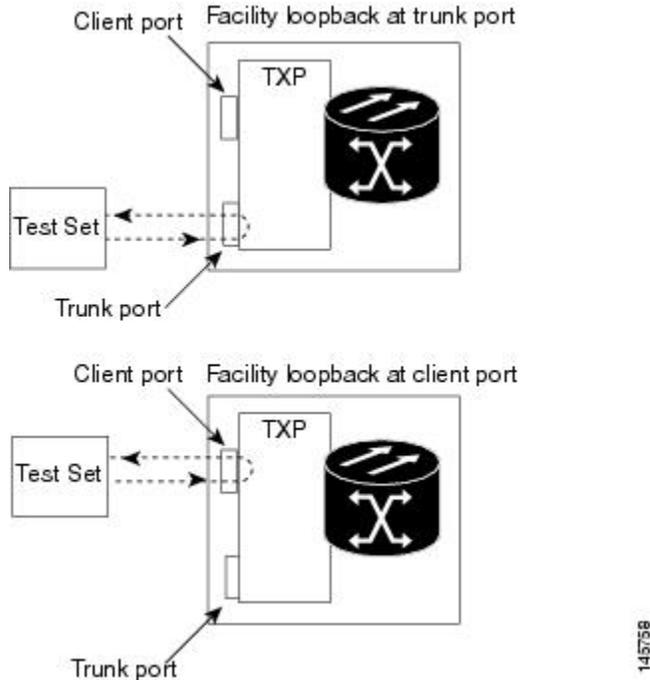
Figure 1: Facility Loopback Path on a Near-End Transponder Card

A facility loopback tests the line interface unit (LIU) of a card, the electrical interface assembly (EIA), and related cabling. After applying a facility loopback on a port, use a test set to run traffic over the loopback. A successful facility loopback isolates the LIU, the EIA, or the cabling plant as the potential cause of a network problem.

Figure 1: Facility Loopback Path on a Near-End Transponder Card, on page 3 shows a facility loopback at a trunk port and at a client port on a TXP card.

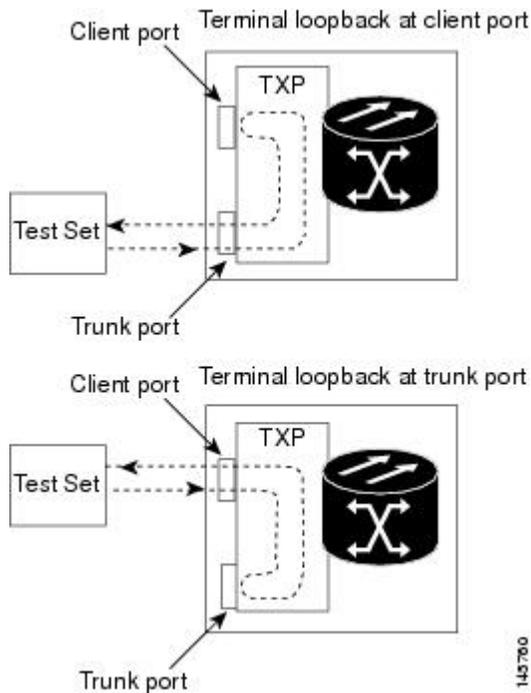
Figure 2: Terminal Loopback on a TXP Card

A terminal loopback tests a circuit path as it passes through a TXP, MXP, or ADM-10G card and loops back. For example, as shown in [Figure 2: Terminal Loopback on a TXP Card, on page 6](#), there are two types of terminal loopbacks shown for a TXP card.

This test verifies that the terminal circuit paths are valid, but does not test the LIU on the TXP card.

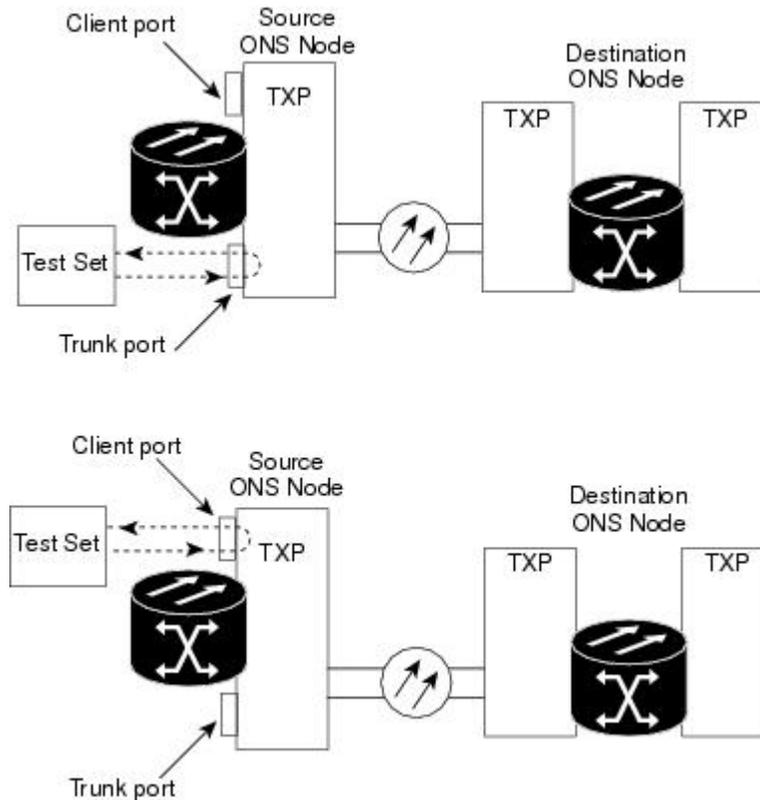
Figure 3: Facility Loopback on a Circuit Source MXP or TXP Port

failure point. [Figure 3: Facility Loopback on a Circuit Source MXP or TXP Port](#), on page 10 shows the facility loopback examples on source ONS node TXP ports (client and trunk).

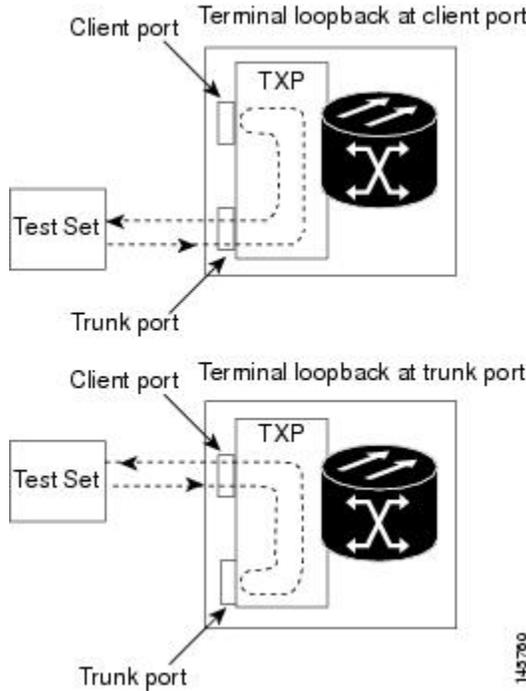
Figure 4: Terminal Loopback on a Source-Node MXP or TXP Port

The terminal loopback test is performed on the node source MXP, TXP, XP, or ADM-10G port. For the circuit in this example, it is the source TXP trunk port or a client port in the source node. Completing a successful terminal loopback to a node source port verifies that the circuit is through the source port. [Figure 4: Terminal](#)

[Loopback on a Source-Node MXP or TXP Port](#), on page 13 shows an example of a terminal loopback on a source TXP port and a client TXP port.

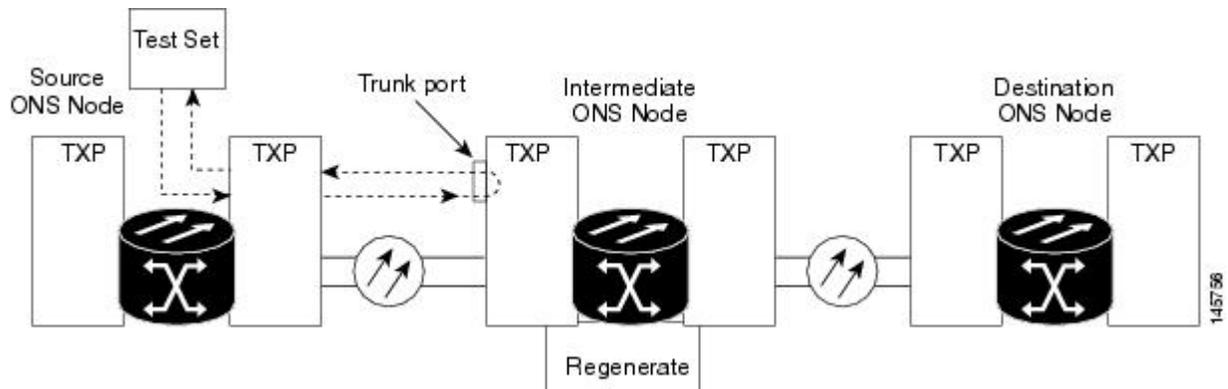
Figure 5: Facility Loopback on an Intermediate-Node MXP or TXP Port

Performing the facility loopback test on an intermediate port isolates whether this node is causing circuit failure. In the situation shown in [Figure 5: Facility Loopback on an Intermediate-Node MXP or TXP Port, on page 16](#), the test is being performed on an intermediate MXP or TXP port.

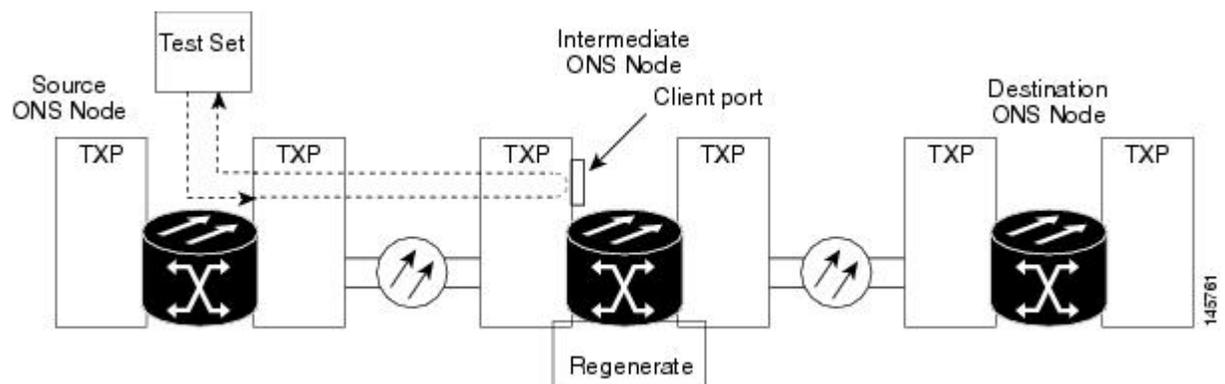
Figure 6: Terminal Loopback on an Intermediate-Node MXP or TXP Port

In the next troubleshooting test, you perform a terminal loopback on the intermediate-node port to isolate whether the intermediate client or trunk port is causing circuit trouble. In the example situation in [Figure 6: Terminal Loopback on an Intermediate-Node MXP or TXP Port](#), on page 18, the terminal loopback is performed on an intermediate MXP or TXP port in the circuit. If you successfully complete a terminal loopback on the node, this node is excluded from possible sources of circuit trouble.

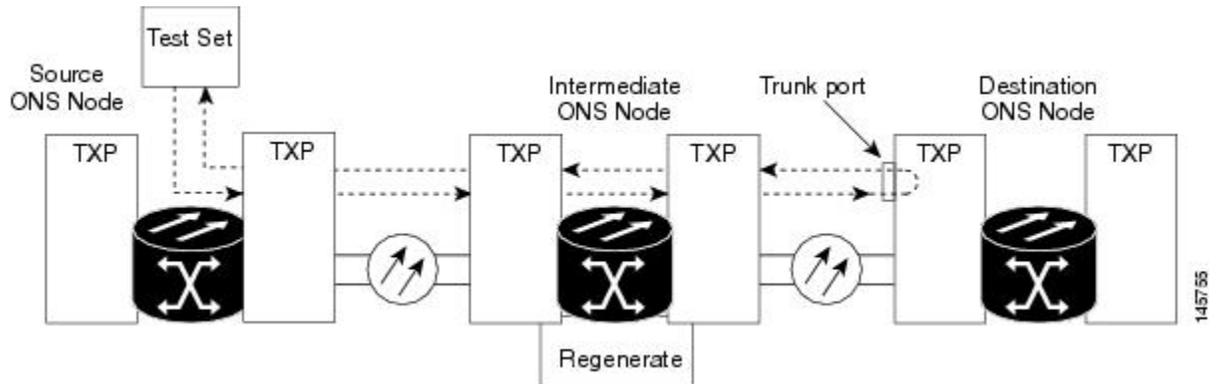
Figure 7: Facility Loopback on a Destination-Node MXP or TXP Port

You perform a facility loopback test at the destination port to determine whether this local port is the source of circuit trouble. The example in [Figure 7: Facility Loopback on a Destination-Node MXP or TXP Port](#), on page 21 shows a facility loopback being performed on a TXP client or trunk port at a destination node.

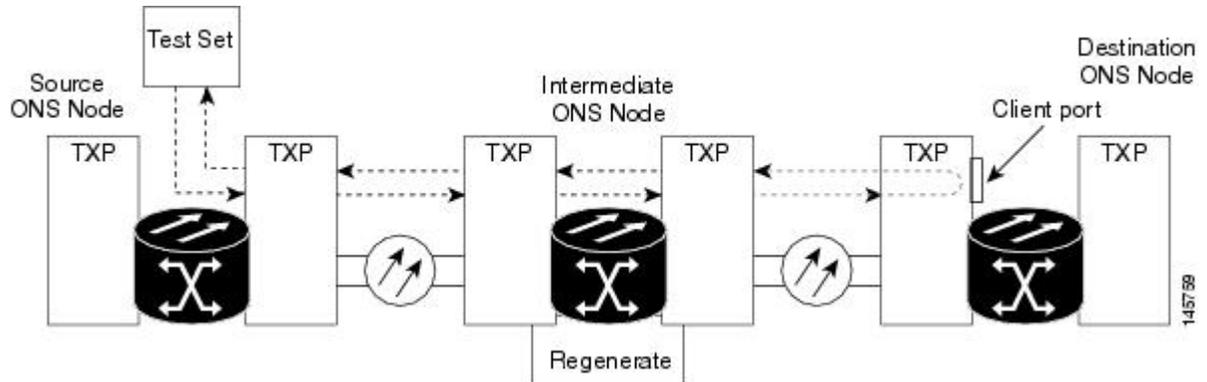
Figure 8: Terminal Loopback on a Destination-Node MXP or TXP Port

the destination port. The example in [Figure 8: Terminal Loopback on a Destination-Node MXP or TXP Port, on page 24](#) shows a terminal loopback on an destination node TXP port.

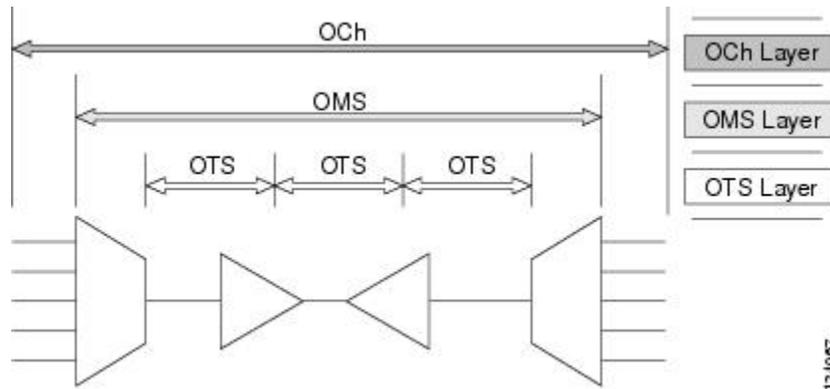
Figure 9: Optical Transport Network Layers

Like traditional SONET networks, ITU-T G.709 optical networks have a layered design (Figure 9: Optical Transport Network Layers, on page 27). This structure enables localized monitoring that helps you isolate and troubleshoot network problems.

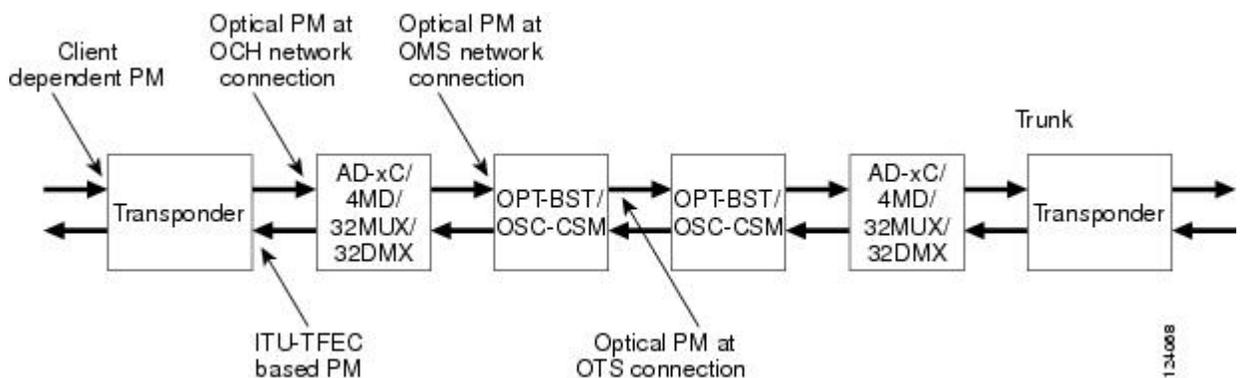
Figure 10: Performance Monitoring Points on ONS DWDM

Different PM count parameters are associated with different read points in a network. [Figure 10: Performance Monitoring Points on ONS DWDM, on page 28](#) illustrates the PM read points that are useful in identifying DWDM circuit points of failure. The [Monitor Performance](#) document lists all PM parameters and provides block diagrams of signal entry points, exit points, and interconnections between the individual circuit cards. Consult these specifications to determine which PM parameters are associated with the system points you want to monitor or provision with CTC or TL1. The monitoring points might vary according to your configuration.

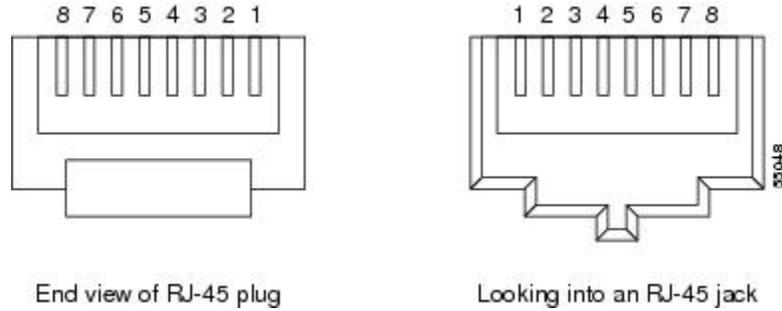
Figure 11: RJ-45 Pin Numbers

You can crimp your own LAN cables for use with the ONS 15454. Use a cross-over cable when connecting an ONS 15454 to a hub, LAN modem, or switch, and use a LAN cable when connecting an ONS 15454 to a router or workstation. Use CAT-5 cable RJ-45 T-568B, Color Code (100 Mbps), and a crimping tool. [Figure 11: RJ-45 Pin Numbers](#), on page 59 shows the wiring of an RJ-45 connector. [Table 9: LAN Cable Pinout](#), on page 59 [Figure 13: Cross-Over Cable Layout](#), on page 60 shows a LAN cable layout, and [Table 9: LAN](#)

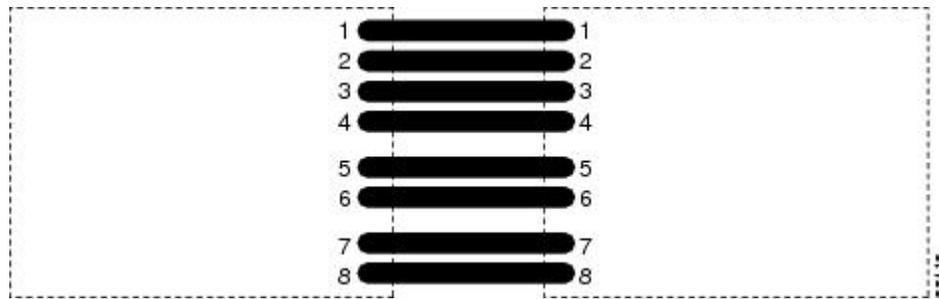
Figure 13: Cross-Over Cable Layout

Cable Pinout, on page 59 shows the cable pinouts. Figure 13: Cross-Over Cable Layout, on page 60 shows a cross-over cable layout, and Table 10: Cross-Over Cable Pinout, on page 60 shows the cross-over pinouts.

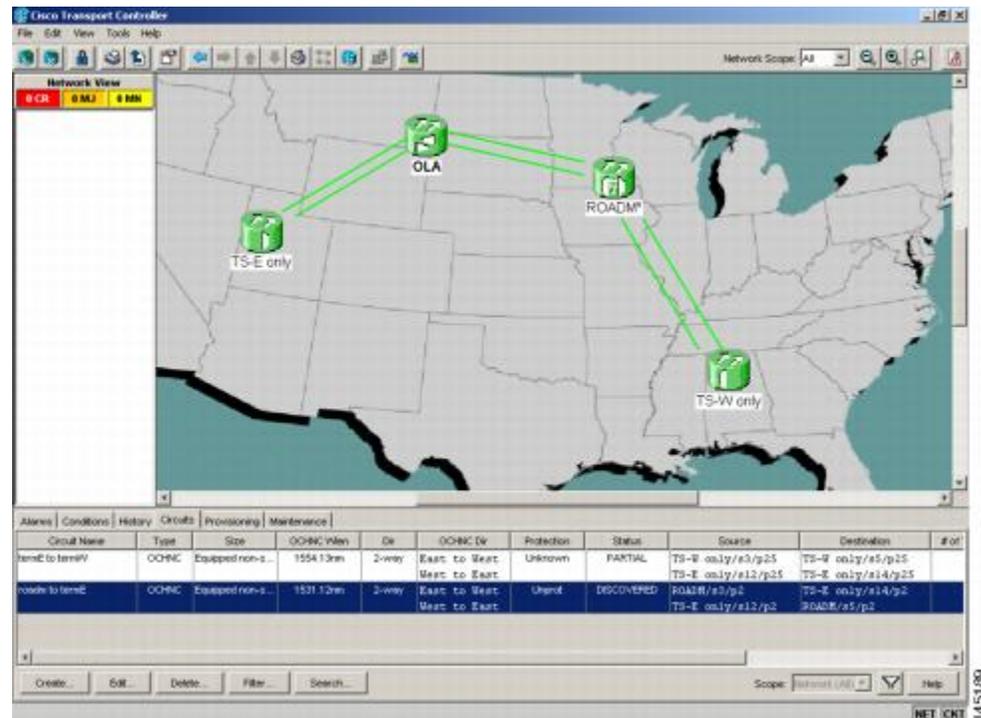
**Figure 14: Linear Network, With No Fiber Cut**

Different symptoms and scenarios can occur, depending on the network ALS settings. Consider the linear network (four nodes) in [Figure 14: Linear Network, With No Fiber Cut](#), on page 65 as a reference. The scenarios are presented after the figure.

The symptoms of the possible span loss scenarios (except for span loss decrease) are described in the following paragraphs. Refer to the linear network in [Figure 14: Linear Network, With No Fiber Cut](#), on page 65 during the discussion of the scenarios.

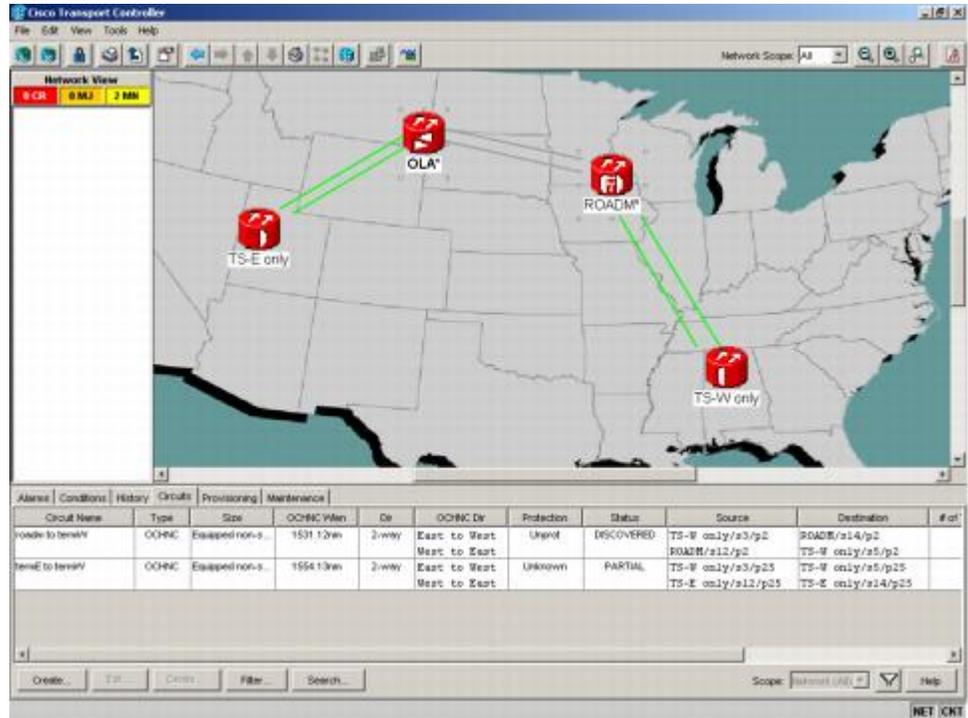
**Figure 15: Fiber Cut with ALS MODE = Auto Restart**

The final fault condition of the network is shown in [Figure 15: Fiber Cut with ALS MODE = Auto Restart](#), on page 66.

In network view, both of the lines representing the span were formerly green and have now changed to gray. Notice also that the status of all the OCHNC circuits on the broken span have changed from Discovered to Partial.

The basic assumption is that the network ALS feature (for feature details, refer to the Network Optical Safety—Automatic Laser Shutdown section in the Network Reference chapter of the *Cisco ONS 15454 DWDM Configuration Guide*) is active (ALS Mode = Auto Restart on the OPT-BST, OPT-AMP-x-C, [+ OSCM] and OSC-CSM). Given this assumption, the starting condition is as shown in [Figure 15: Fiber Cut with ALS MODE = Auto Restart](#), on page 66.

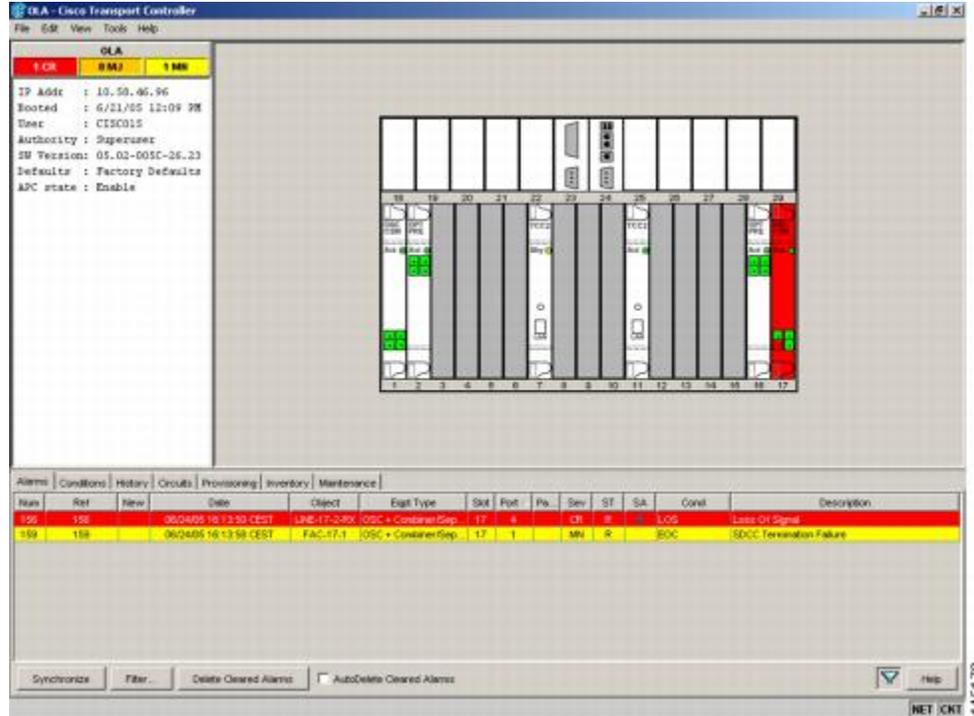
**Figure 16: LOS Indication on the ROADM Node OSC-CSM**

In node view (single-shelf mode) or shelf view (multishelf mode), the alarm panel of the two nodes (reconfigurable optical add/drop multiplexing [ROADM] and optical line amplification [OLA] in the example) show the LOS (AOTS) alarm on Port 4 of the OSC-CSM (see [Figure 16: LOS Indication on the ROADM](#)

Node OSC-CSM, on page 67) and the LOS (OTS) on Port 5 of the OPT-BST (see Figure 17: LOS Indication on the OLA Node OPT-BST, on page 67).

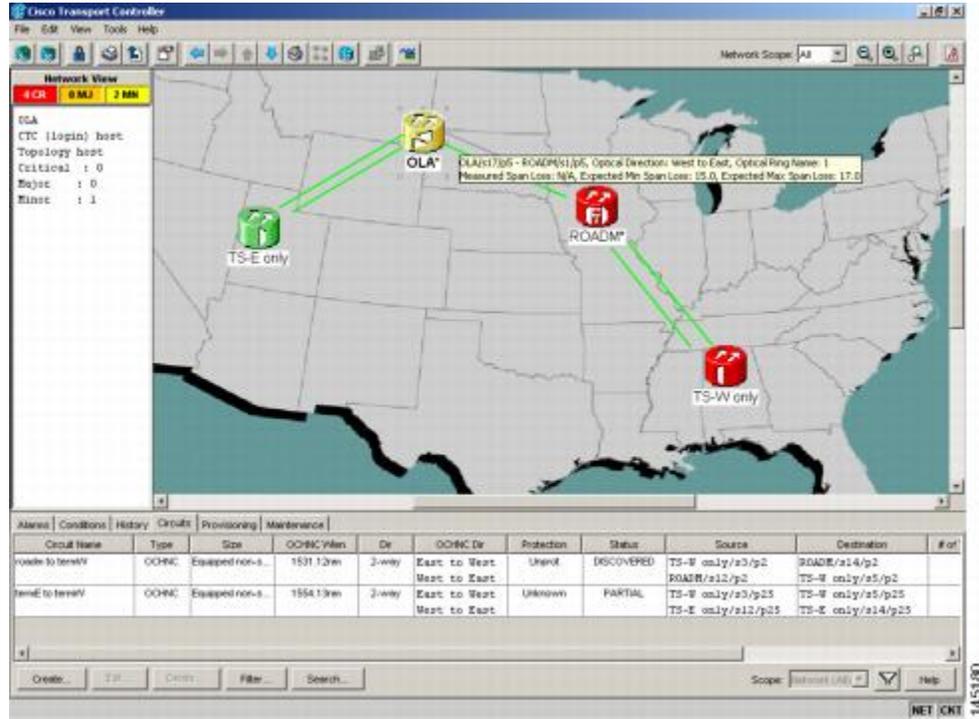
**Figure 18: Network View Fault Condition for Fiber Cut with ALS Mode Disabled**

The LOS (OTS or AOTS) alarm is raised by the ROADM-RX node that was receiving the signal coming from the broken fiber. The final fault condition of the network is shown in [Figure 18: Network View Fault Condition for Fiber Cut with ALS Mode Disabled](#), on page 69.

In network view ([Figure 18: Network View Fault Condition for Fiber Cut with ALS Mode Disabled](#), on page 69), only the actual affected fiber becomes gray, whereas the traffic (and OSC signal as well) on the good fiber is active and fault identification is immediate.

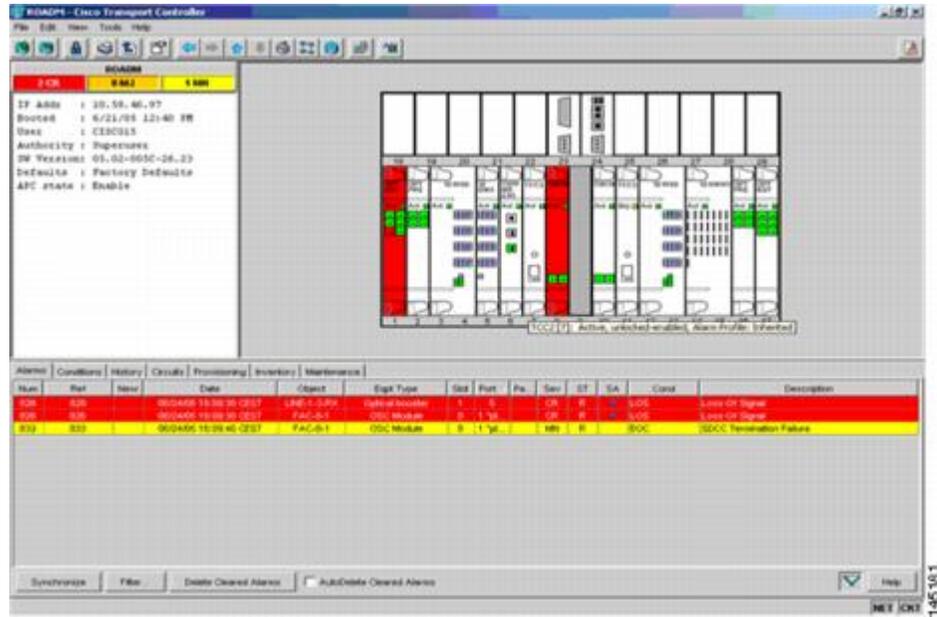
**Figure 19: ONS 15454 SDH ROADM Node View with Fault Condition for ALS MODE Disabled**

In node view (single-shelf mode) or shelf view (multishelf mode) ([Figure 19: ONS 15454 SDH ROADM Node View with Fault Condition for ALS MODE Disabled](#), on page 70 and [Figure 20: ONS 15454 SDH OLA Node View with Fault Condition for ALS MODE Disabled](#), on page 70), the alarm panel of the receiving

node (ROADM in this example) reports the LOS (OTS), while the transmitting node (OLA) reports only an EOC alarm.

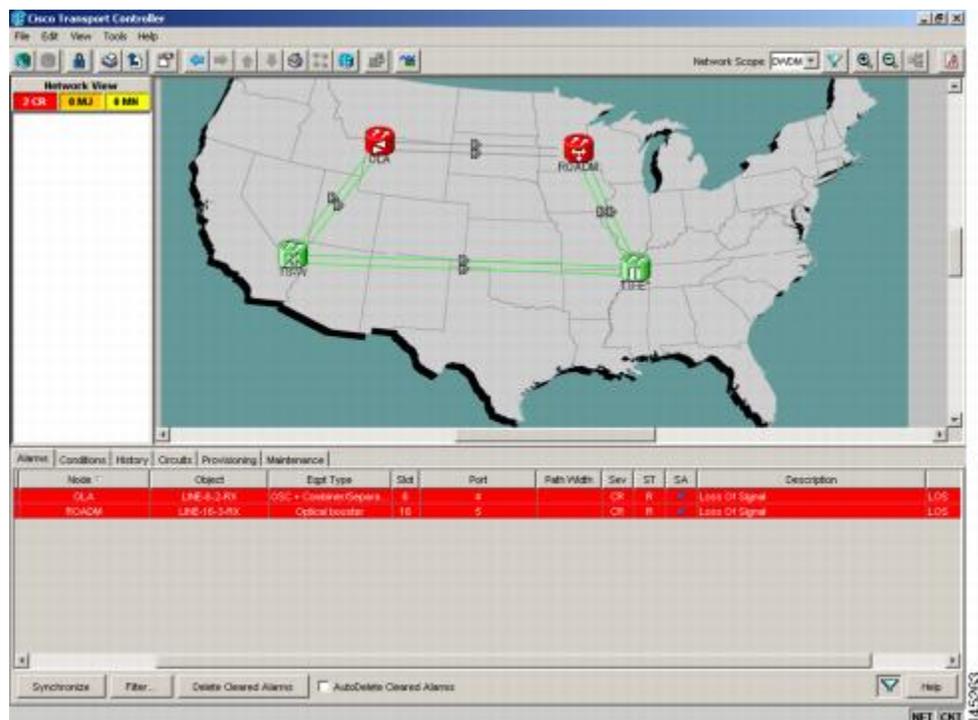
**Figure 21: Network View for Span Loss Change > 5 dBm and OSC Power Value at Receiver > -42 dBm**

This change is due to the fact the physical optical power value received by the OSC transceiver is above the sensitivity limit (-42 dBm) and consequently, the OSC optical link can be rebuilt, allowing the restoration of the Section DCC (SDCC) or multiplex section DCC (MS-DCC). The network view for this condition is shown in [Figure 21: Network View for Span Loss Change > 5 dBm and OSC Power Value at Receiver > -42 dBm, on page 75](#).

In node view (single-shelf mode) or shelf view (multishelf mode), the EOC condition is cleared, but the alarm panels of the two nodes (ROADM and OLA in the example) continue to show LOS (OTS or AOTS) on the LINE-RX port of the OPT-BST, OPT-AMP-x-C, or OSC-CSM.

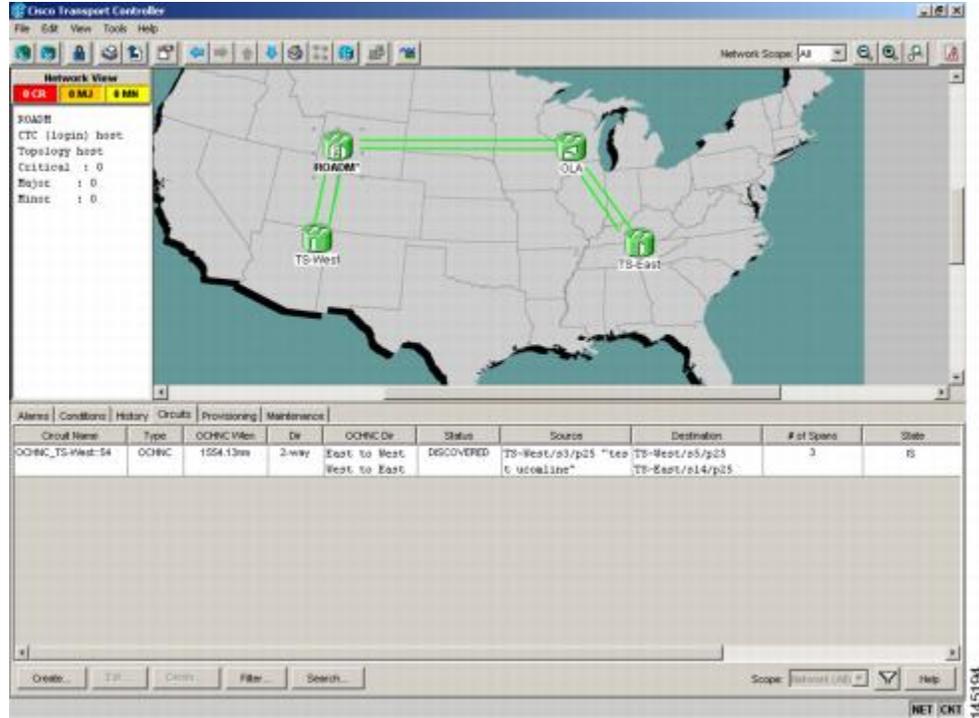
**Figure 22: OCHNC Circuit Successfully Completed**

OCHNC circuit creation is successfully completed when the CTC circuit table reports the situation shown in [Figure 22: OCHNC Circuit Successfully Completed](#), on page 83.

- Circuit State reports IS (or unlocked).

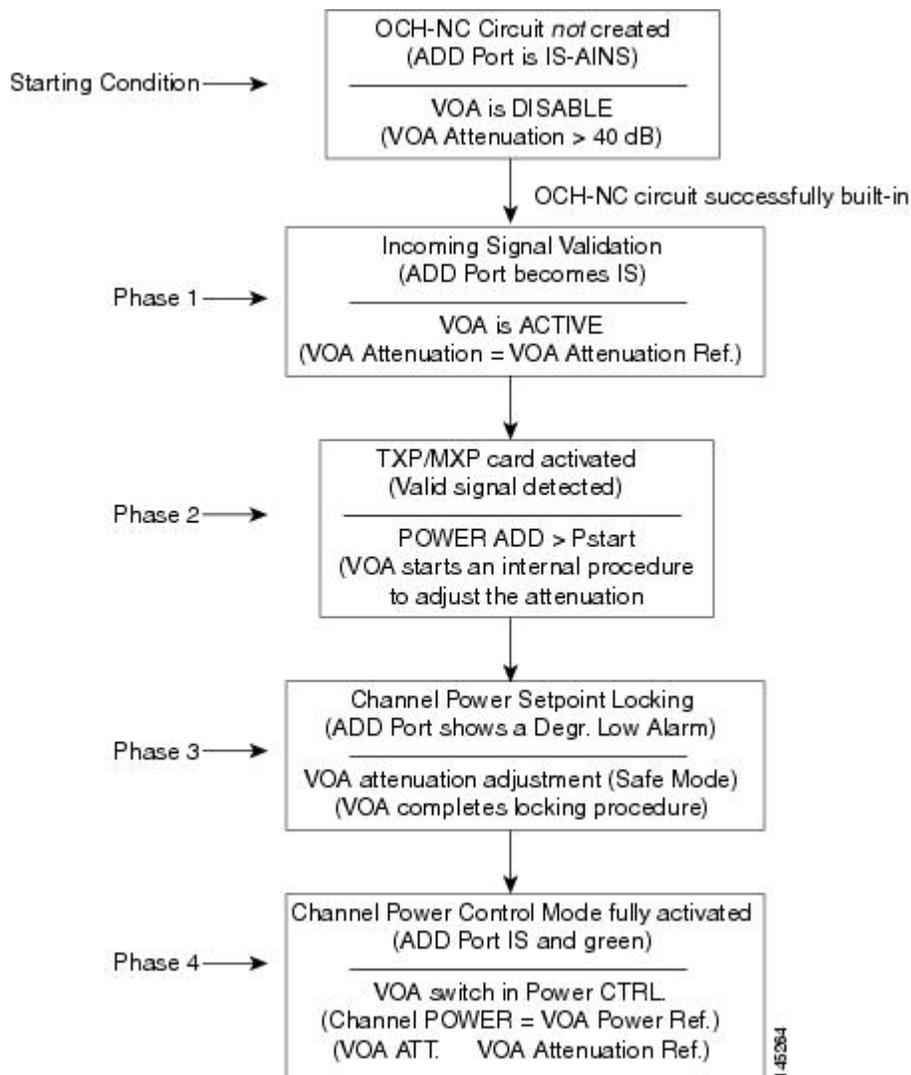
**Figure 25: VOA Startup Procedure**

The final VOA condition is achieved through a startup procedure divided into the four sequential phases shown in [Figure 25: VOA Startup Procedure](#), on page 86.

Until the VOA has completed all the phases shown in [Figure 25: VOA Startup Procedure](#), on page 86, the power control mode is not fully activated.

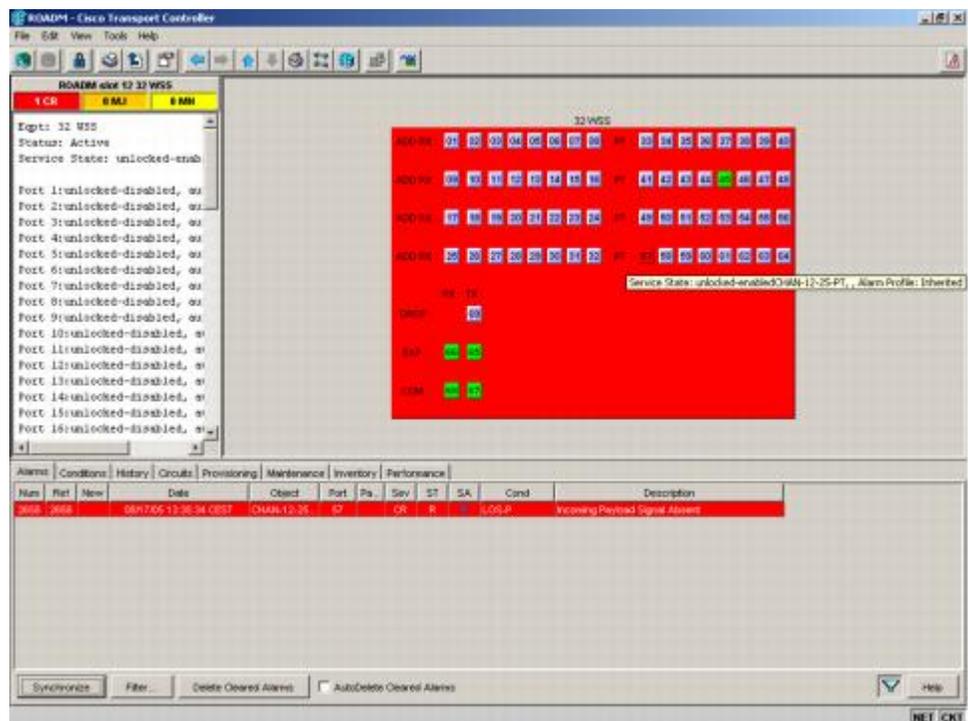
**Figure 26: LOS-P Indication on the VOA Port**

If the incoming power level is lower than the minimum allowed, the startup procedure always stops at Phase 1 (see [Figure 26: LOS-P Indication on the VOA Port, on page 88](#)). This is the case even if the final VOA Power Reference reported in CTC is reachable.

- A LOS-P (OCH layer) alarm on the port associated with the VOA (see [Figure 26: LOS-P Indication on the VOA Port, on page 88](#))
- A valid optical power value (different from the end of scale value of  $-50$  dBm) in the Power field, but the value for Power is less than  $-33$  dBm. (To view the Power field, in card view, click the **Provisioning** > **Parameters** tabs.)
