Alarm Troubleshooting

This chapter gives a description, severity, and troubleshooting procedure for each commonly encountered Cisco DWDM alarm and condition. Tables [Table 1: Critical DWDM Alarm List, on page 2](#) through [Table 5: NR DWDM Conditions List, on page 13](#) provide lists of DWDM alarms organized by severity. [Table 7: Alarm Logical Object Type Definitions, on page 26](#) provides a list of alarms organized alphabetically. [Table 7: Alarm Logical Object Type Definitions, on page 26](#) gives definitions of all DWDM alarm logical objects, which are the basis of the alarm profile list in [Table 8: Alarm List by Logical Object in Alarm Profile, on page 28](#). For a comprehensive list of all conditions and instructions for using TL1 commands, refer to the *Cisco ONS SONET TL1 Command Guide*. An alarm troubleshooting procedure applies to both the Cisco Transport Controller (CTC) and TL1 version of that alarm.

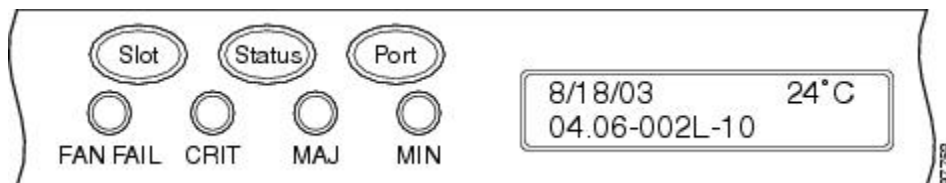
Figure 1: Shelf LCD Panel

- Step 1** View the temperature displayed on the ONS 15454 LCD front panel ([Figure 2: Shelf LCD Panel, on page 144](#)).
[Figure 2: Shelf LCD Panel, on page 144](#) shows the shelf LCD panel.

- Step 1** View the temperature displayed on the ONS system LCD front panel. For example, the ONS 15454 front panel is illustrated in [Figure 2: Shelf LCD Panel](#), on page 144.

- 
- Step 1** Check for any outstanding alarms that were raised against the active and standby TCC2/TCC2P/TCC3 and resolve them.
- Step 2** If the alarm does not clear, determine whether the LCD display on the fan tray ([Figure 2: Shelf LCD Panel, on page 144](#)) is blank or if the text is garbled. If so, proceed to [Step 8, on page 159](#). If not, continue with [Step 3, on page 158](#).
- Step 3** At the earliest maintenance window, reset the standby TCC2/TCC2P/TCC3:
- Note** The reset requires approximately five minutes. Do not perform any other step until the reset is complete.
- a) Log into a node on the network. If you are already logged in, continue with [Step 3.b, on page 158](#)
  - b) Identify the active TCC2/TCC2P/TCC3.
