## **Cisco ONS 15454 DWDM Troubleshooting Guide, Release 9.8**

Text Part Number: 78-21192-01

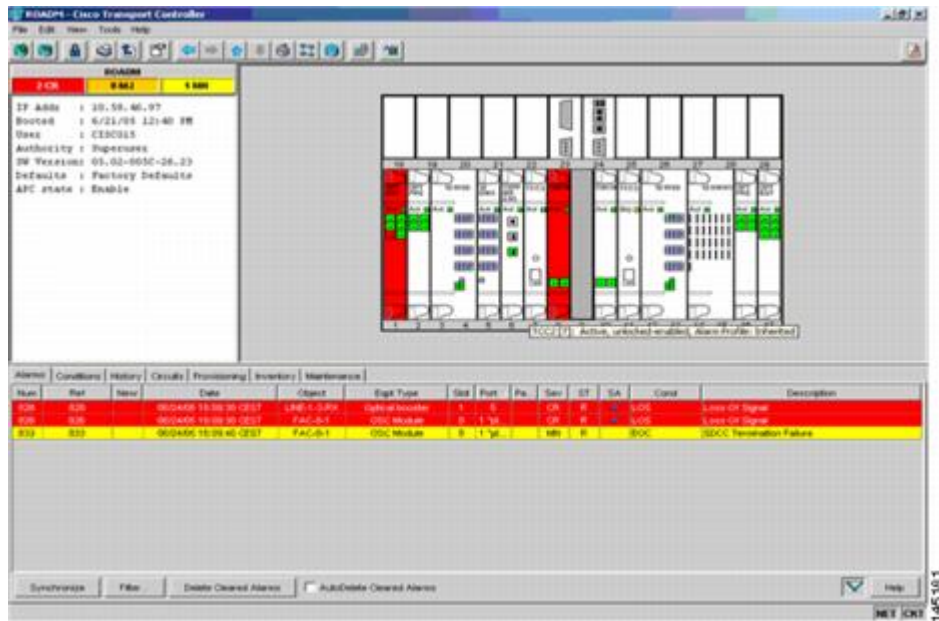
**Figure 19: ONS 15454 SDH ROADM Node View with Fault Condition for ALS MODE Disabled**

In node view (single-shelf mode) or shelf view (multishelf mode) ([Figure 19: ONS 15454 SDH ROADM Node View with Fault Condition for ALS MODE Disabled](#), on page 70 and [Figure 20: ONS 15454 SDH OLA Node View with Fault Condition for ALS MODE Disabled](#), on page 70), the alarm panel of the receiving

node (ROADM in this example) reports the LOS (OTS), while the transmitting node (OLA) reports only an EOC alarm.
