# Troubleshooting Switch Stacks

## Problem: Switch Does Not Join the Stack

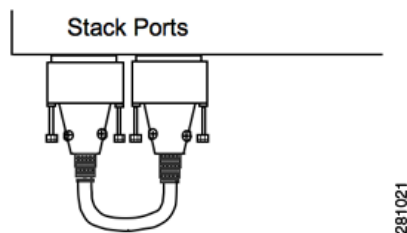
**Figure 1** Using One Cable and Switch to Test a StackWise Cable or Interface

You can also test a StackWise cable or interface by using only one cable and one switch. Connect the StackWise cable to both StackWise interfaces on the same switch (see [Figure 1](#)).

Boot or reboot the switch. This message appears:

```
SM: Detected stack cables at PORT1 PORT2
```

If a StackWise cable is connected to both StackWise ports on the switch and this message appears, either the cable is defective or StackWise port 2 is defective:

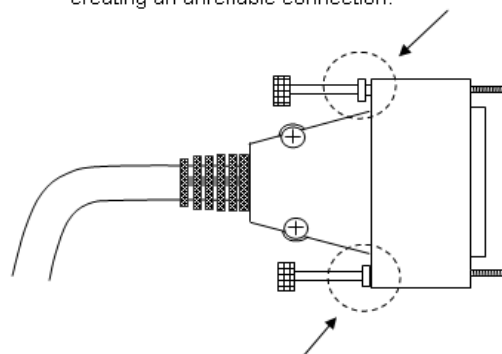
**Figure 2 Example of Loose Retainer Screw**

The retainer screw shown on the top of the connection shown in [Figure 2](#) is not fully engaged, which can result in the connector working itself loose. The best practice is to finger-tighten both retainer screws to the same degree.

This retainer screw is not fully engaged. The connector can loosen, creating an unreliable connection.

StackWise pins connect to the StackWise connector on the switch chassis. Correct alignment is essential.

This retainer screw is fully engaged.

- Loose connector retainer screws allow the connector to move and possibly disconnect. Always tighten the retainer screws when you test a StackWise cable. A connector or retainer screw might appear to be fully engaged, but if it is not adequately tightened, port flapping or a no-link-present state might occur.
- If you use a screwdriver to tighten the retainer screws, avoid excessive force. Tighten the screws only until the connector is fully engaged. Tighten each of the retainer screws to the same degree.
