Release Notes for the Catalyst 4900M Series Switch, Cisco IOS Release 12.2(53)SG

12.2(53)SG3—August 30, 2010

These release notes describe the features, modifications, and caveats for Cisco IOS software on the Catalyst 4900M switch.

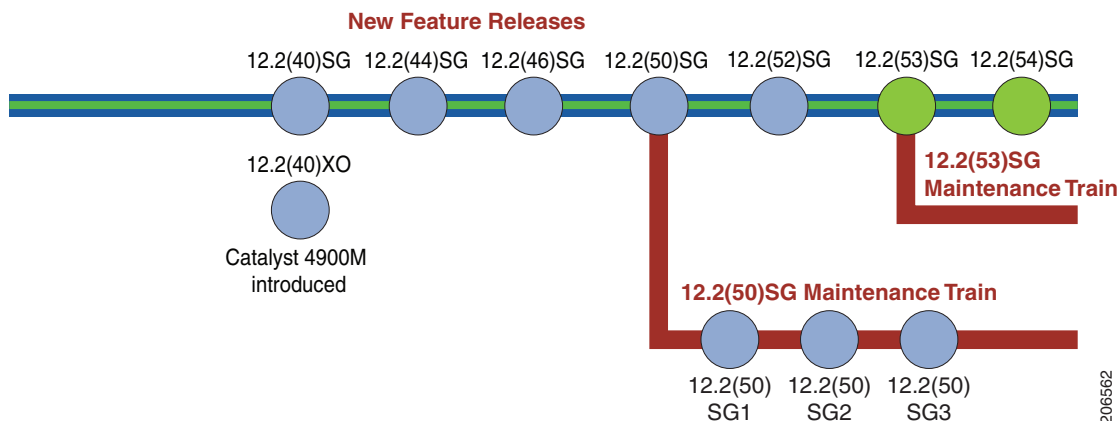
Figure 1 *Software Release Strategy for the Catalyst 4900M Series Switch*

Figure 1 displays the two active, 12.2(31)SGA and 12.2(50)SG, and newly introduced 12.2(53)SG extended maintenance trains.

Support for the Catalyst 4900M platform was introduced in 12.2(40)XO. Moving forward, the Cisco Catalyst 4900M platform has two maintenance trains. The Cisco IOS Release 12.2(53)SG is the latest maintenance train and includes the most recent features including support for OSPF for routed Access
