## 1.1.23 Version Software Release Notes Cisco WAN MGX 8850 Software

### About the 1.1.23 Release

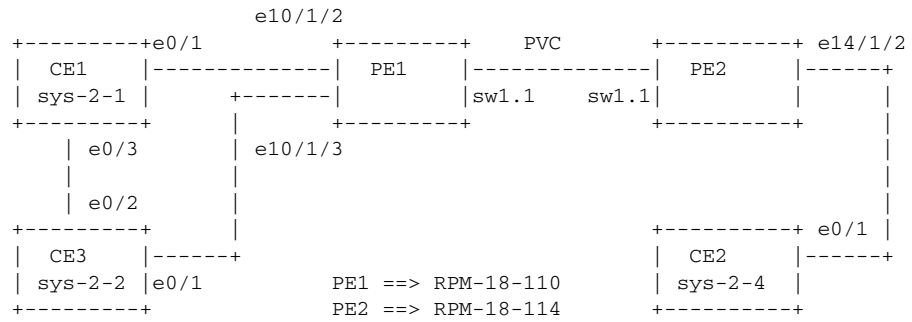
Both RPMs are in the same shelf or chassis.

# One PE - Two CE Configuration - OSPF & IBPG Between PEs & EBGP between PE-CE
