Cisco TelePresence System C/EX/MX-Series

Software release notes TC5

October 2012

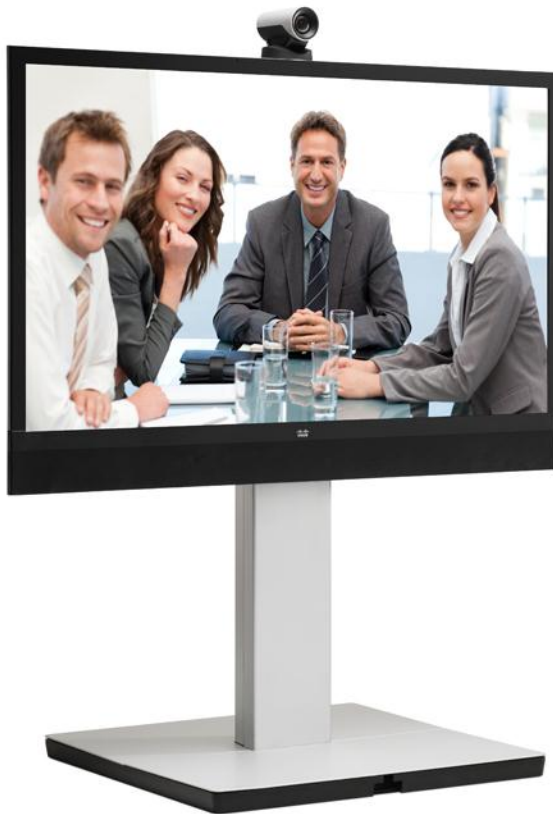
The Cisco TelePresence MX300 is a multi-purpose, room-based TelePresence system designed to make it easier and more cost effective to enable deeper integration of TelePresence into customers businesses. The MX300 can be set up in as little as 15 minutes quickly, easily turning any small to medium-sized meeting room into a nine-person TelePresence team room. The system offers 1080p, 30 frames per second, high-quality video at an affordable price. Global availability is targeted for the first quarter 2012.

Note: Cisco TelePresence MX300 requires software version TC5.0.0 or later.

The TC5.0.0 release introduces support for the new Cisco TelePresence MX300.

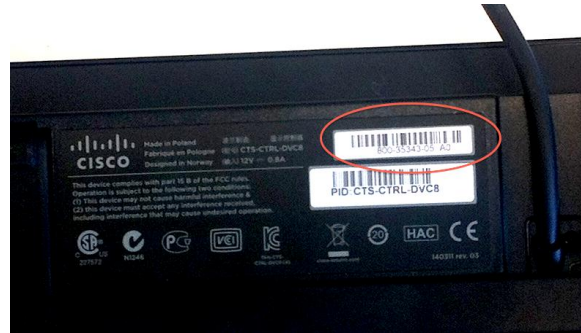
The TAN number can be found on the back of the Cisco TelePresence Touch 8 panel on the sticker positioned in the upper right corner.

Identify the compatibility level of the Touch panel by finding the TAN number in this table.

Version	Type	Compatibility level	TAN number
0	EX	A	800-35447-04
0	SX/C/Profile	A	800-35343-05
0	MX	A	74-9543-02
1	EX	C	800-35447-06
1	SX/C/Profile	C	800-35343-07
1	MX	C	74-9543-04
2	EX	B	800-38887-01
2	MX	B	800-38886-01
2	SX/C/Profile	B	800-38885-01
3	EX	C	800-38887-02
3	MX	C	800-38886-02
3	SX/C/Profile	C	800-38885-02
