# **Cisco TelePresence System C/SX/EX/MX/Profile Series**

Software release notes TC7

D1507103

January 2014

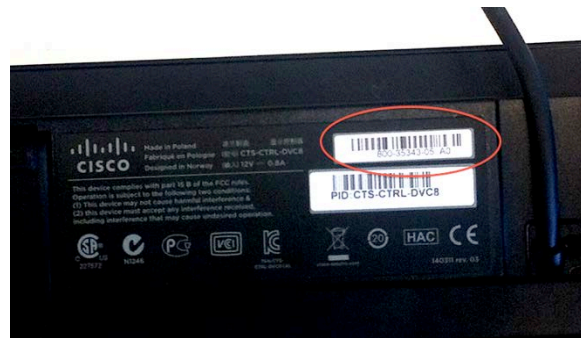
The TAN number can be found on the back of the Cisco TelePresence Touch 8 panel on the sticker positioned in the upper right corner.

Identify the minimum software supported by using the TAN number with this table.
