# Cisco RF Gateway 1 Release 3.02.07 Release Note

Cisco® RF Gateway 1 Release 3.02.07 fixes a bug that prevented new VoD streams from getting routed through RF Gateway 1 when the backup GbE port is active.

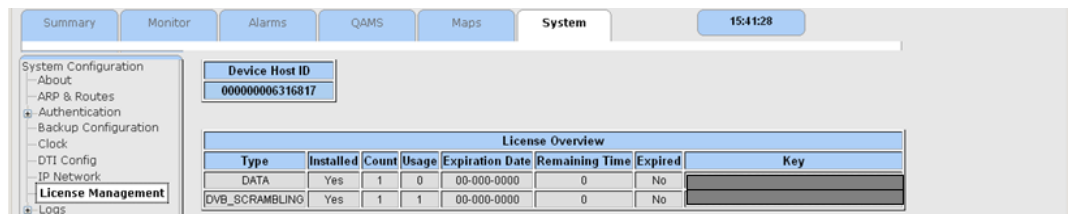
For systems requiring a license upgrade, a licensing capable RF Gateway 1 provides the operator with a new tree menu item, *License Management* located under the **System** tab. See the following screen. The menu provides an FTP mechanism to transfer license files to the device. It is recommended that the operator monitor the file transfer status using feedback from the FTP server.

The screenshot shows the Cisco RF Gateway 1 web interface. At the top, there are tabs for Summary, Monitor, Alarms, QAMS, Maps, and System. The System tab is selected, and the time 15:41:28 is displayed. On the left, a System Configuration tree menu is visible, with License Management highlighted. The main content area shows the Device Host ID as 000000006316817. Below this is a License Overview table.

License Overview							
Type	Installed	Count	Usage	Expiration Date	Remaining Time	Expired	Key
DATA	Yes	1	0	00-000-0000	0	No	
DVB_SCRAMBLING	Yes	1	1	00-000-0000	0	No
