Cisco RF Gateway 1 Software Release Notes, Release 2.02.19

Software Release 2.02.19 contains improvements in GbE port-pair operation in regards to redundancy and recovery. It also provides a new loop-through feature per port-pair for GbE traffic only. Release 2.02.19 includes IGMP implementation enhancements resulting in efficient IGMP message handling.

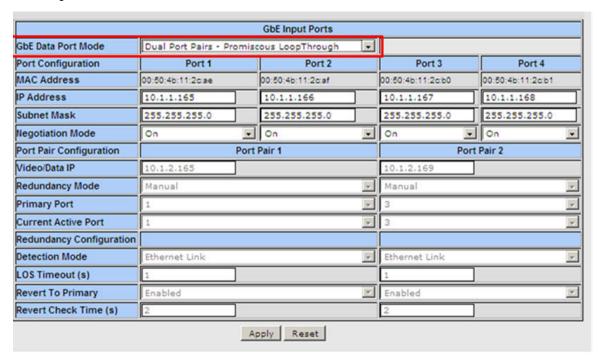
Software Release 2.02.19 includes GbE loop-through capability while operating in *Dual Port Pairs* mode. The user can operate the RF Gateway 1 in two additional GbE data port modes. Refer to Chapter 3, *General Configuration and Monitoring* of the *Cisco RF Gateway 1 Configuration Guide*, part number 4025112 for details. The user can navigate to the *System/IP Network* page to access the two new modes called *Dual Port Pairs - Promiscuous Loop Through* and *Dual Port Pairs - Non Promiscuous Loop Through*. While operating in *Dual Port Pairs - Non Promiscuous Loop Through* mode, packets destined for the active GbE port MAC address (for example, unicast traffic) are forwarded to the RF Gateway 1 packet processor for normal processing. All other multicast or broadcast traffic is sent to the backup port for loop-through. Conversely, while operating in *Dual Port Pairs - Promiscuous Loop Through* mode, all traffic (including unicast, multicast, or broadcast packets) are looped through to the backup port. In this mode, the traffic that needs to be processed by the RF Gateway 1 will still be processed.

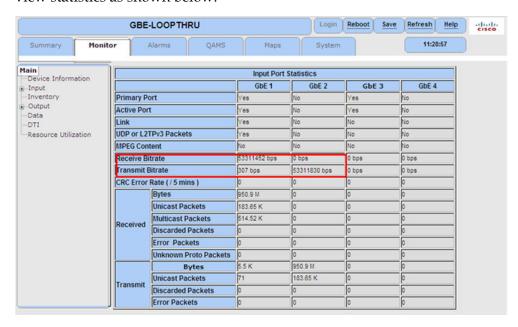
While operating in GbE Loop Through modes, monitoring capabilities are provided to view Receive/Transmit bitrates indicating flow of traffic across GbE ports belonging to a Dual Port Pair. The user can navigate to the *Monitor/Main* page and view statistics as shown below.

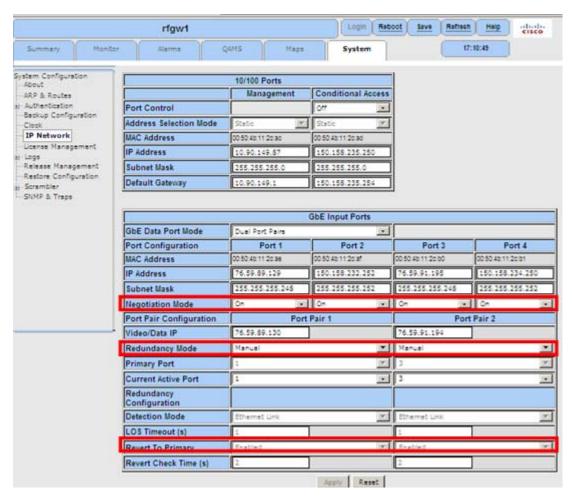
- 1 Launch your web browser.
- 2 In the IP Address field, enter the RF Gateway 1 IP address.
- 3 Click Enter.
- 4 Click the *System/IP Network* tab and review the IP settings. See the following screen.

Follow these instructions to display the *System/IP Network* page.
